Re: Application of Dwight Project for Certification by the Low Impact Hydropower Institute

Dwight Station Penstock Failure 10/10/13

DWIGHT HYDROELECTRIC PROJECT

FERC No. 10675-MA

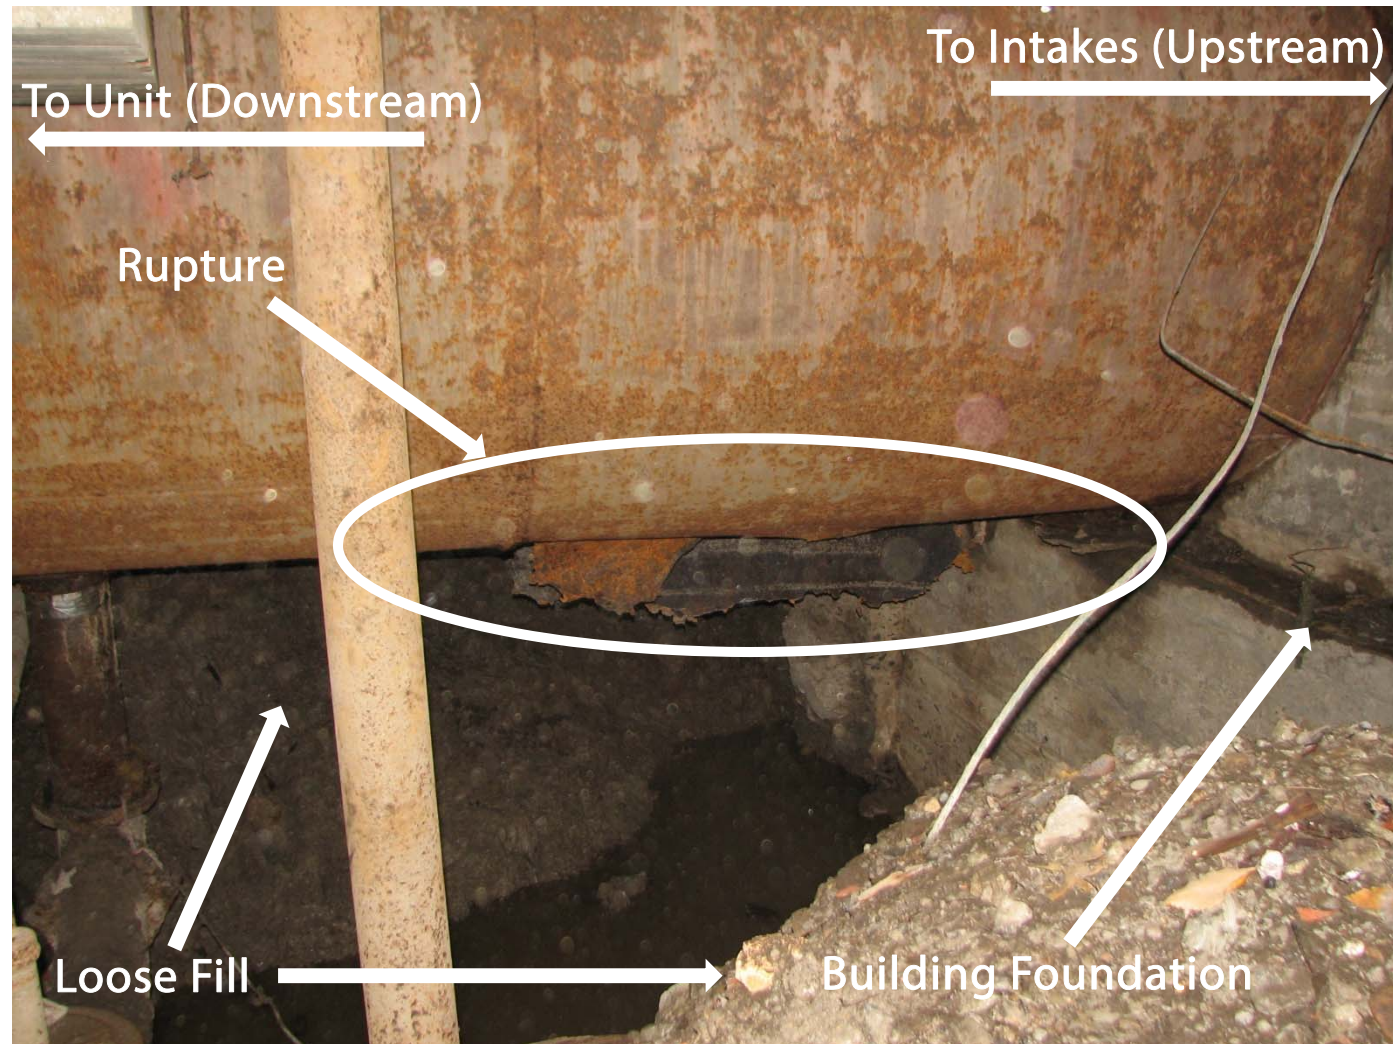
The rupture is in the Unit 2 penstock, a riveted steel penstock initially constructed in 1920 and lined with a spray on rubber coating in 2004.

The failure occurred at the 6 o'clock position in the part of the penstock located in the crawl space beneath the main operating floor of the plant.

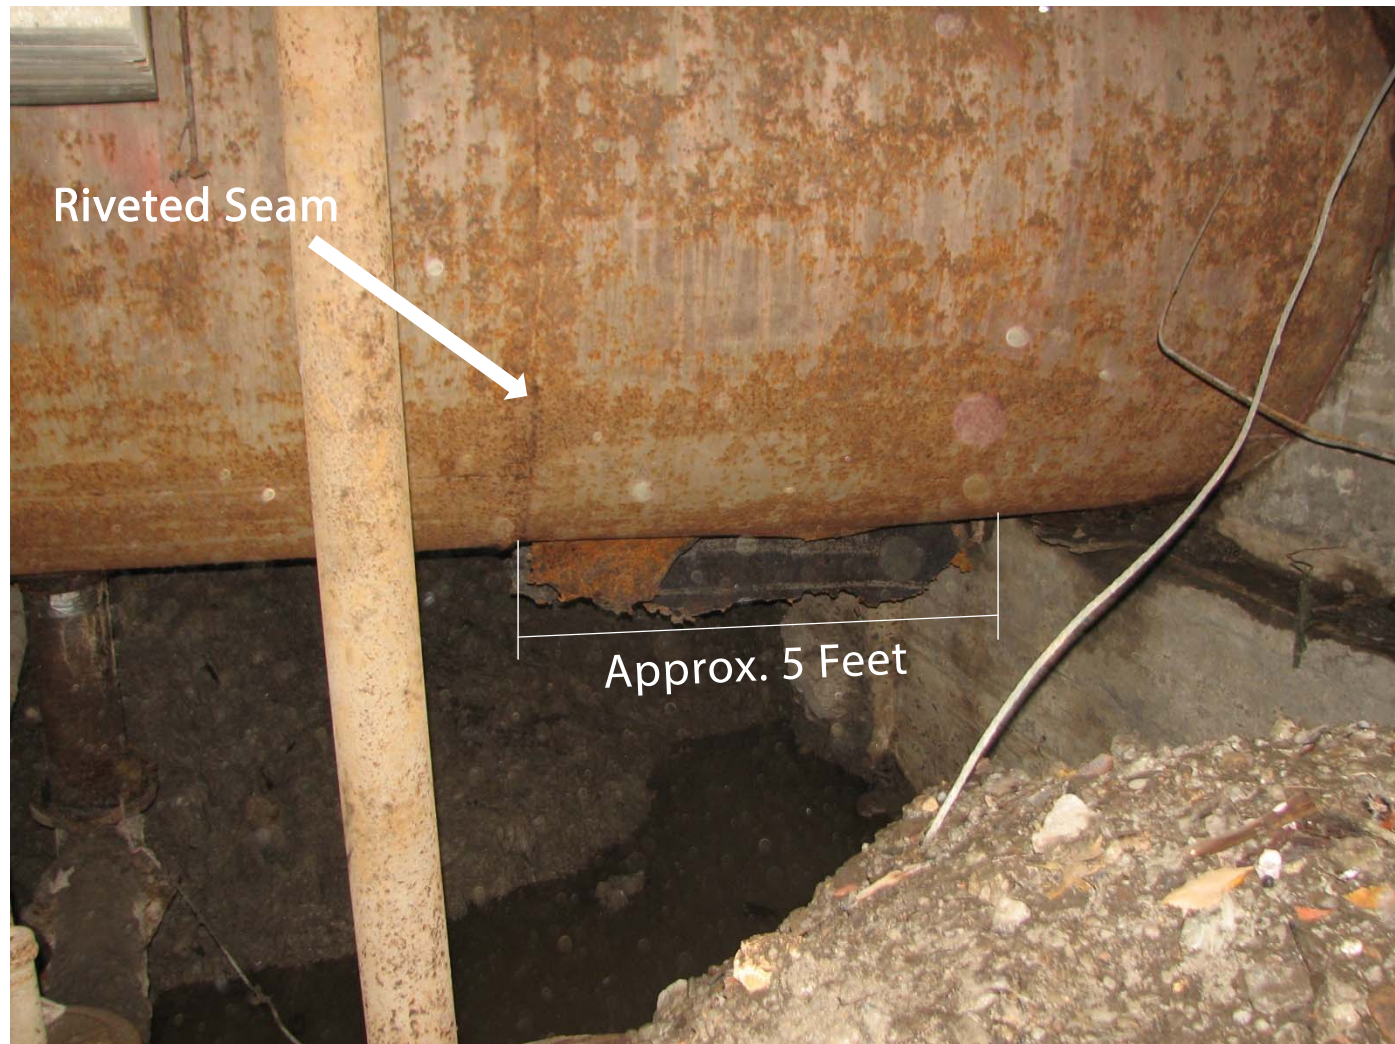
The rupture is approximately 5 feet long extending from the circumferential riveted seam to the foundation wall.

There is no longitudinal seam in the location of the failure.

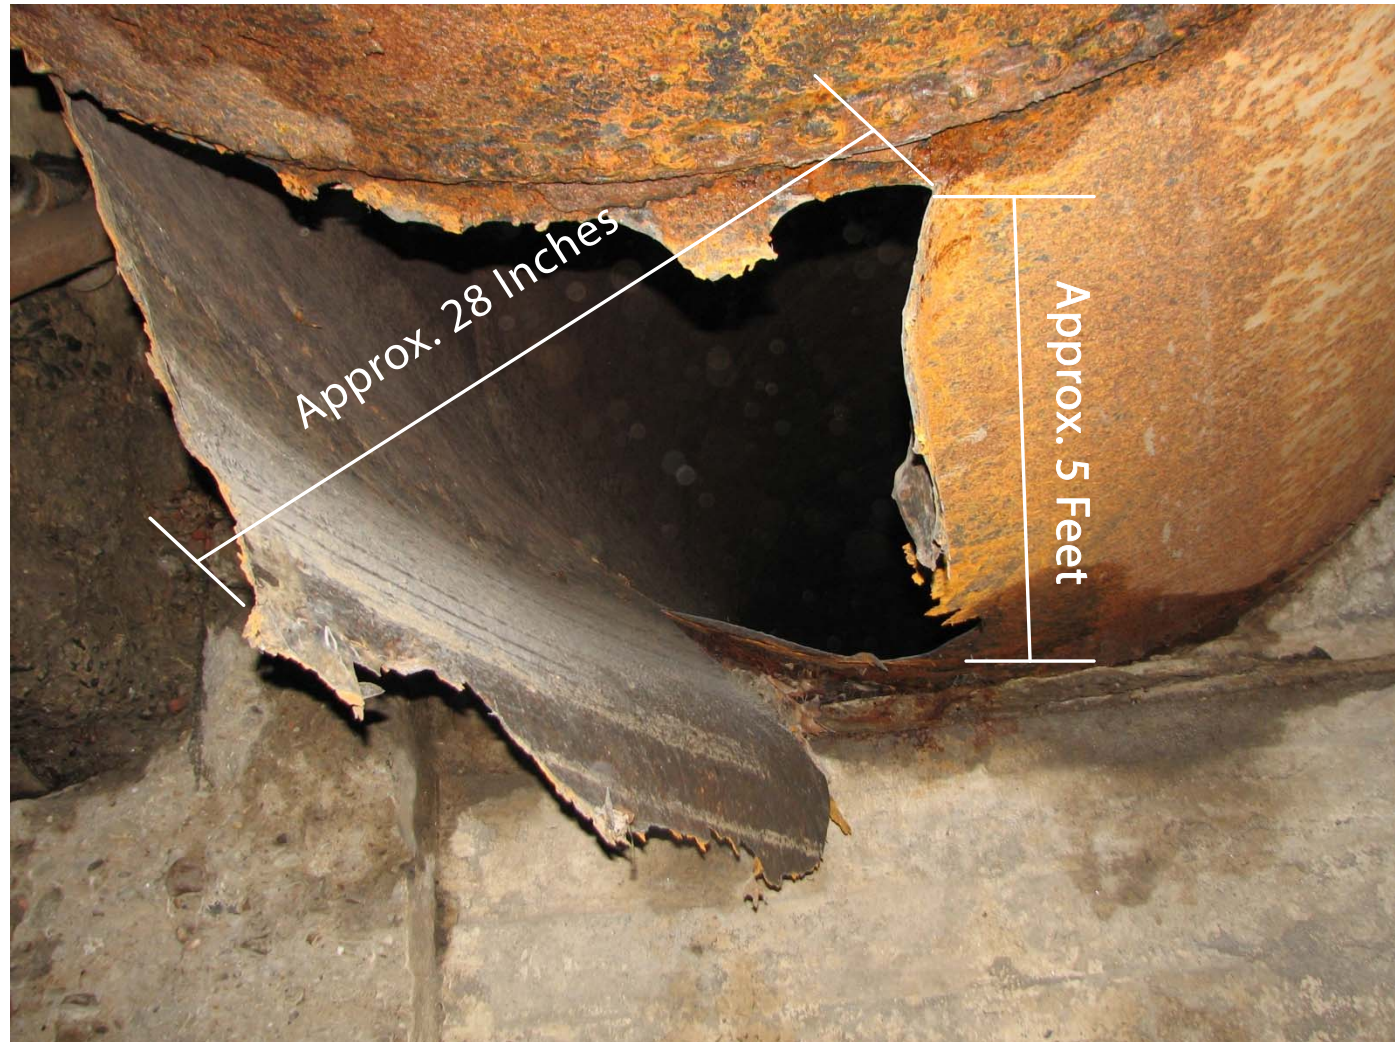
This photo was taken looking towards the intakes (upstream)

In addition to the longitudinal tear, there is a circumferential tear just before the riveted joint and another at the foundation wall.

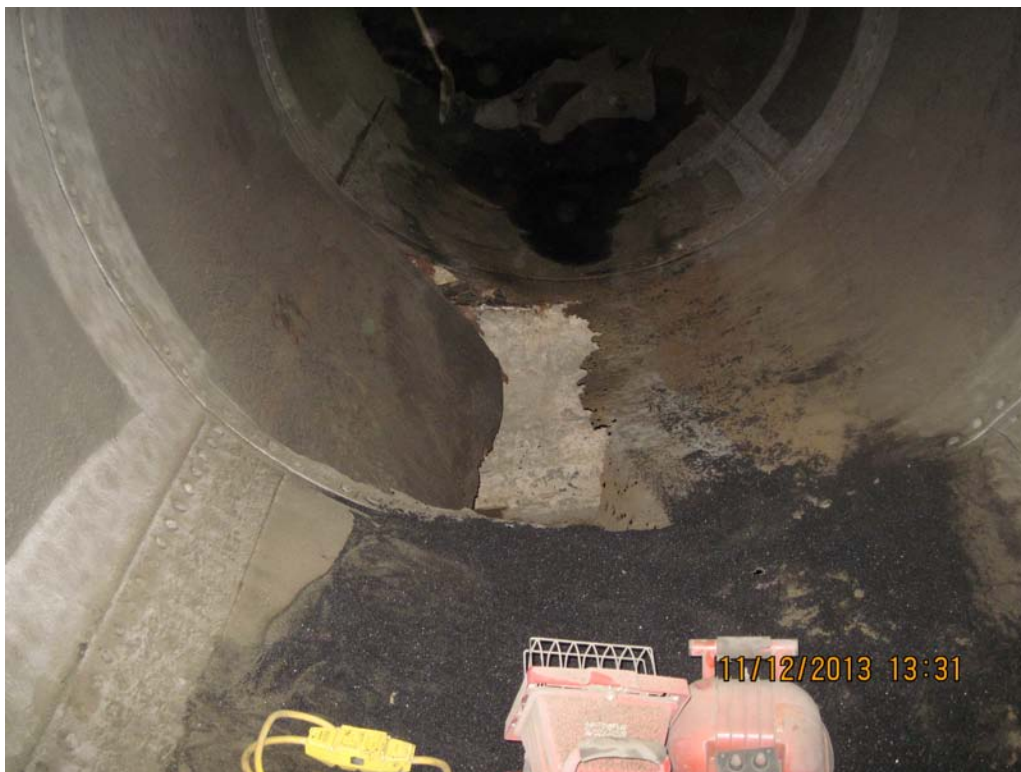
PHOTO 1 – INTERIOR OF PENSTOCK NO. 2 FAILURE LOOKING UPSTREAM

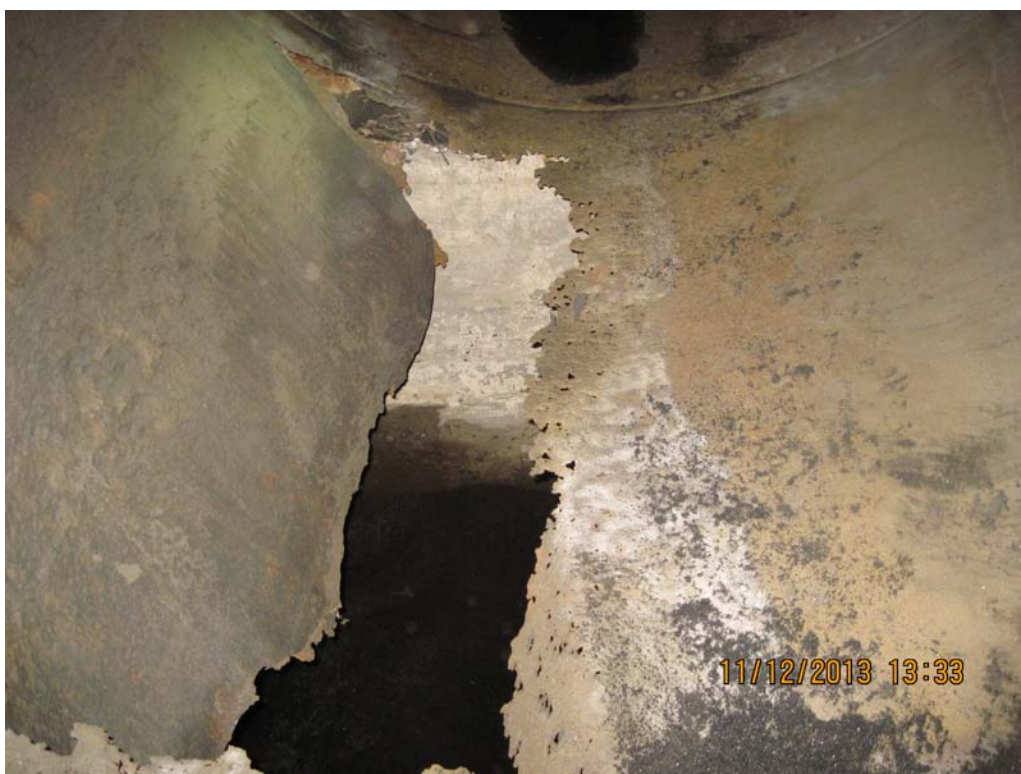
PHOTO 2 – CLOSER VIEW OF PENSTOCK NO. 2 FAILURE

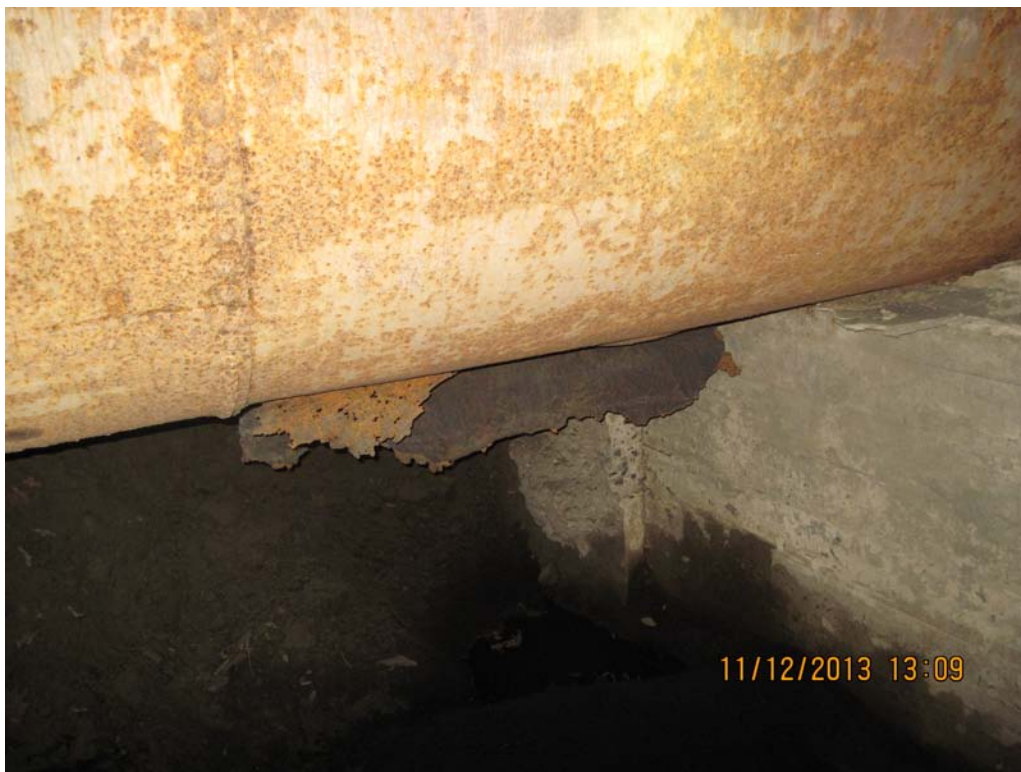
PHOTO 3 – EXTERIOR OF PENSTOCK NO. 2 FAILURE

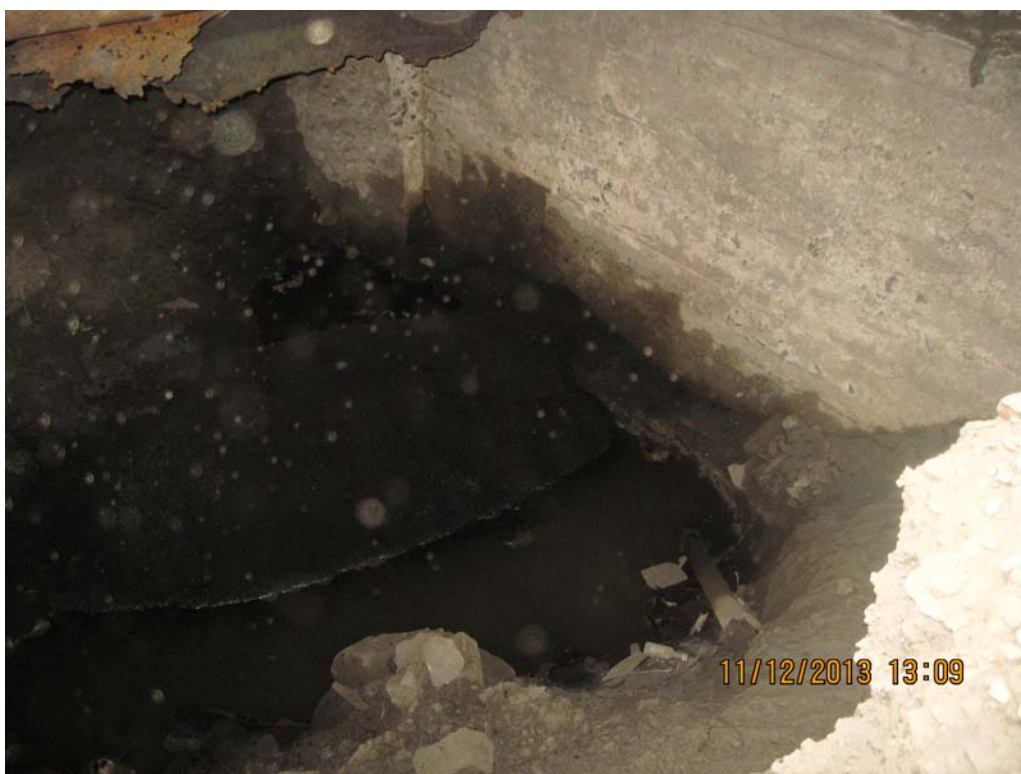
PHOTO 4 – DISPLACED SOIL BELOW PENSTOCK NO. 2 FAILURE

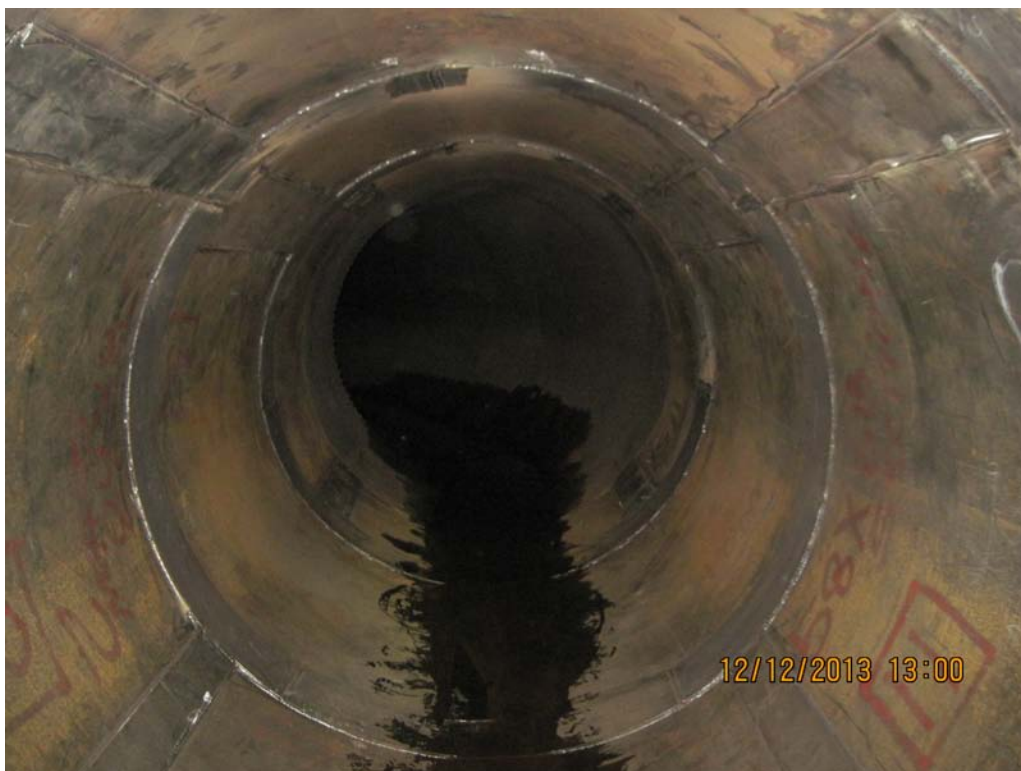
PHOTO 6 – PENSTOCK NO. 2 INTERIOR STEEL SLEEVE REPAIRED SECTION

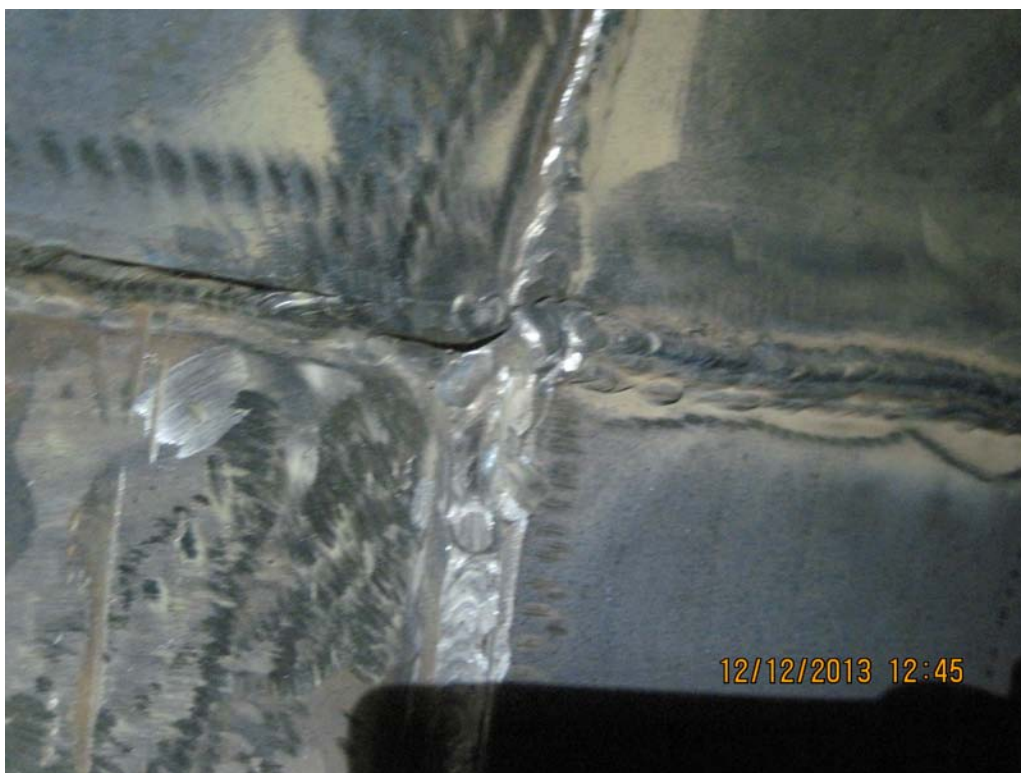
PHOTO 9 – PENSTOCK NO. 2 CLOSE UP OF 1/4 INCH FILLET WELDS

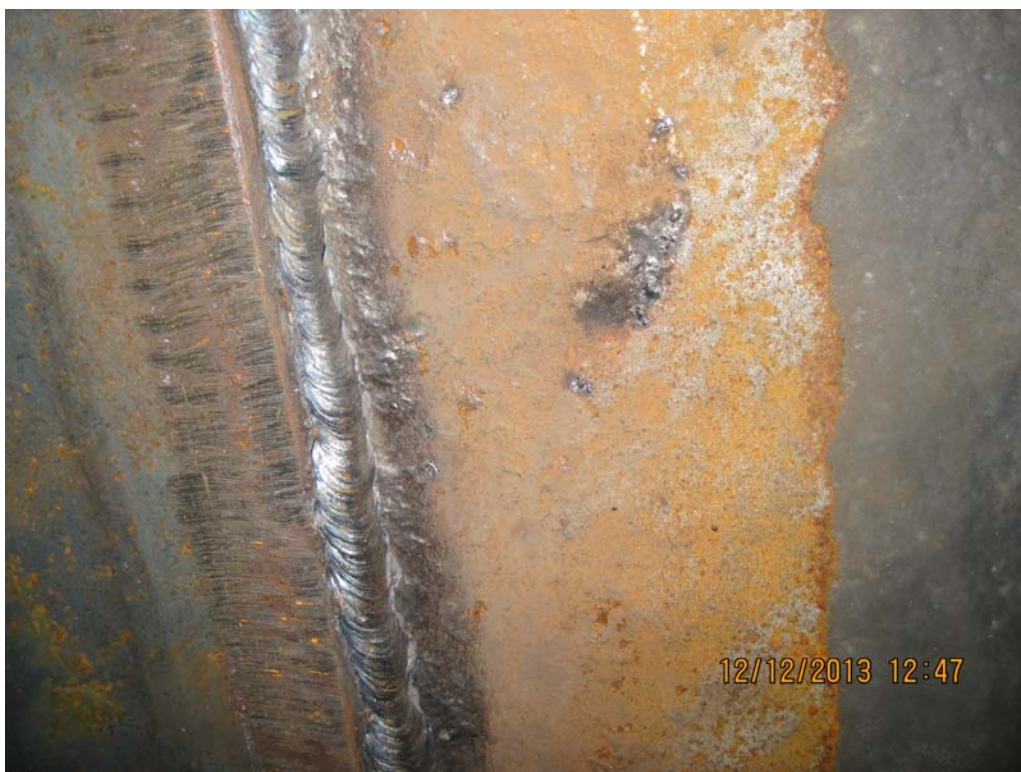
PHOTO 10 – PENSTOCK NO. 2 CLOSE UP OF 1/4 INCH FILLET WELD & SAND BLASTED COATING

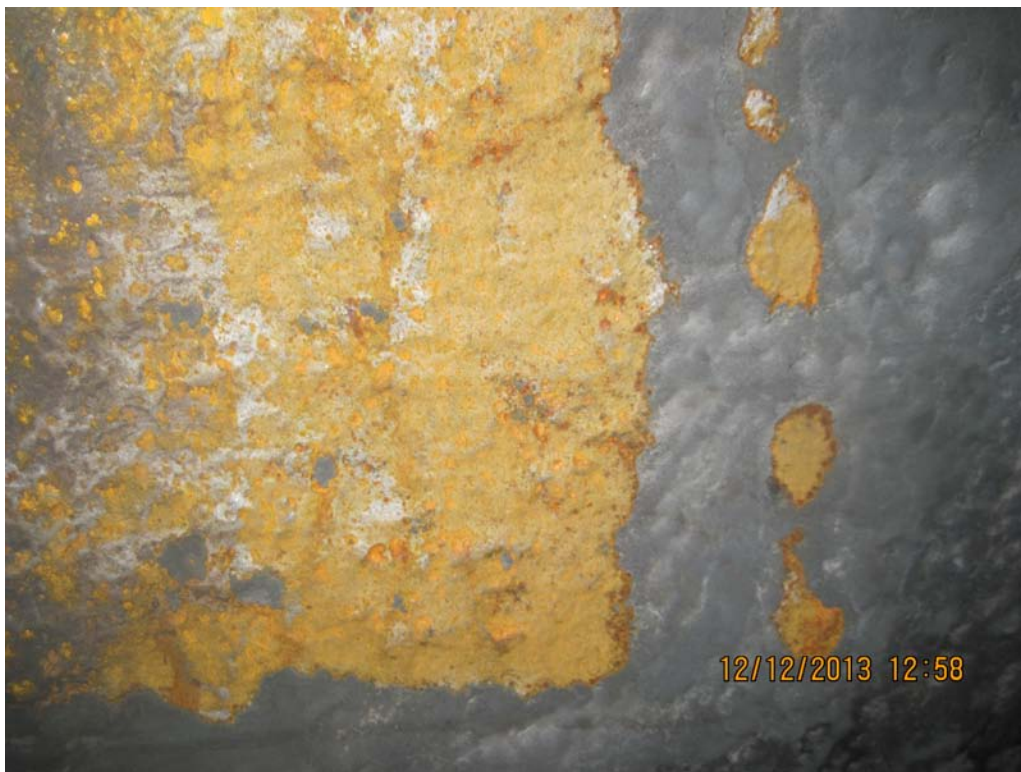
PHOTO 13 – EDGE OF PENSTOCK NO. 2 COATING NEAR REPAIR SLEEVE

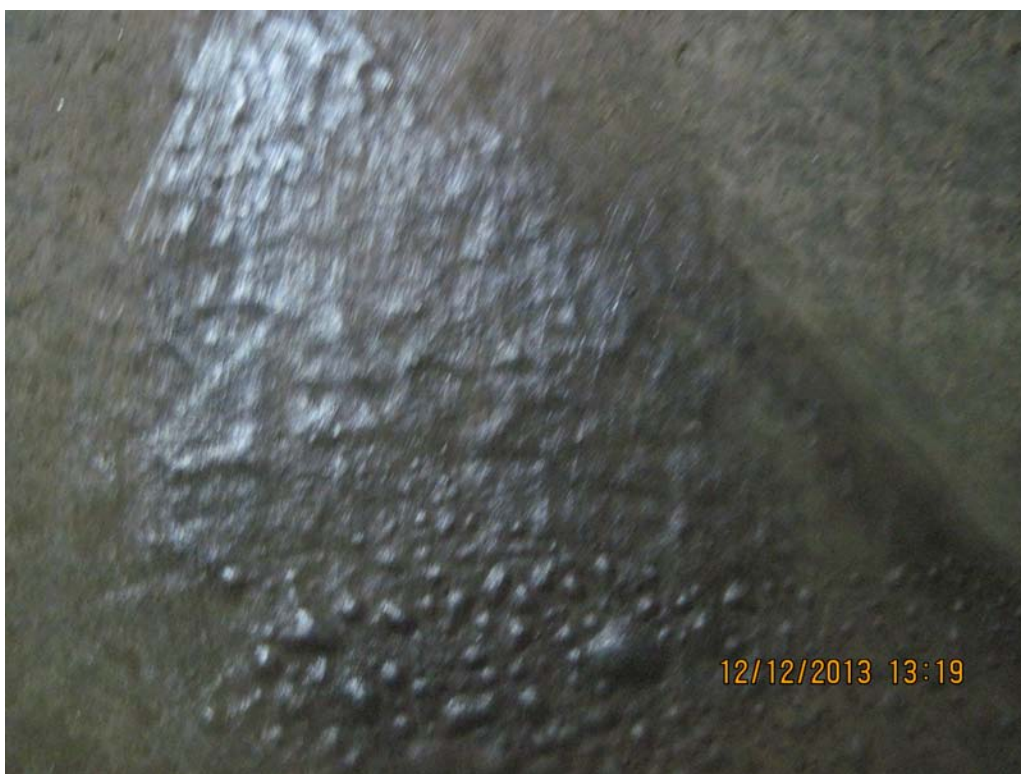
PHOTO 14 – PENSTOCK NO. 2 IRREGULAR SURFACE OF INTERIOR COATING

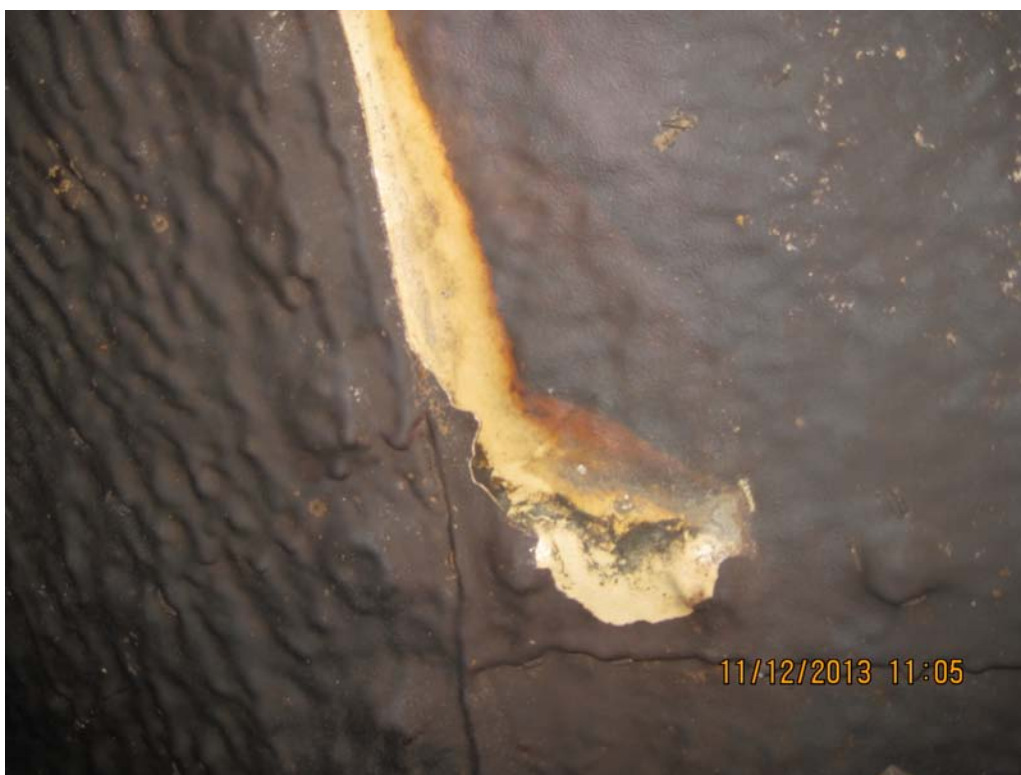
PHOTO 18 – DELAMINATION OF PENSTOCK No. 3 COATING

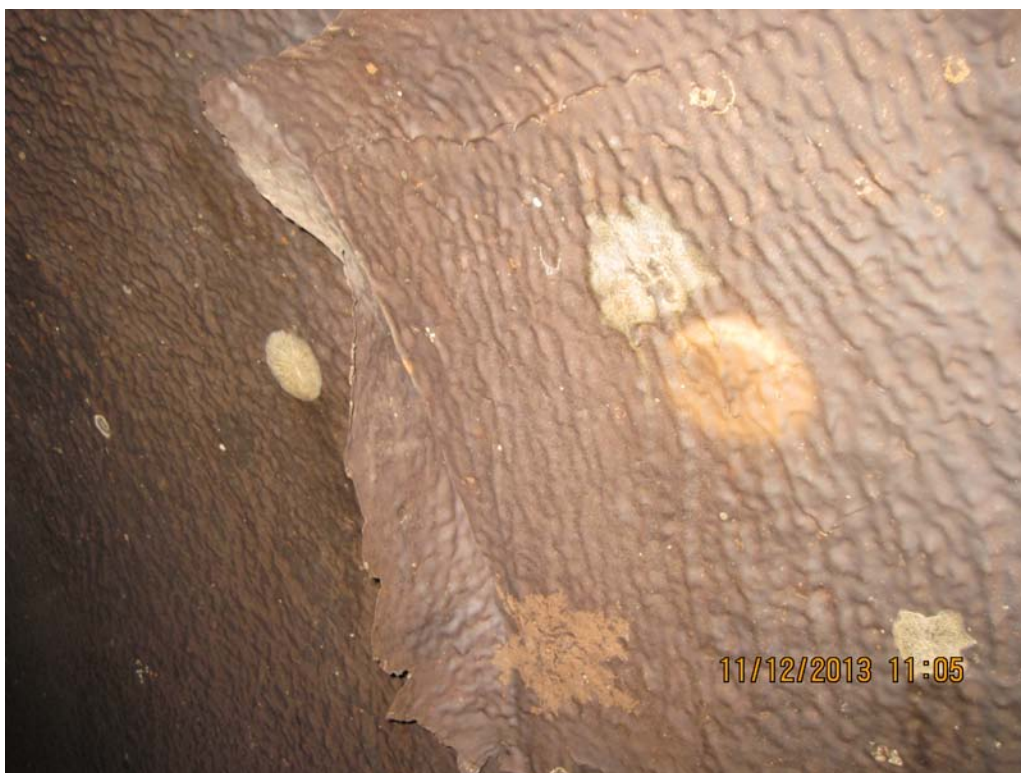
PHOTO 19 – DELAMINATION OF PENSTOCK NO. 3 INTERIOR (1)

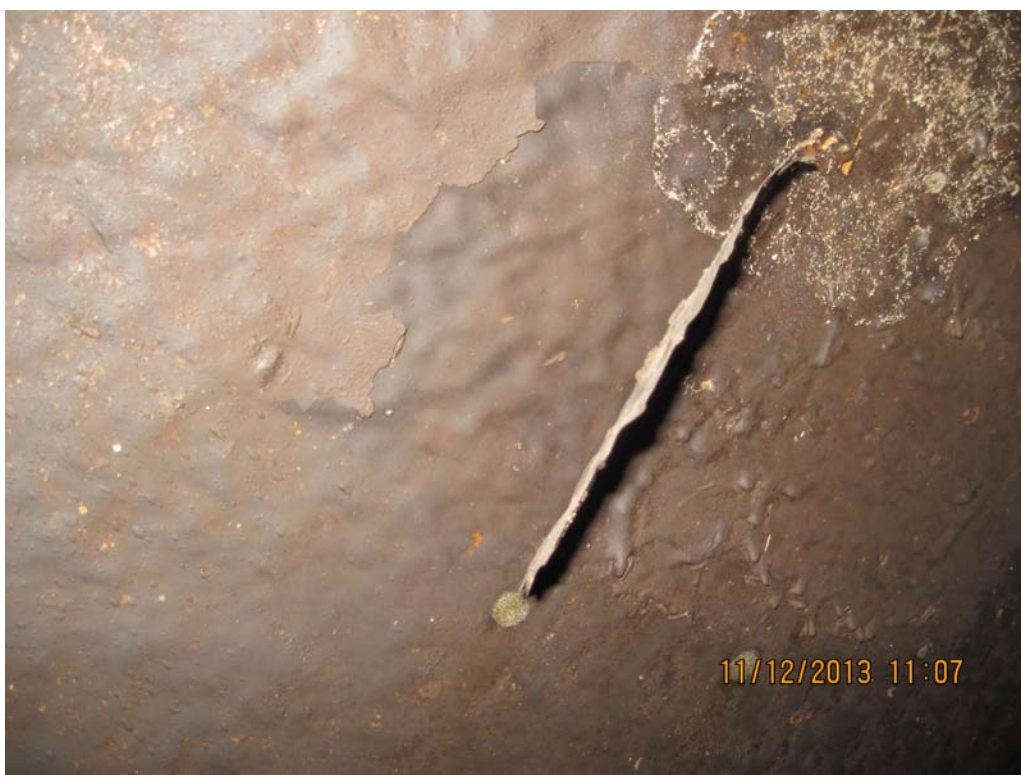
PHOTO 20 – DELAMINATION OF PENSTOCK NO. 3 INTERIOR (2)

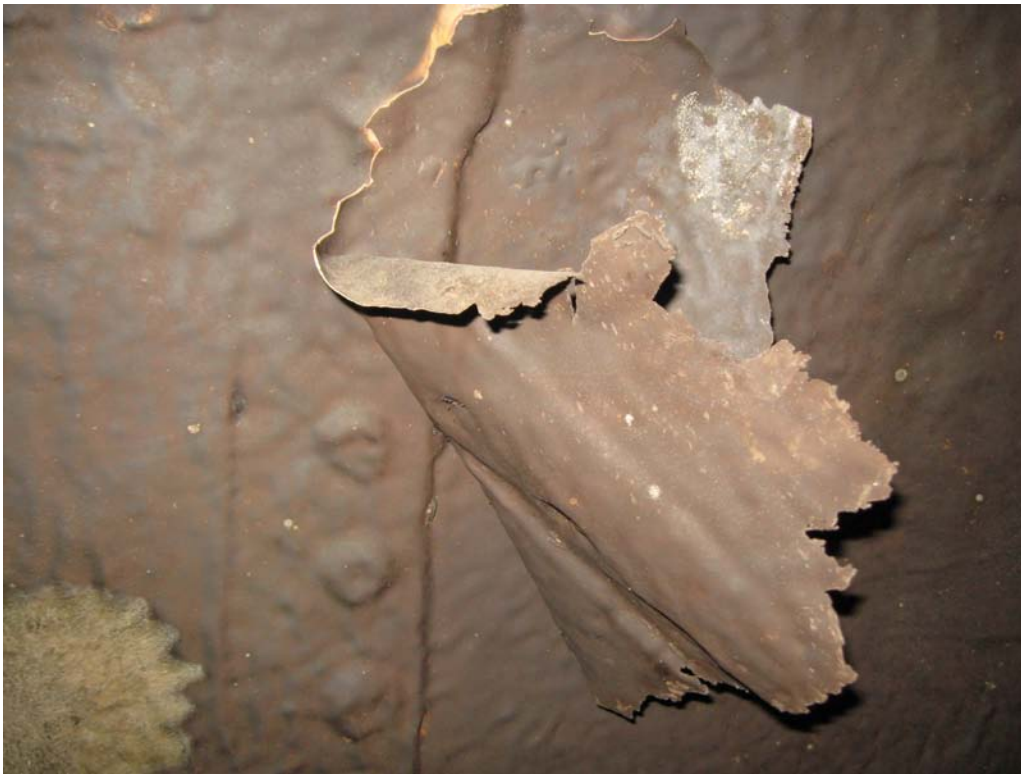
PHOTO 21 – DELAMINATION OF PENSTOCK NO. 3 INTERIOR (3)

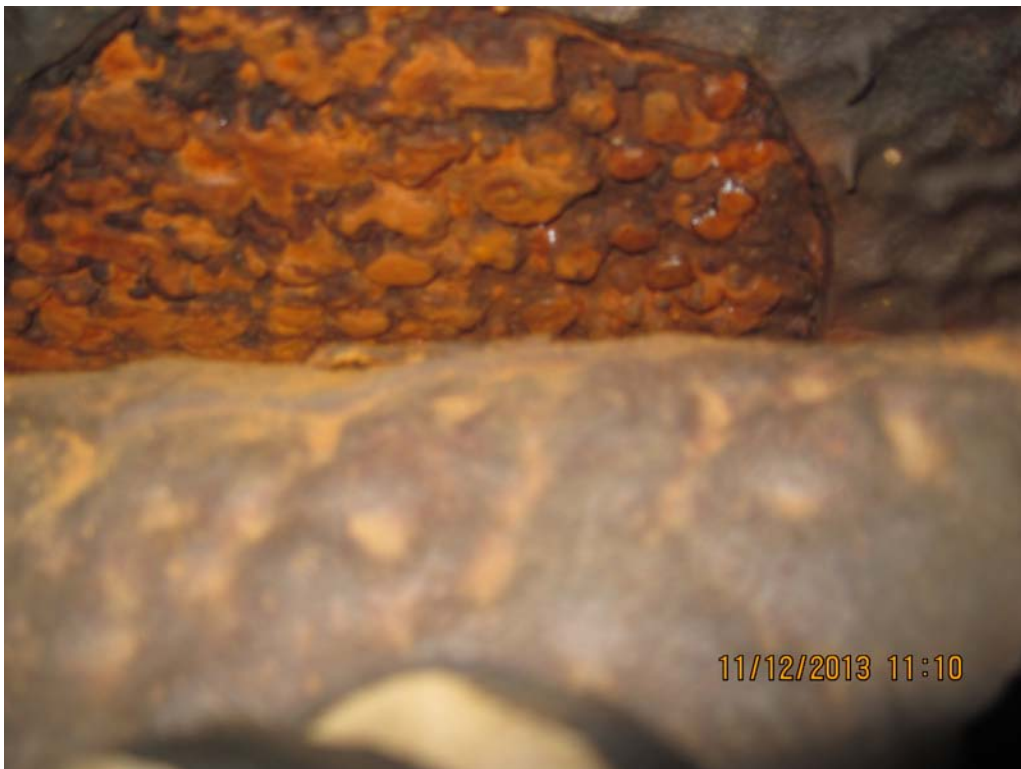
PHOTO 22 – CLOSE UP VIEW OF PENSTOCK NO. 3 DELAMINATION

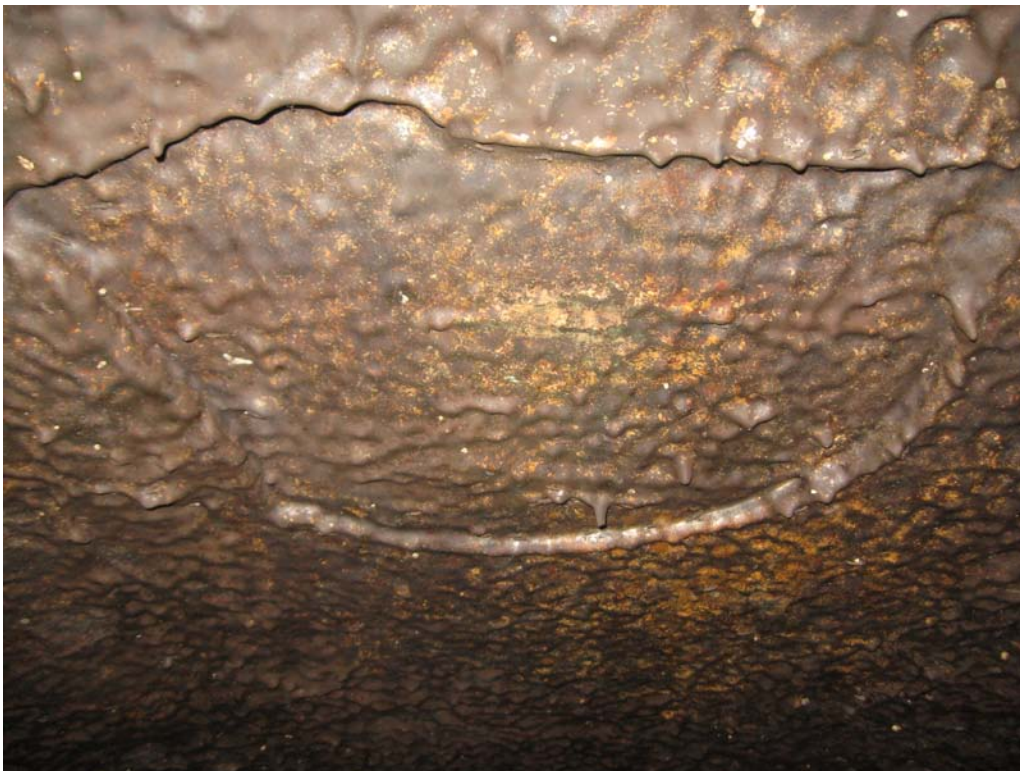
PHOTO 32 – PENSTOCK NO. 4 DELAMINATED COATING

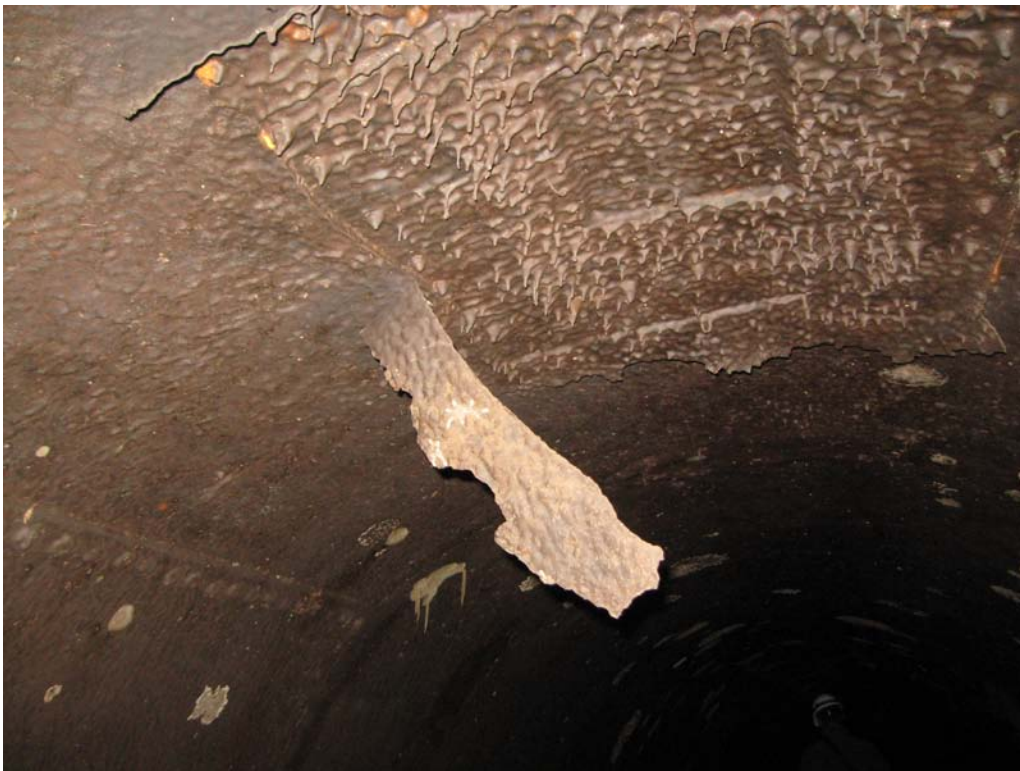
PHOTO 34 – PENSTOCK NO. 4 PATCH PLATE (APPROX. 2' X 4') AT STATION 0+86

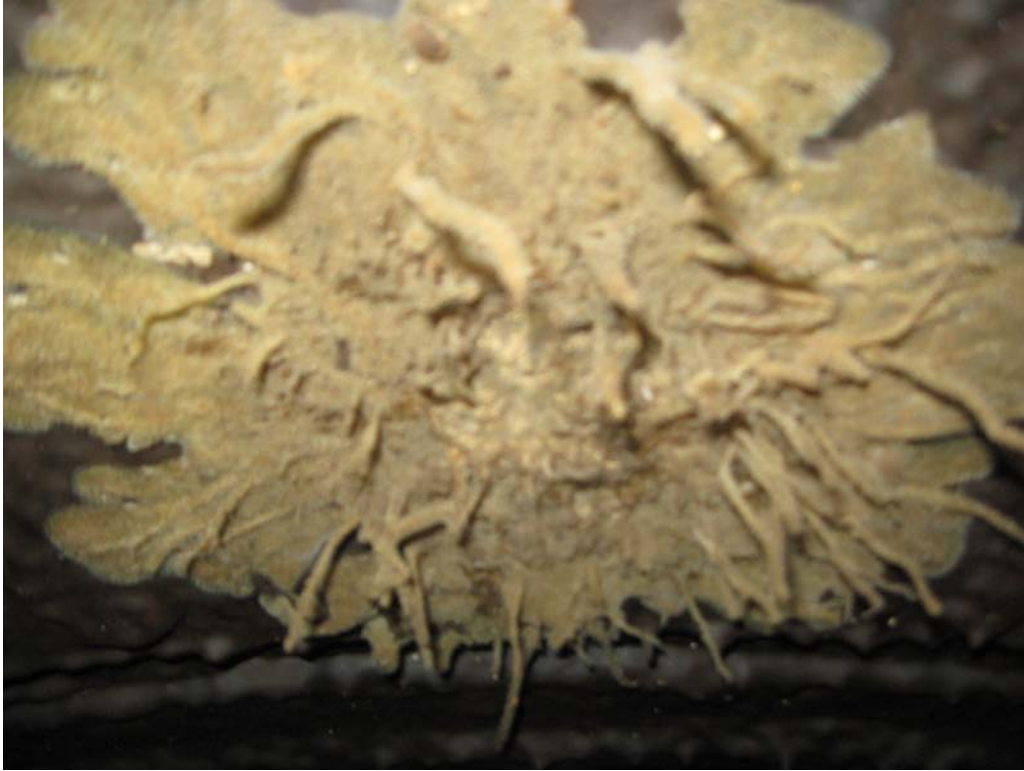
PHOTO 35 – BACTERIA ATTACHED TO INTERIOR PENSTOCK COATING (MULTIPLE LOCATIONS)

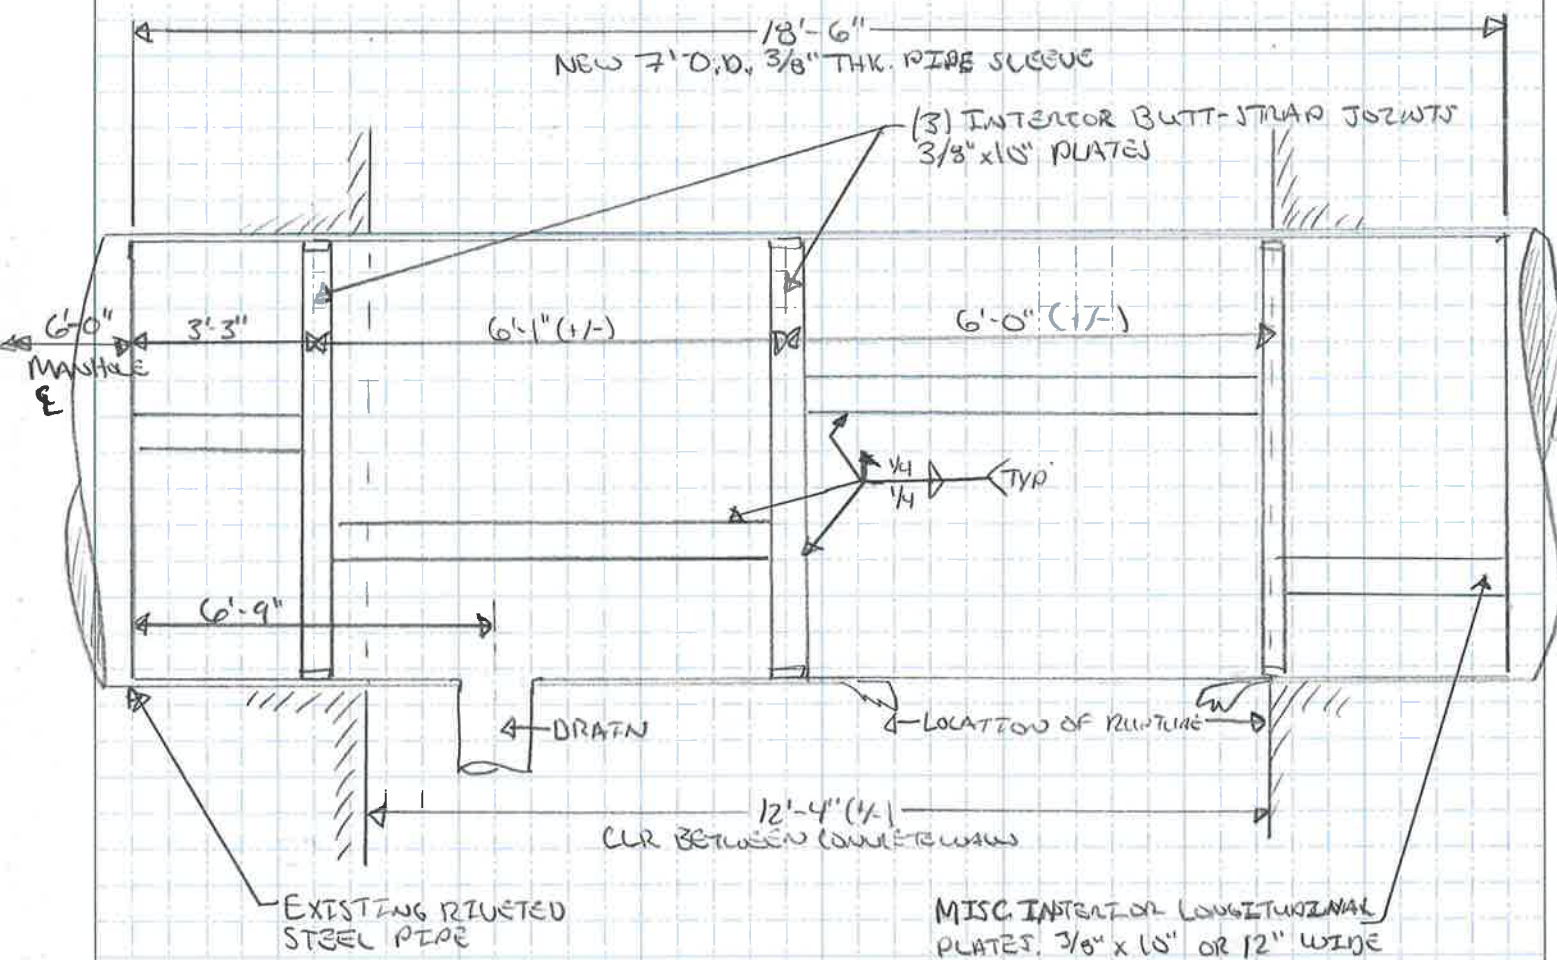
PENSTOCK NO. 2 REPAIR DETAIL

- AS OBSERVED DURING 12/12/13 SITE INSPECTION
