**DAM SAFETY INSPECTION REPORT
FEDERAL ENERGY REGULATORY COMMISSION
OFFICE OF ENERGY PROJECTS
DIVISION OF DAM SAFETY AND INSPECTIONS
NEW YORK REGIONAL OFFICE**

Licensee Indian River Hydro LLC Project No. 2631-MA

Project Name Woronoco (NATDAM No. MA00737)

Inspected by C Y Hsu & Noel Aglubat Date July 29, 2010

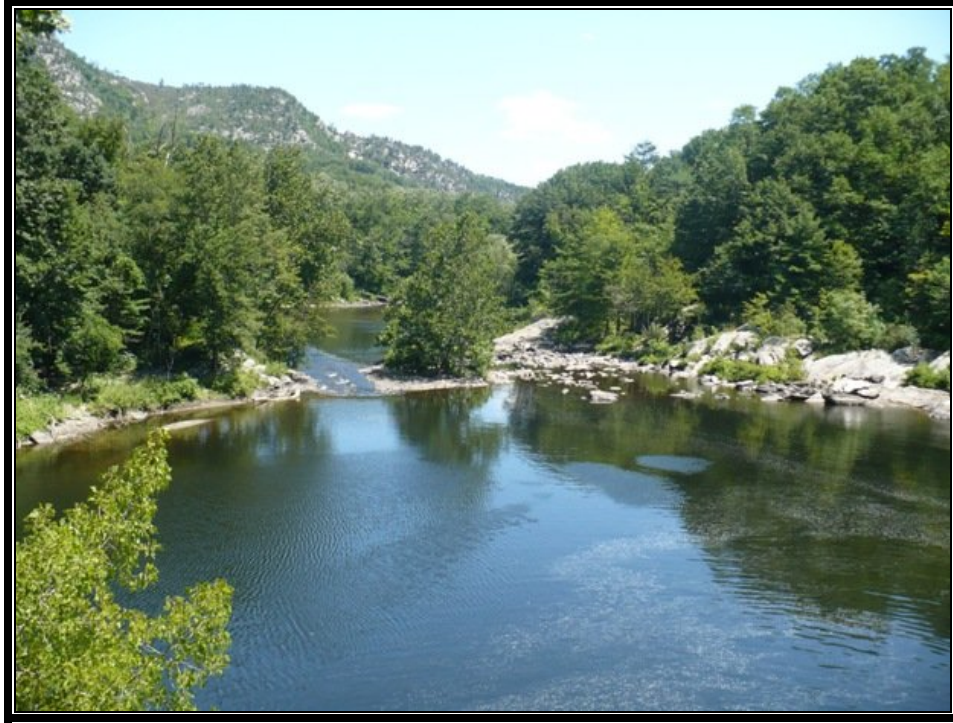
Field observations during the inspection revealed no significant changes in downstream conditions (**Photo Nos. 1 & 2**) to warrant a revision in the present hazard potential classification.

Photo No. 1 - View of the downstream channel on the project south side. Note the lower left water is fish drop pool.

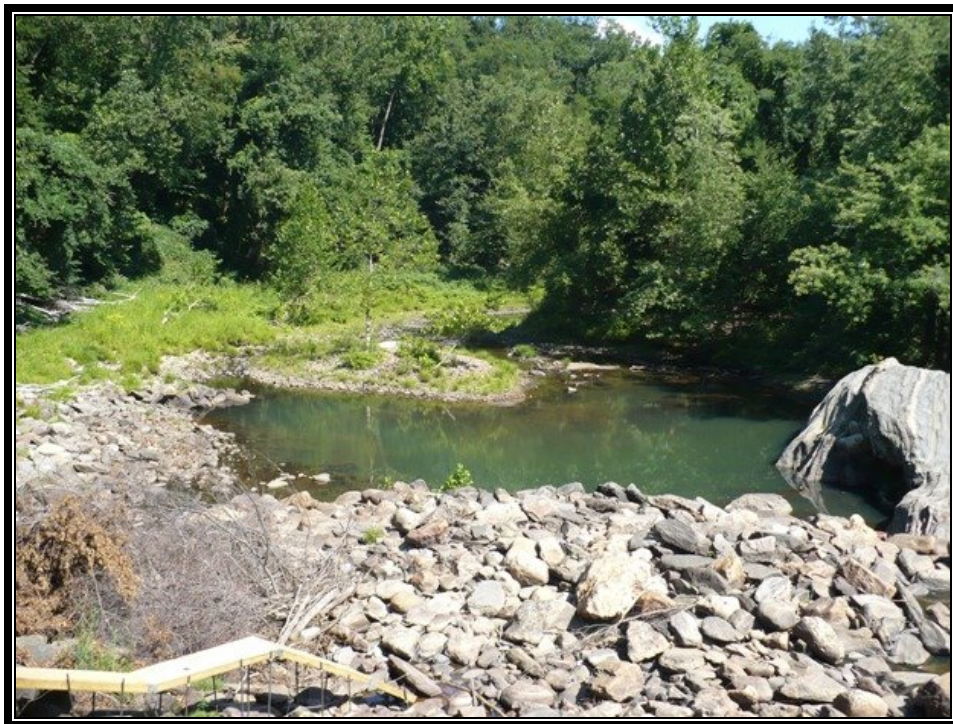
Photo No. 2 - View of the north side project downstream channel.

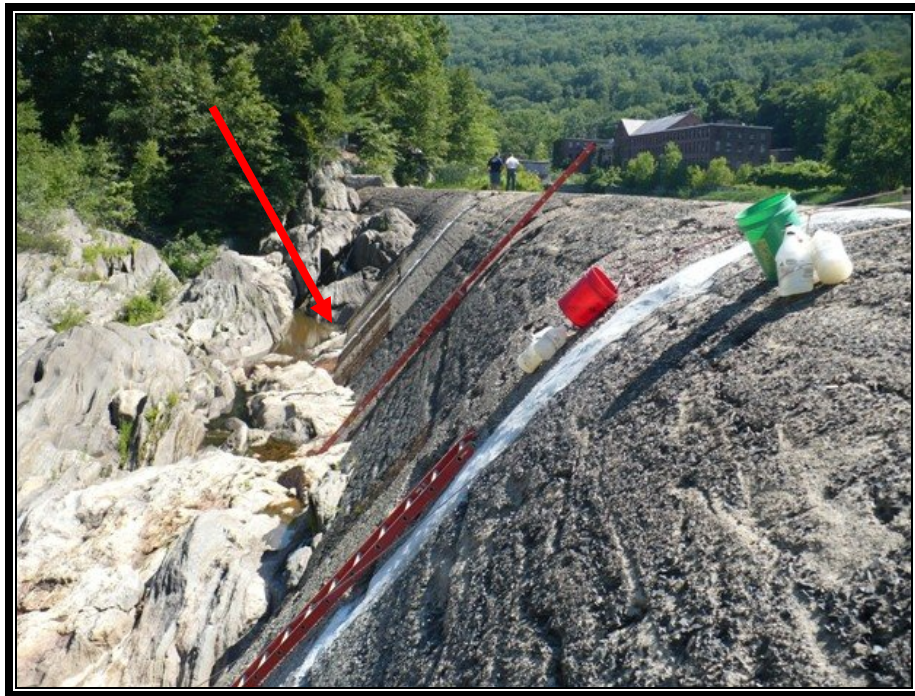
The north dam was found to be in satisfactory conditions. At the time of the inspection the Licensee was performing concrete maintenance on the downstream face of the dam (**Photo No.3**). The south dam was found to be in satisfactory condition with the exception of some deteriorated concrete on the down stream face (**Photo No. 4**). The Licensee proposed to perform concrete maintenance work once the work was completed on the north dam. The work will be verified during the next dam safety inspection.

Photo No. 3 – North Dam looking toward south from the left abutment gate structure. Note the repairs being made to the dam surface.

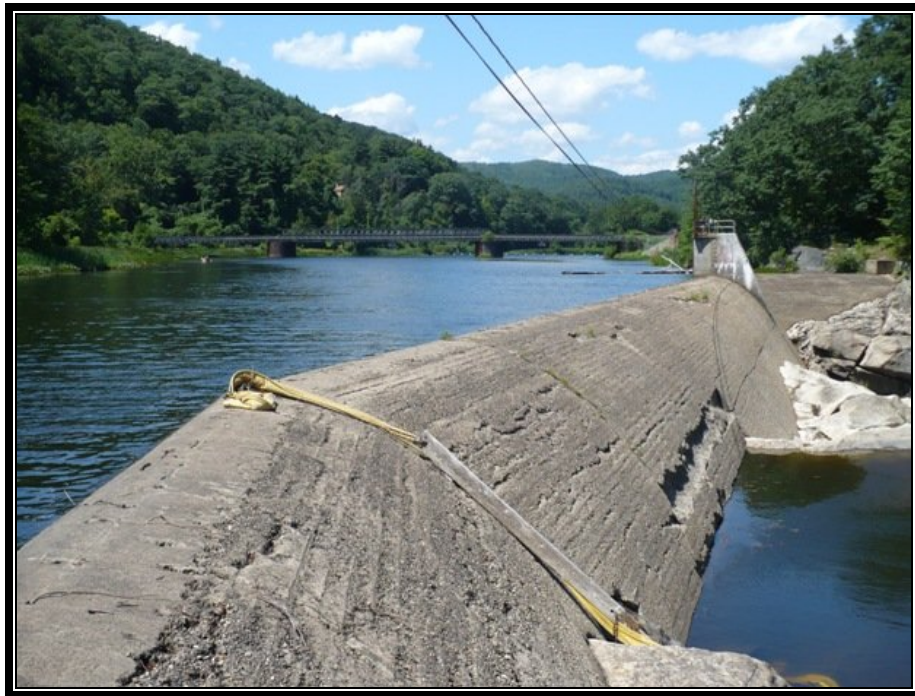
The Licensee has begun repairs to the South Dam as shown in **(Photo No. 4)** as per last year's inspection recommendation. The Licensee has also established a vegetation control program and the Licensee have maintained control of brush growth throughout the project.

Photo No. 4 – South Dam looking north toward south from the rock outcropping in the Westfield River. Note the gouges at the dam surface, the Licensee proposed to repair the remaining gouges at a later date.

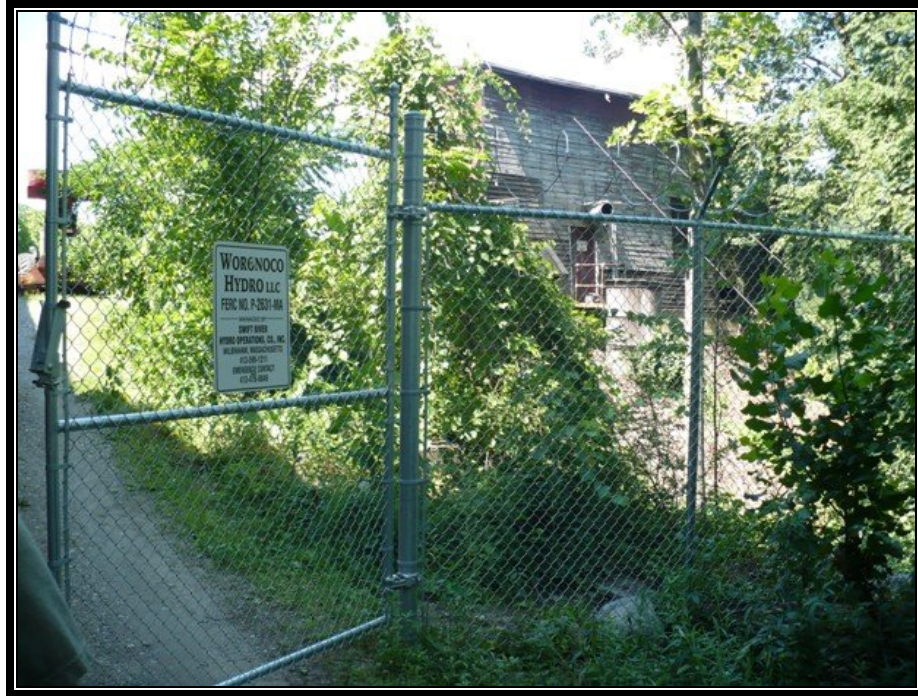
The project intake structure is located adjacent to the south dam, and includes trash racks with 1.25-inch-clear bar spacing and a downstream fish passage facility. The gatehouse and intake structure (**Photo No. 5**) were found to be in good to fair condition. During the previous report period the Licensee installed a new steel roller safety gate in place of the dilapidated wooded bulkhead gate. The new gate can close under its own weight if there is a plant trip and the turbine wicket gate fails to close. The gate can also be manually closed.

Photo No. 5 – Gatehouse and intake structure looking upstream from the project security fence. Note the project sign.

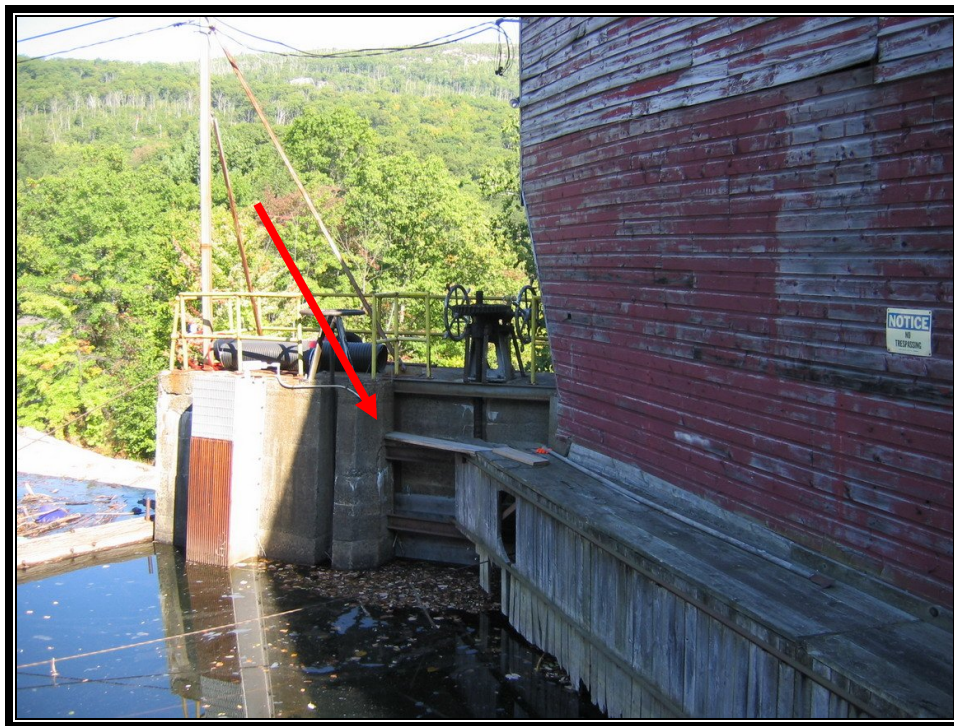
The sluice gate (**Photo No. 6**) located next to the gatehouse is in good condition. According to the Licensee, a gate efficiency test was conducted during this report period. Due to the gate mechanism failure, the gate could not be closed. In order to restore the gate operating condition, the reservoir was drawn down and an emergency repair performed. The Licensee had informed all resource agencies of the reservoir draw down. A new stoplog closure structure was installed immediately upstream, in the previous report period, to dewater the forebay area without draining the entire impoundment.

Photo No. 6 – View of the sluice gate adjacent to the intake Structure.

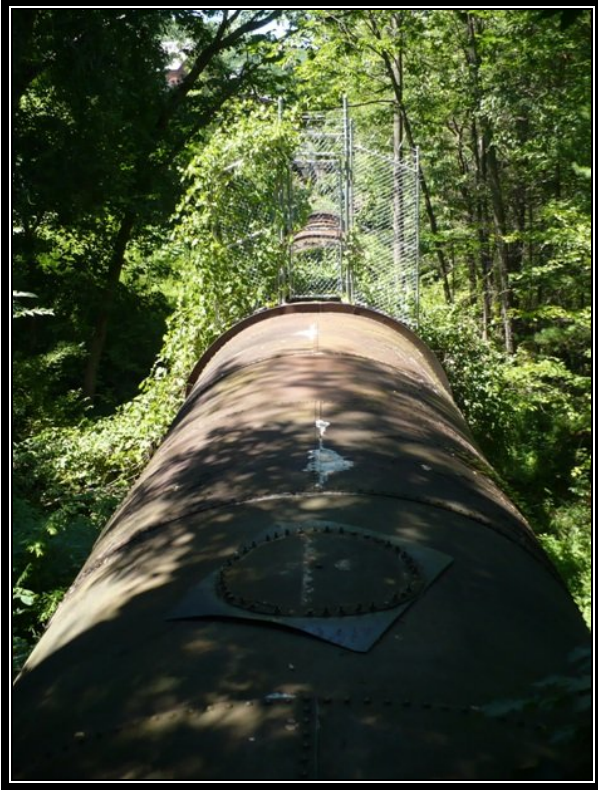
The penstock which runs partially underground and partially above ground appeared to be in good condition with no leakage or any significant deterioration of the concrete saddles (**Photo Nos. 7 & 8**). The concrete piers supporting the penstock leading to the powerhouse were under repair during this reporting period (**Photo No. 9**). The V-shape expansion joint (**Photo No. 10**) was observed during this inspection and was found to have slightly expanded compared to the previous inspection. The Licensee was asked to monitor this condition and report on any changes.

Photo No. 7 – View of the above ground steel penstock looking upstream from the powerhouse.

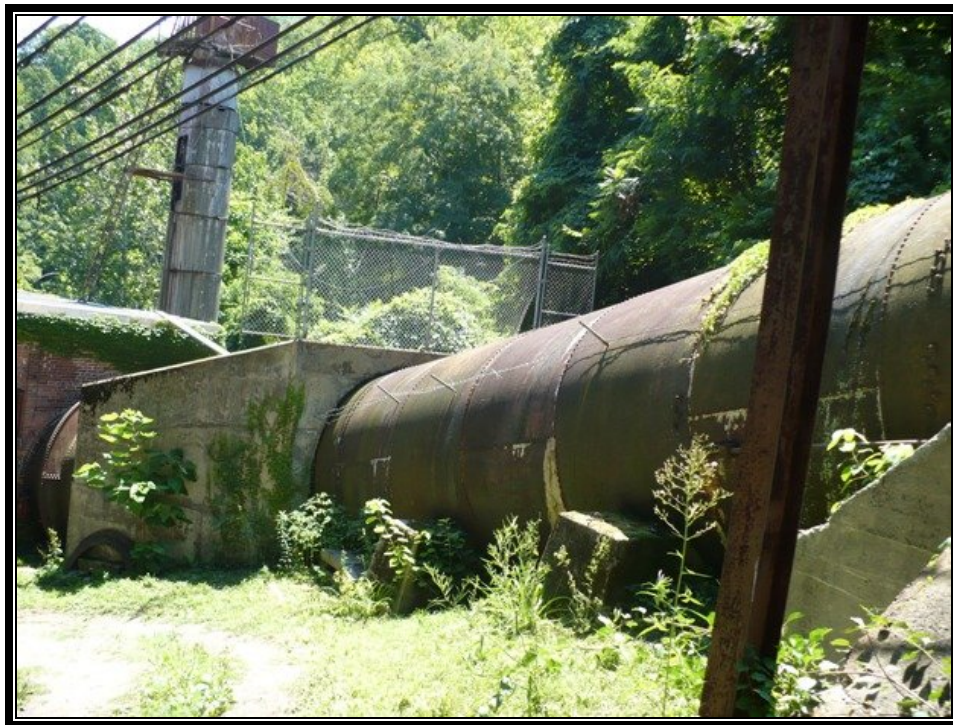
Photo No. 8 – View of project penstock at access road.

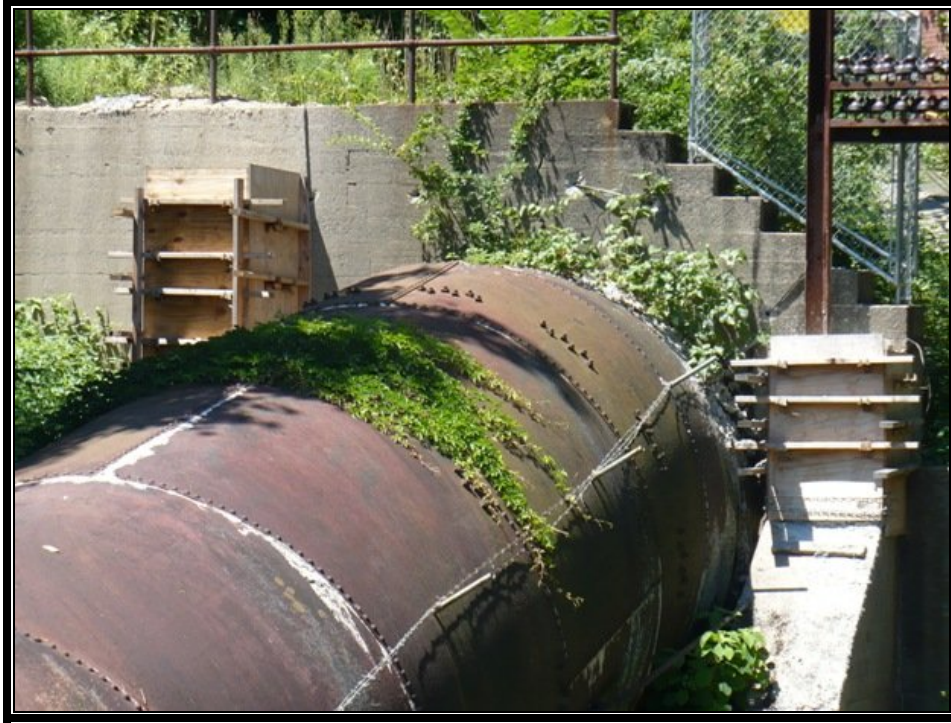
Photo No. 9 – Close view of repairs made to concrete piers supporting penstock.

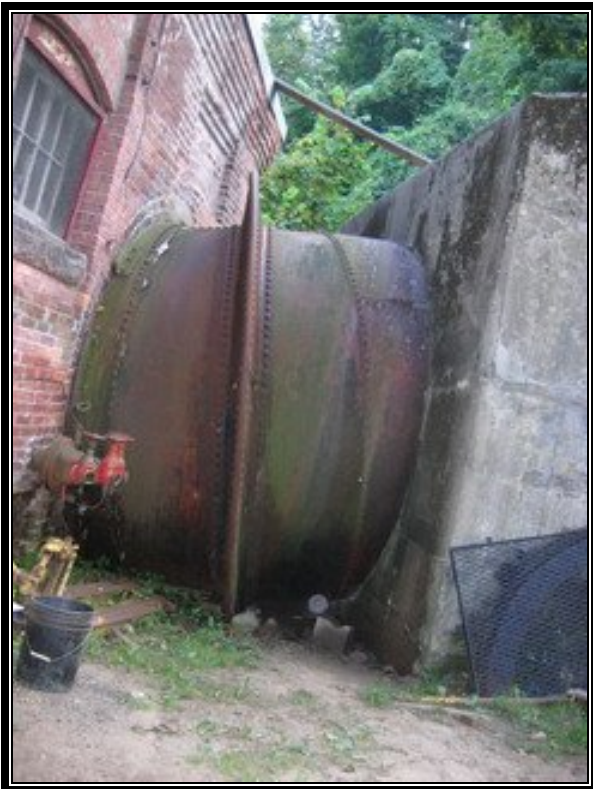
Photo No. 10 – View of V shape of the penstock expansion joint which is in very good condition. Some movement was observed from the previous inspection.

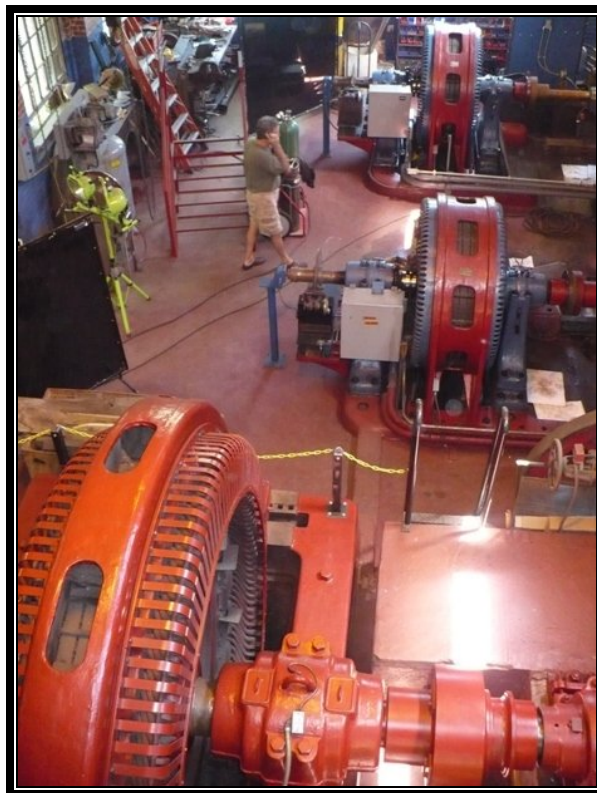
Both the interior and exterior of the powerhouse was observed to be in good condition, (**Photo Nos. 11 & 12**). The structure appears to be well maintained. The Licensee reported that no significant changes have occurred in the previous found cracks located along the top of the tailrace portal (**Photo No. 13**).

Photo No. 11 – View of the interior of powerhouse (not on photo location map).

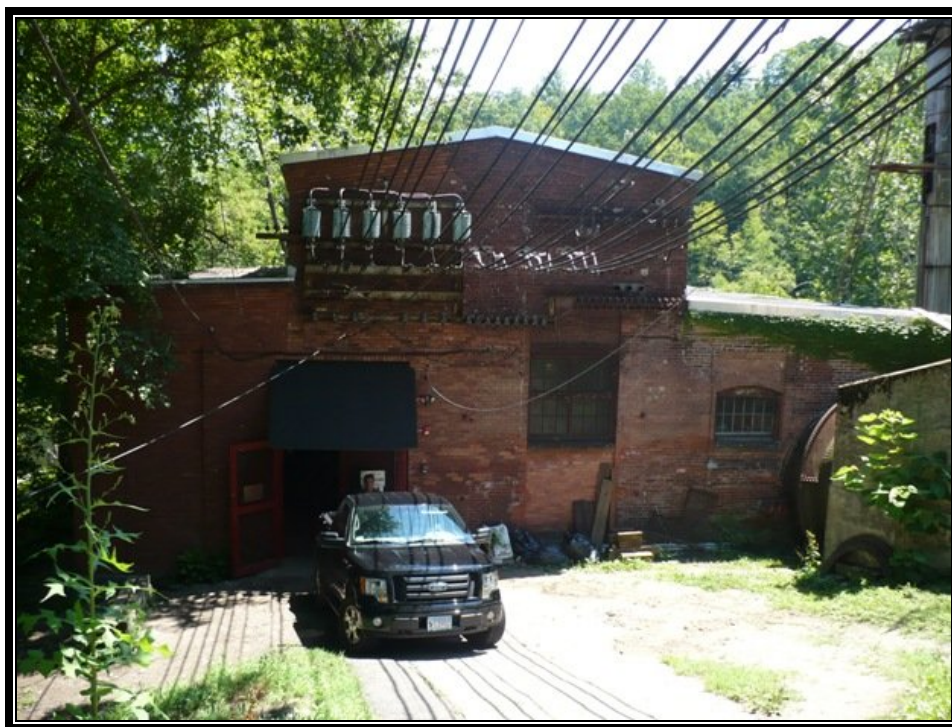
Photo No. 12 – View of the powerhouse.

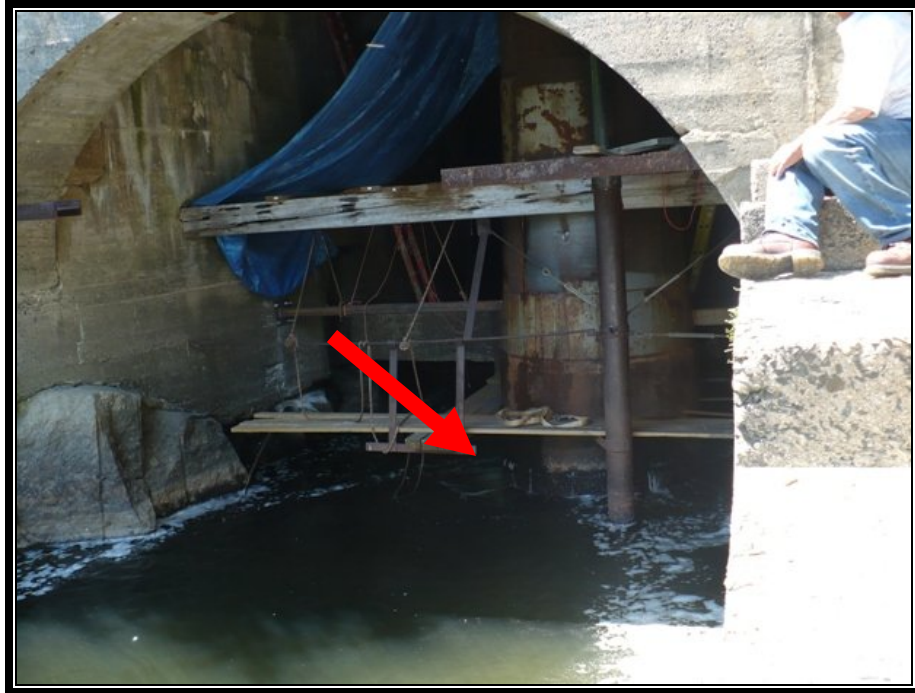
Photo No. 13 – View from the back of the powerhouse tailrace chute.

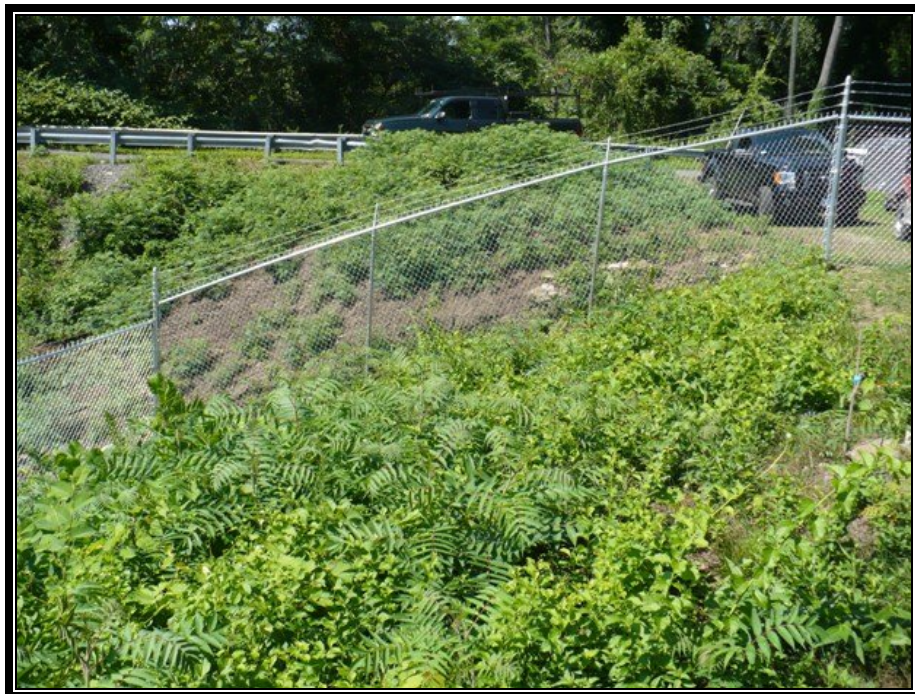
No settlement or depression was noted along the crest of the earth embankment (**Photo No. 14**); during the previous inspection, the Licensee was requested to cut and remove the vegetation overgrowth. The Licensee indicated that overgrown vegetation had been cut and removed, but it has grown back. During this site visit, the Licensee was requested to conduct a vegetation control program to remove the overgrowth as part of their regular maintenance and to make a thorough inspection on the earth dike after clearing the vegetation.

Photo No. 14 - Crest of the earth dike looking longitude toward the south. Note the overgrown vegetation (not on photo location map). Note the licensee was requested to remove the vegetation.

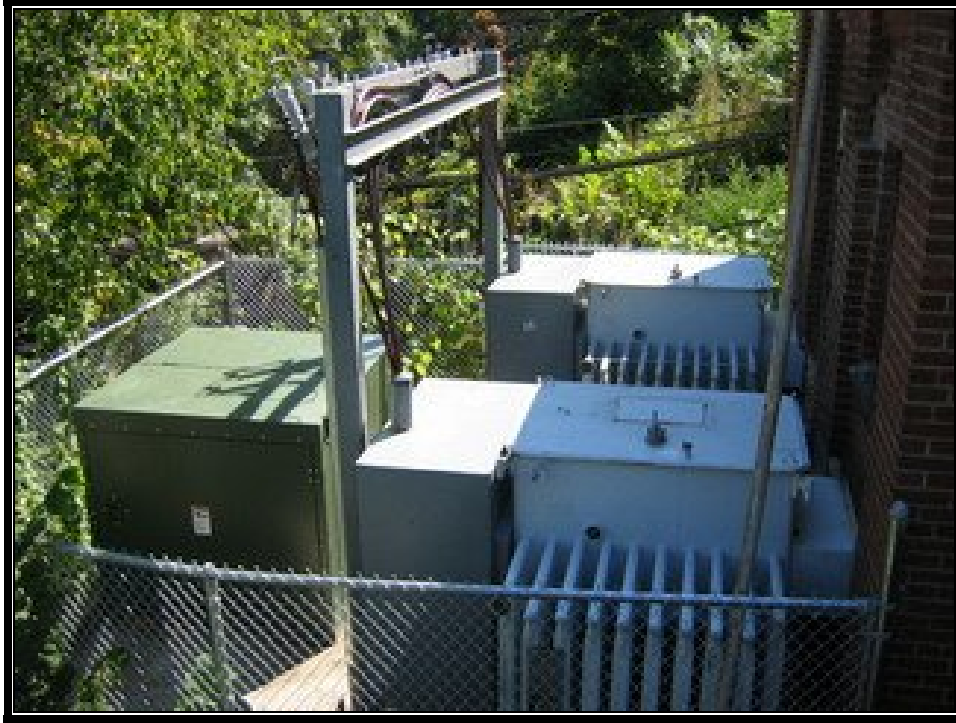
A new transformer which would bring the voltage up from 600KV to 2300KV was installed during this report period (**Photo No. 15**).

Photo No. 15 – View of the new transforms at the project substation.

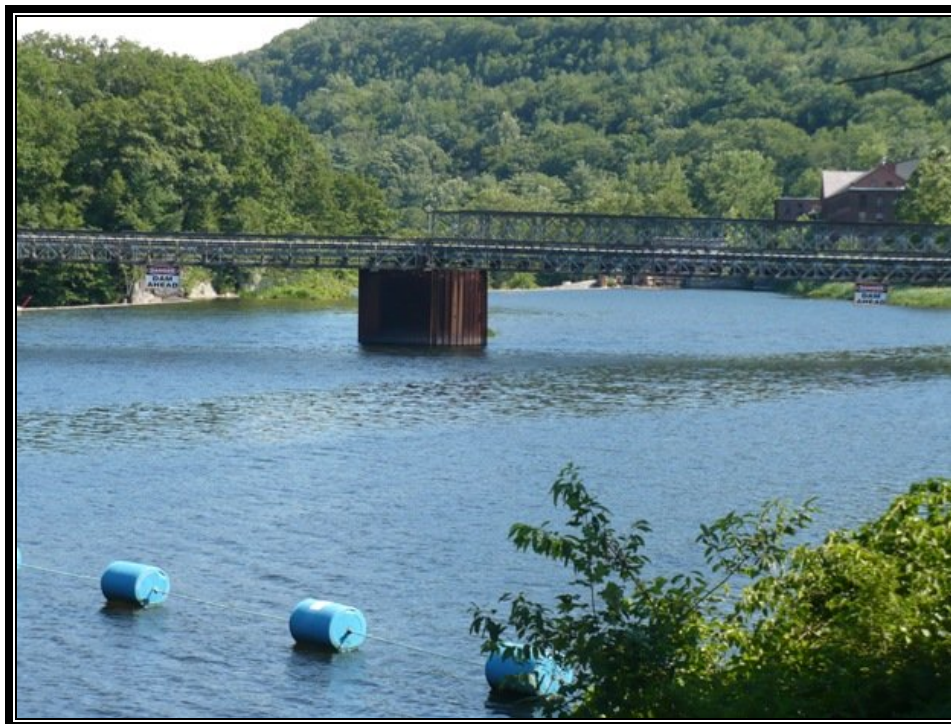
No debris was observed in the project impoundment or on the crest of the North and South dams during the inspection. No evidence of shoreline erosion or slope instability was visible in the immediately upstream of the project site (**Photo No. 16**).

Photo No. 16 – Downstream view of the project reservoir. Note the installed safety boom (not on photo location map).

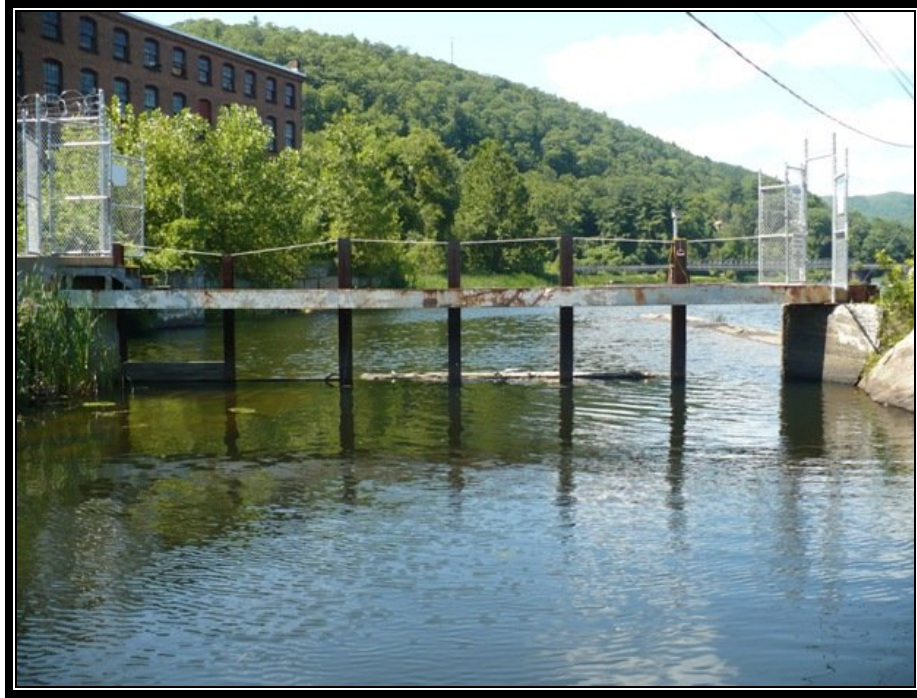
Woronoco Hydro LLC has implemented the approved public safety plan. All safety devices such as safety barriers, fencing and gates **(Photo Nos. 16 & 17)** and warning signs shown on the existing safety plan were in place during the inspection and

Photo No. 17 – View of the entrance at the project headwork. Note the installed fenced gates.

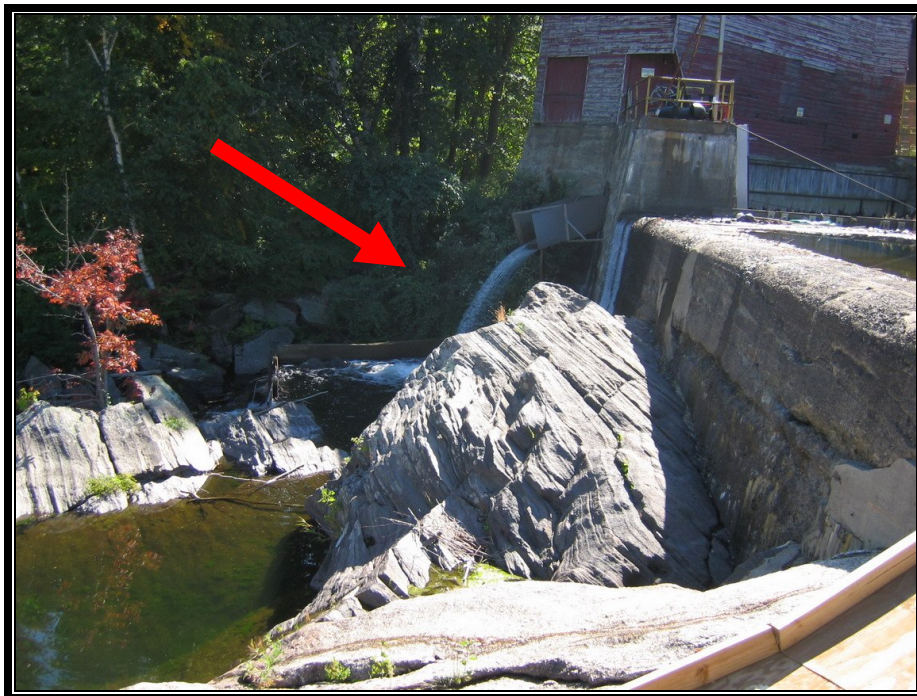
- a. 35cfs in the south channel (20cfs through the existing fish passage facility located adjacent to the gatehouse (**Photo Nos. 18 & 19**) and 15cfs through the mud gate located in the northern section of the South Dam);
- b. 22cfs through the mud gate (**Photo No. 20**) located at the left abutment of the North Dam.

Photo No. 18 – View of the fish passage chute. Note fish passage was not in operation. However, the flow releases (at red arrow) was satisfying the project minimum requirements.

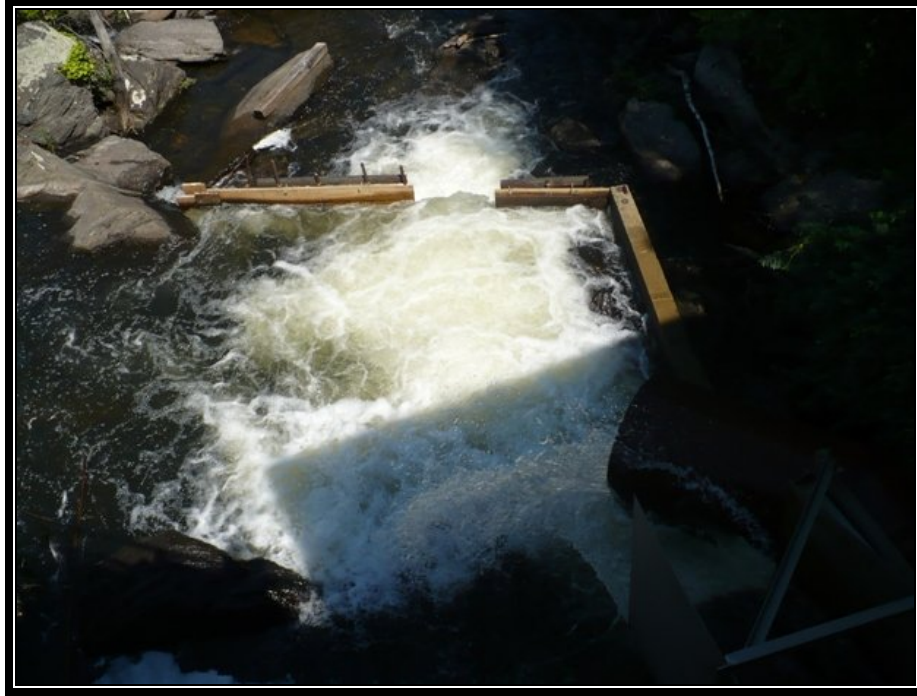
Photo No. 19 – View of the fishway plunge pool.

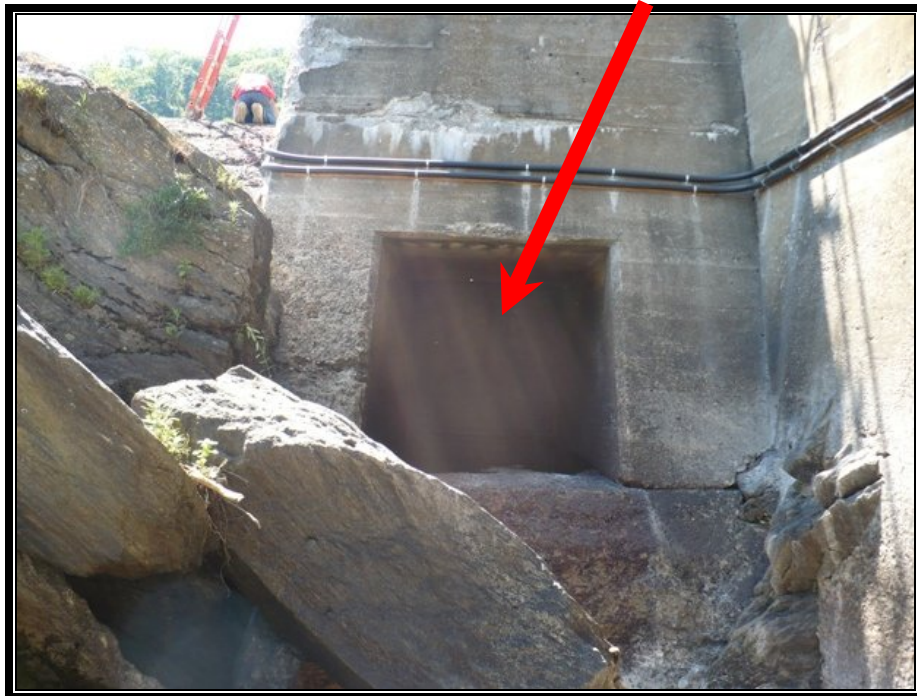
Photo No. 20 - View of the flow releases (at red arrow) from opening of the north side mud gate to satisfy the project minimum requirements.

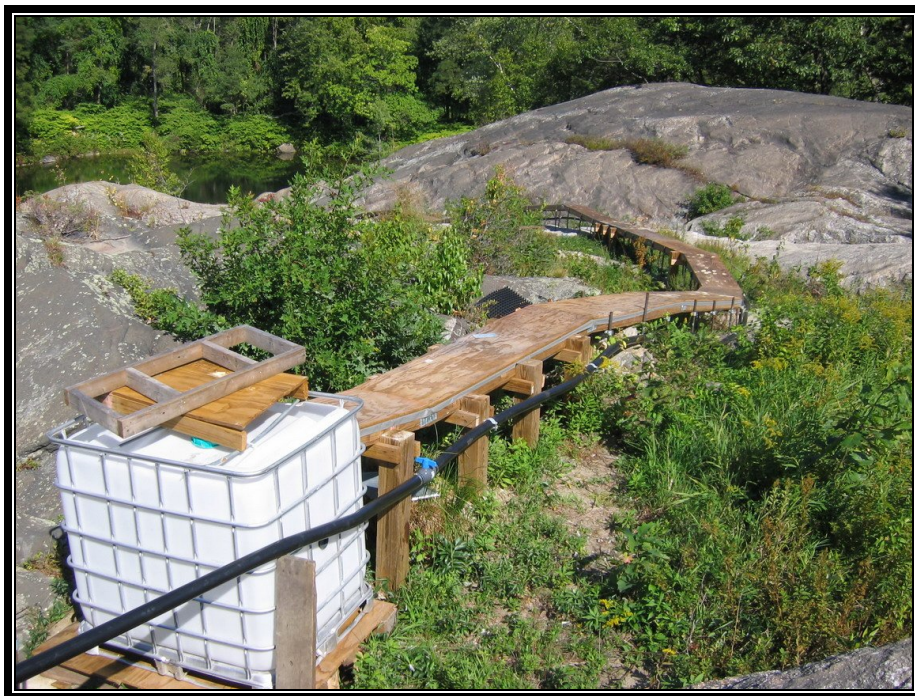
2. To satisfy Article 404 of the license, the Licensee filed a draft Comprehensive Fish Passage Plan on April 12, 2004 and a Modifying Comprehensive Fish Passage Plan on September 1, 2005. These Plans were approved by the Commission Order on April 26, 2006. The same Order set out specific requirements and times frames for installation of upstream eel fishways, completion of downstream salmon smolt passage studies and developing plan to evaluate upstream eel ways, downstream eel passage and downstream adult salmon passage. Subsequent to that order, the Commission issued an Order Granting Extension of Time to file the revised plan on August 1, 2007 that extended the deadlines for completing final filings to August 31, 2007. The revised plan filing has included the eel ways effectiveness monitoring studies which the Licensee installed three eel ways (**Photo No. 21**) on the dam for these studies.

Photo No. 21 – View of one of the three eelways that was constructed for monitoring of the eelway effectiveness studies.
