**Pierce Mills hydroelectric generating station (FERC No. 2396 VT)  
Arnold Falls hydroelectric generating station (FERC No. 2399 VT)  
Gage hydroelectric generating station (FERC No. 2397 VT)  
Passumpsic hydroelectric generating station (FERC No. 2400 VT)  
St. Johnsbury, Waterford and Barnet, Caledonia County, Vermont**

**2009 Annual CRMP Report**

November 30, 2009

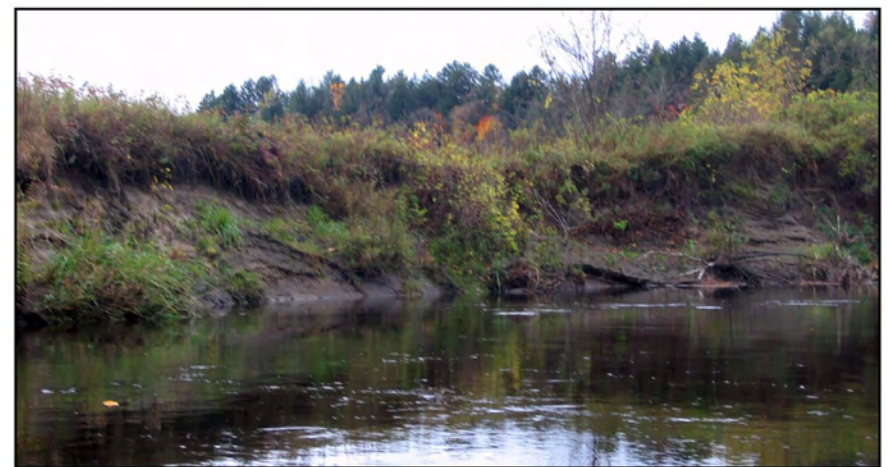
From the upper Project limit, below Great Falls Dam and just north of the St. Johnsbury–Lyndon town boundary, to Pierce Mills Dam, the river channel remains relatively unchanged since the 2008 inspection, although several noted exceptions are described below. The right bank just above the limits of the project continues to slump in the vicinity of a power pole that was reset after erosion documented during past inspections (Location 1). Just downstream, minor undercutting of the left bank noted in the 2008 report has continued and a 60-meter length of the bank has slumped and exposed soils (Location 2). The slumping bank at this location supports a cornfield with minimal riparian growth along the shoreline. Consistently high precipitation rates in July 2009 may have contributed to this recent bank failure (Chart 2). No archaeological information was observed during the surface inspection of exposed soils at Location 2.

**Location 1: Erosion near powerline at upper limit of the Project, looking southwest. October 10, 2009.**

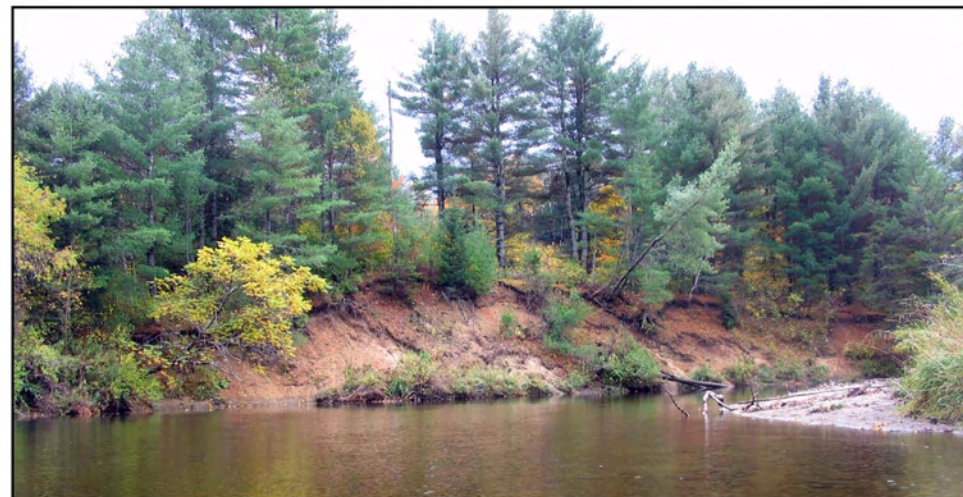
The eroding bank, pictured as Location 3, and noted in past annual reports has remained stable during the past several years. An instance of minor erosion noted in September 2008 on the right bank below Location 3, which supports a healthy riparian zone, has not significantly deteriorated since 2008. However, a cedar tree has been undercut and now leans over the river, and the rate of erosion may accelerate in the future (Location 4). This location will be monitored during future annual inspections to determine if the bank deteriorates further and severe erosion develops.

**Location 3: Erosion on left outer bend of the river within the Pierce Mills impoundment, looking southeast, October 10, 2009.**

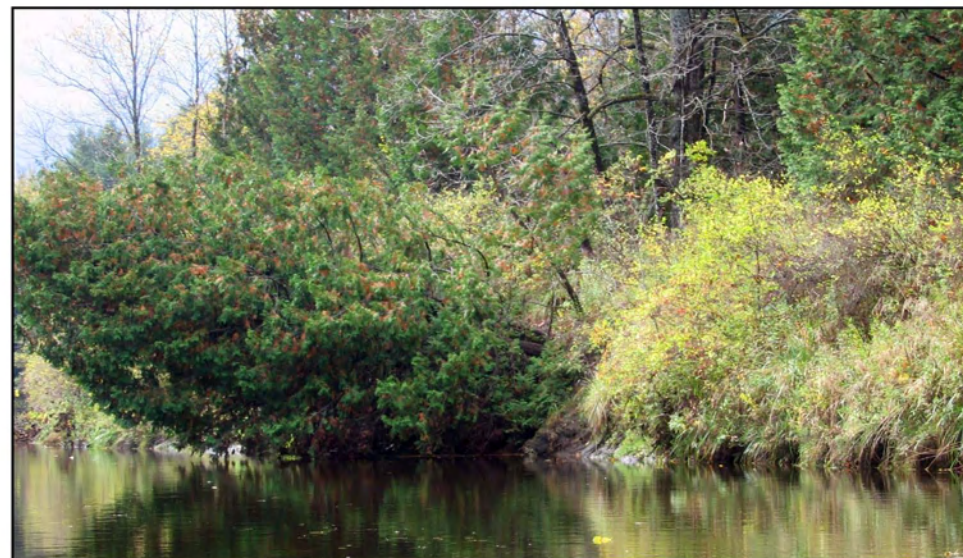
**Location 4: Erosion undercutting cedar tree on right bank first observed in 2008, looking southwest. October 10, 2009.**

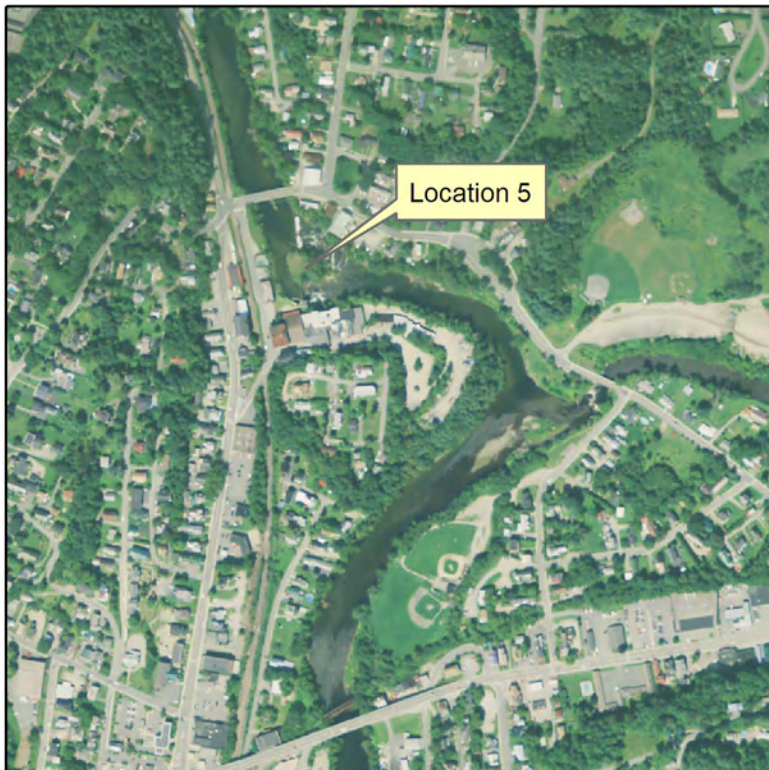
No inspection of the Project shorelines was conducted between the Pierce Mills and Arnold Falls dams during the 2009 field season. Construction activities related to the installation of concrete dams immediately downstream of the existing north and south log-crib dams at the Arnold Falls generating station prohibited use of the canoe takeout at Arnolds Falls. For additional details regarding construction at Arnold Falls Dam, refer to the 2008 annual report that includes the architectural historian's complete Section 106 report. The section of the river above the generating station is bound by relatively steep banks, and lacks a suitable substitute takeout in the vicinity of the station. While scouting for landing alternatives, construction progress at Arnolds Falls was inspected and documented (see Location 5 photographs).

**Location 5: Partially constructed south dam at Arnold Falls generating station, looking southwest, October 10, 2009.**

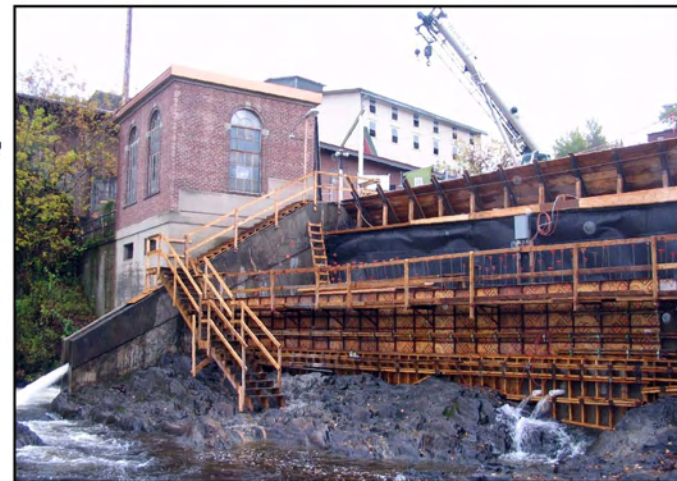
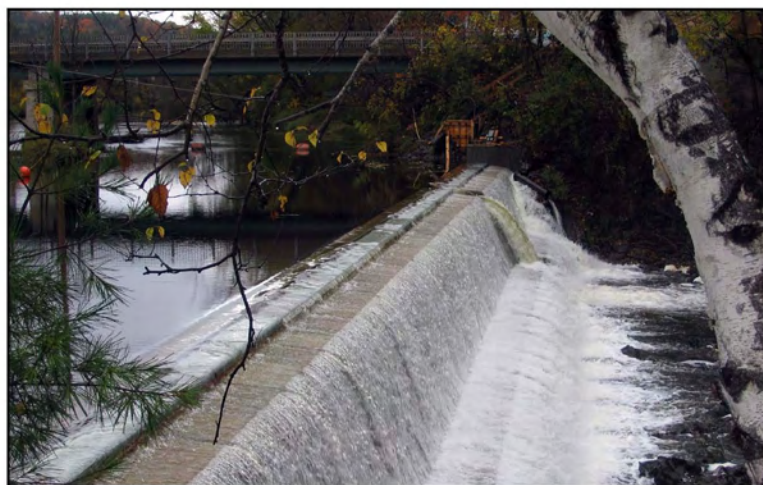
**Location 5: Completed north dam at Arnold Falls generating station, looking northeast, October 10, 2009.**

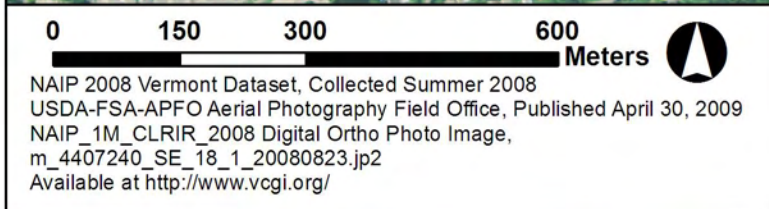
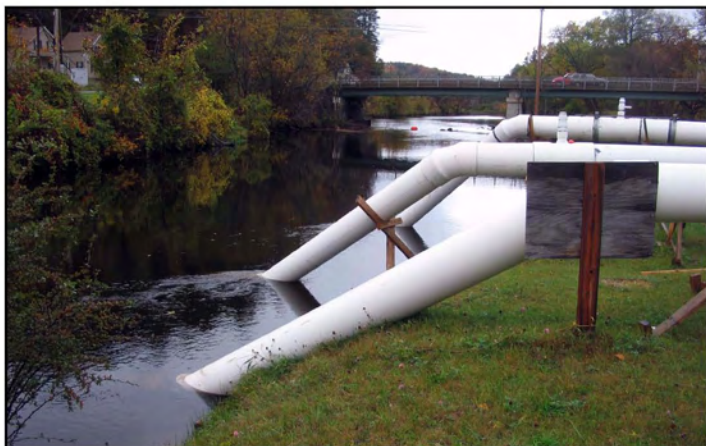
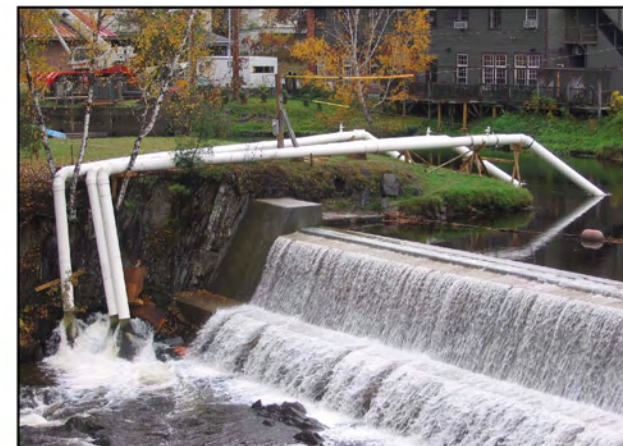
**Location 5: Waterflow diversion pipes required by VT ANR during dam construction, looking north in left image and looking southwest in right image. October 10, 2009.**

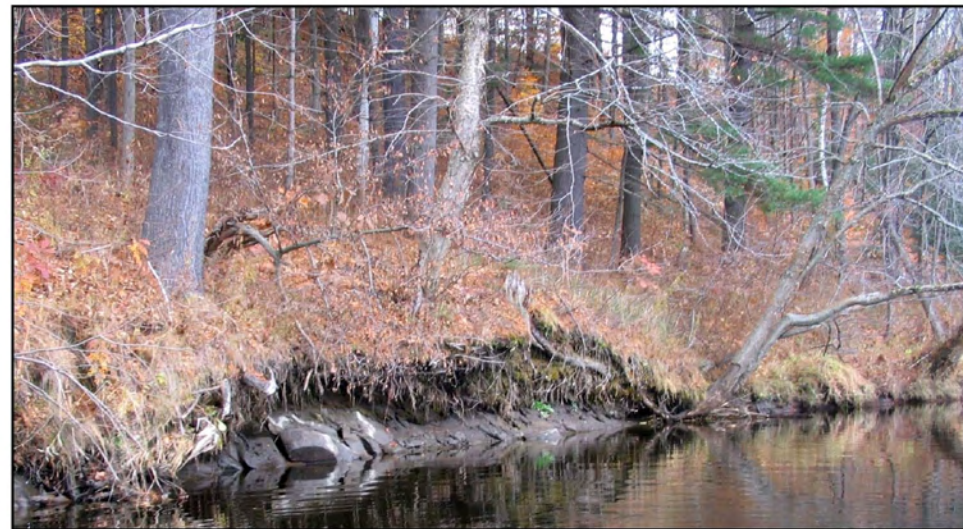
Riverbank conditions between the Arnold Falls and Gage generating stations remain relatively unchanged from those documented in prior reports. One instance of minor erosion, new since the 2008 inspection, was observed during this inspection. Soils have been lost at the base of a steep, wooded area along an 8-meter length of the right bank (Location 6). The soils are shallow at this location and the erosion exposed bedrock ledge, which is expected to minimize the rate of further erosion, although the steepness of the bank may result in further destabilization. Exposed soils were inspected for archaeological information, although no artifacts were observed and none were anticipated due to the landform's steep slope (greater than 8%).

**Location 6: Newly documented erosion exposing bedrock ledge at the base of a steeply, wooded bank within the Gage impoundment, looking northwest. October 29, 2009.**

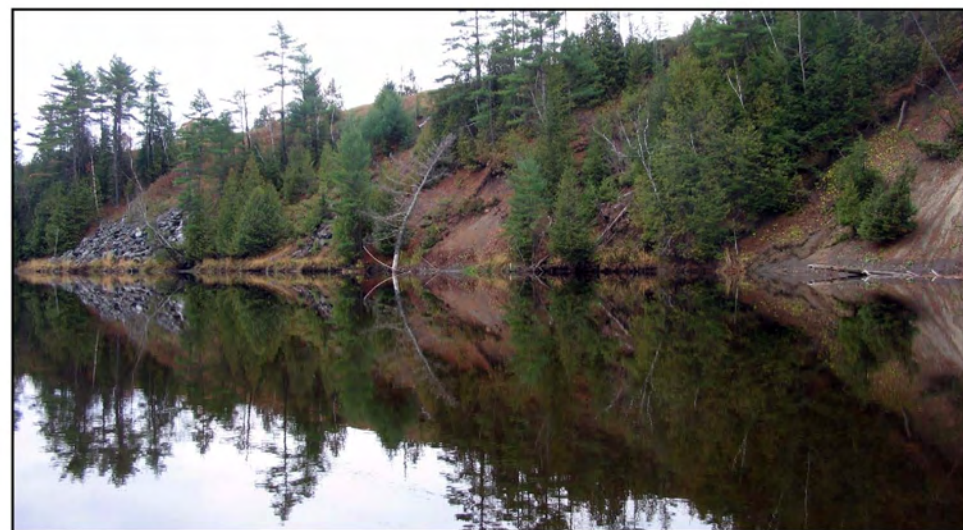
As noted in past annual reports, stone rip-rip installed by VTrans on the left bank adjacent to US Route 5 upstream from the Gage generating station has slowed the rate of erosion on the steep bank. This section of the riverbank is the most severe example of erosion in the Gage impoundment, although it has not noticeably deteriorated during the past year (Location 7).

**Location 7: Stone rip-rapped right bank adjacent to US Route 5 upstream of the Gage generating station, looking southwest, October 29, 2009.**

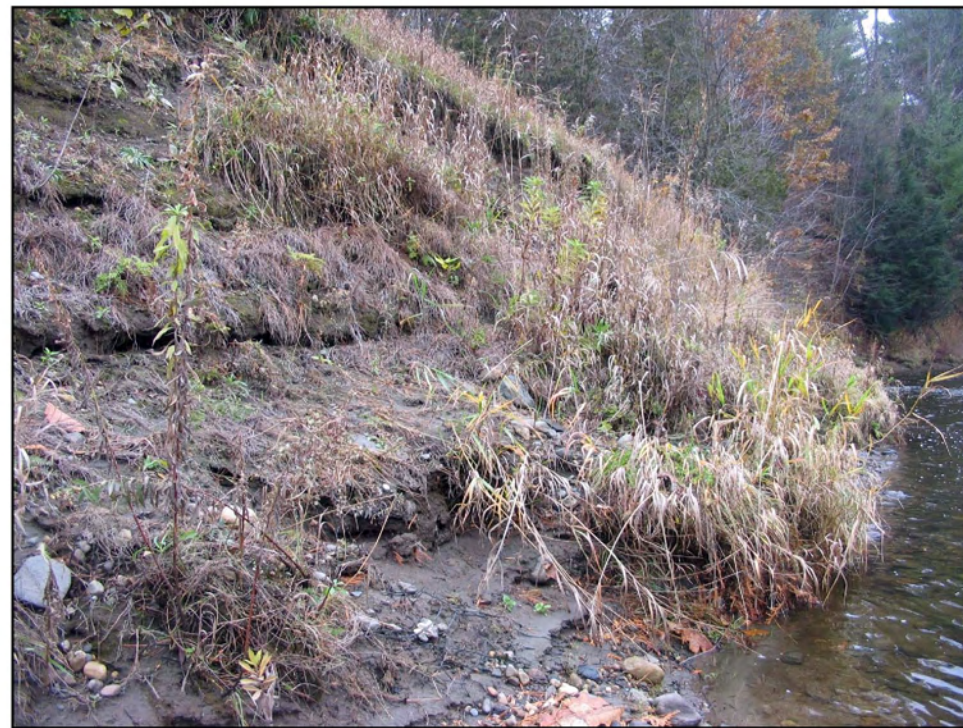
Below the Gage generating station, a 28-meter length of slumping bank was observed both upstream and downstream of stone rip-rap installed in 2008 on the right outside bank (Location 8). As with other exposed sediments along the Project impoundment shorelines, the newly exposed bank was closely inspected for archaeological information, but no cultural materials were observed.

**Location 8: Slumping bank just upstream of stone rip-rap installed circa 2008 on the right outside bank, looking northwest. October 29, 2009.**

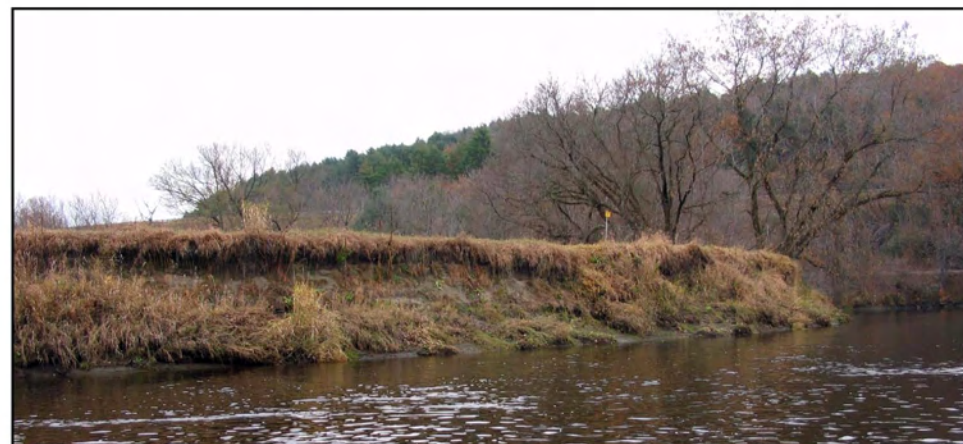
Exposed soils along a slumped, 50-meter length of shoreline, opposite Location 8, were inspected (Location 9). The sheared bank at this left, inside bend of the river supports a cornfield with no riparian buffer along the shoreline. As with Location 2, consistently high precipitation rates in July 2009 may have contributed to this bank failure (see Chart 2). No archaeological information was observed during the surface inspection of exposed soils at Location 9. This location will be closely monitored during future inspections.

**Location 9: Slumping left bank on inner bend of the river adjacent to a cornfield within the Passumpsic impoundment, looking northeast, October 29, 2009.**

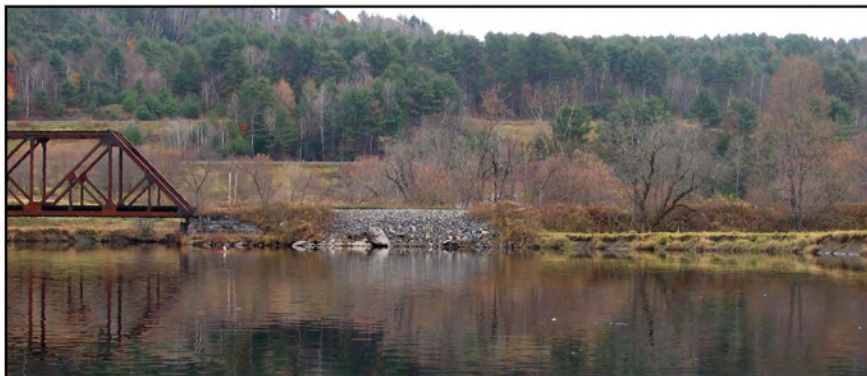
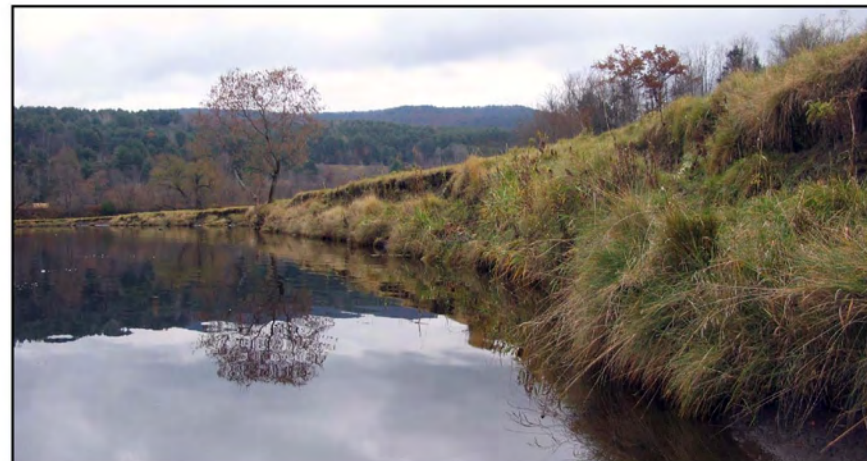
The broad, outer bend on a 255-meter length of the right bank of above a railroad bridge continues to be subject to moderate erosion, as reported in the past. The bank is slowly being undercut and this grassy shoreline continues to slump its soils (see Location 10 photographs). Archaeological identification studies have been sponsored by CVPS in the past<sup>4</sup>, but no significant information was encountered. Likewise, exposed soils inspected in 2009 failed to reveal any cultural information.

**Location 10a: Slumping soils on right bank along broad, outer bend above a railroad bridge, looking southeast. October 29, 2009.**

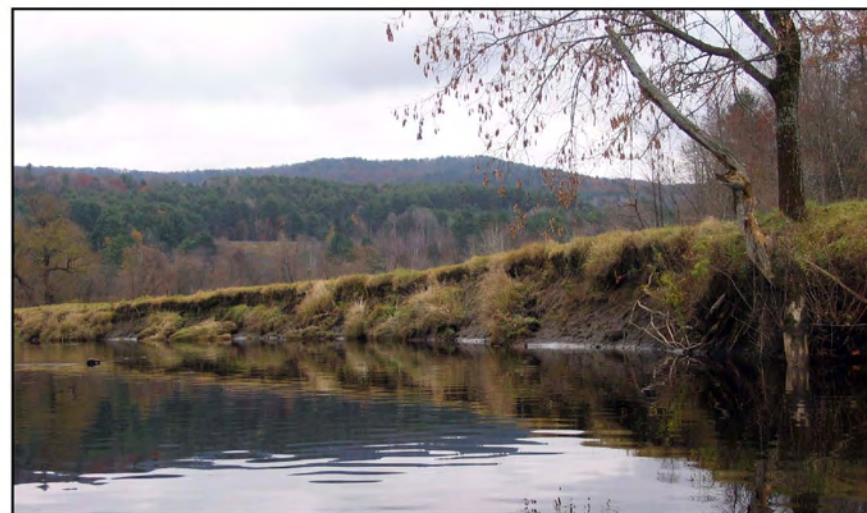
**Location 10b: Slumping soils on right bank along broad, outer bend above a railroad bridge, looking southeast. October 29, 2009.**

**Location 10c: Slumping soils on right bank along broad, outer bend above a railroad bridge, looking east. October 29, 2009.**

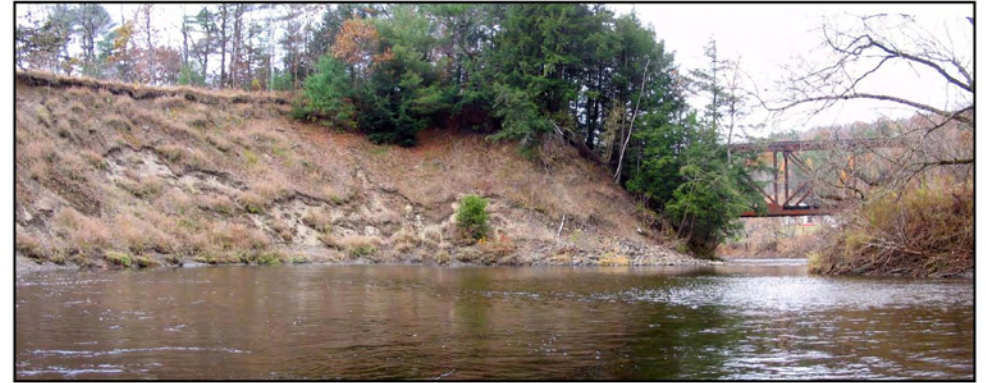
The left bank between the Passumpsic generating station and the railroad bridge approximately 300 meters downstream has remained stable since the 2008 inspection. The steep sandy bank appears to have reached a stable angle of repose (Location 11).

**Location 11: Steep sandy left bank below Passumpsic generating station appears to have reached a stable angle of repose, looking west. October 29, 2009.**

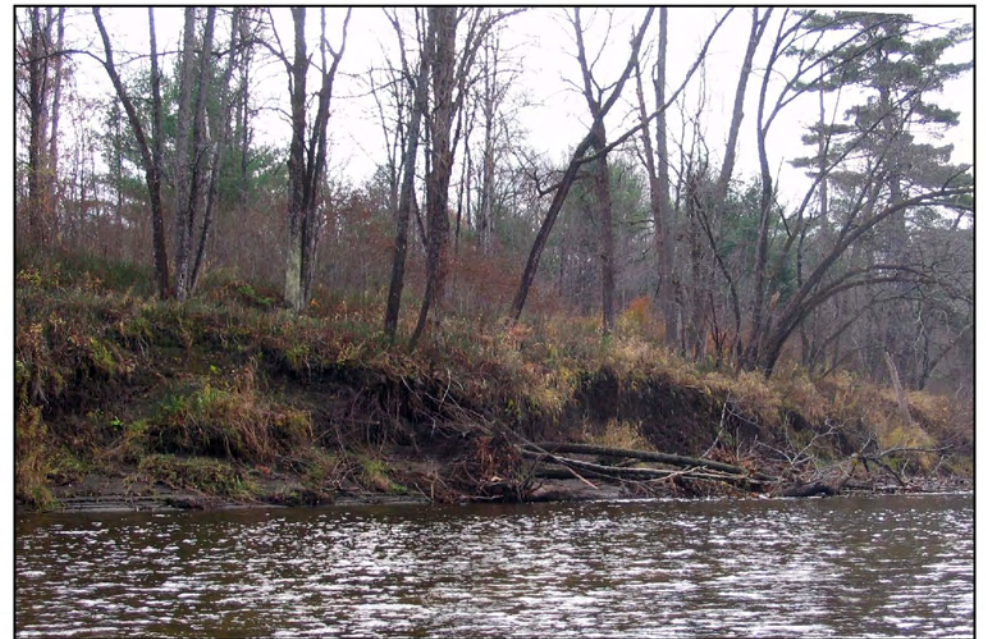
An instance of undercutting and erosion observed in 2007 near the lower limit of the Project appears to have changed very little during the past year, with one exception. A cluster of four young trees noted and pictured as being undercut in the 2007 and 2008 reports, collapsed into the river in the intervening year (Location 12). As noted in the past, hundreds of tires have been observed in this section of the river channel, and the tires continue to collect sediments and create low, wide channel bars. The sediment collection may displace enough water to cause lateral erosion along this narrow strip of bank, which is bound by US Route 5 to its immediate west and by railroad tracks roughly 50 meters to the east.

**Location 12: Undercutting and erosion observed on the left bank near the lower limit of the Project has resulted in the collapse of cluster of four young trees (center of photo) within the past year, looking southeast, October 29, 2009.**
