WORONOCO HYDROELECTRIC PROJECT
(FERC NO. 2631)

Appendix N: June 2009 FERC Inspection Report of Woronoco Recreation Areas

**ENVIRONMENTAL INSPECTION REPORT
(ELECTRONICALLY SUBMITTED)
FEDERAL ENERGY REGULATORY COMMISSION**

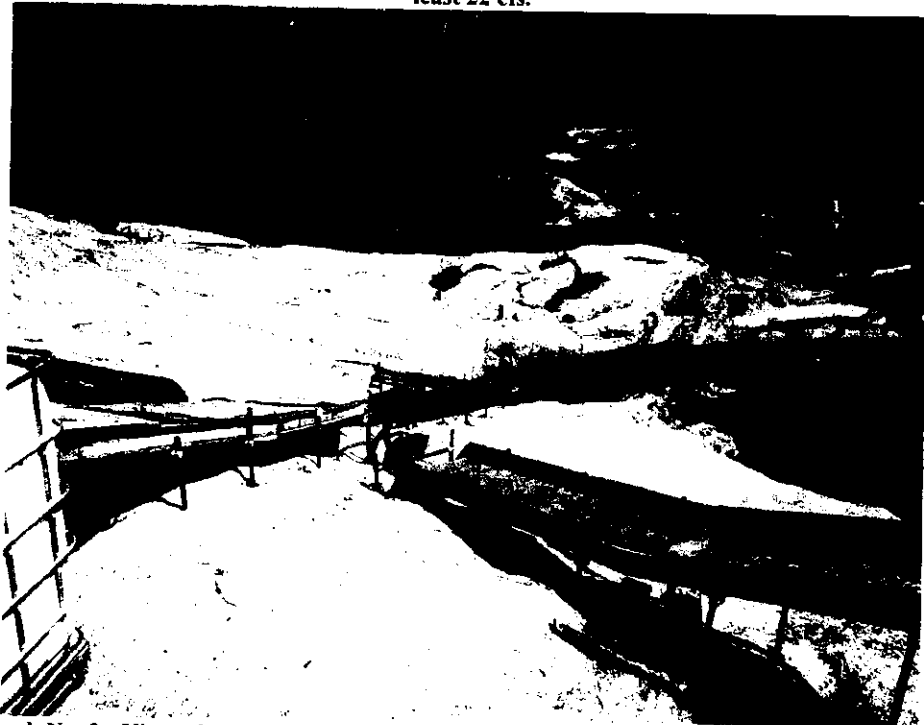
Photograph No. 2 - View of upstream eel ladder sections along the rock face downstream of the spillway.

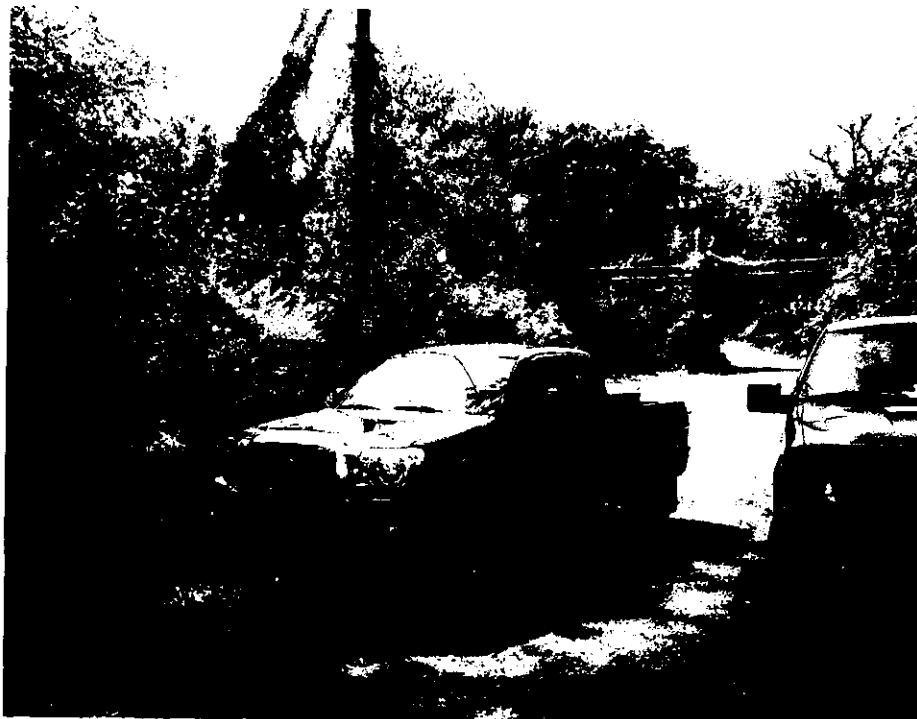
Recreation: The licensee is finalizing the installation of recreational enhancements at the project including the canoe takeout, rest stops and trail and associated parking areas. Some signs were in place however signs in compliance with Part 8 section 8.2(a) were not yet installed. This was noted in the follow-up letter to the licensee.

Photograph No. 6 - Newly installed parking area at canoe takeout, upstream of project. Small sign on pole indicates parking but no Part 8 sign was available.

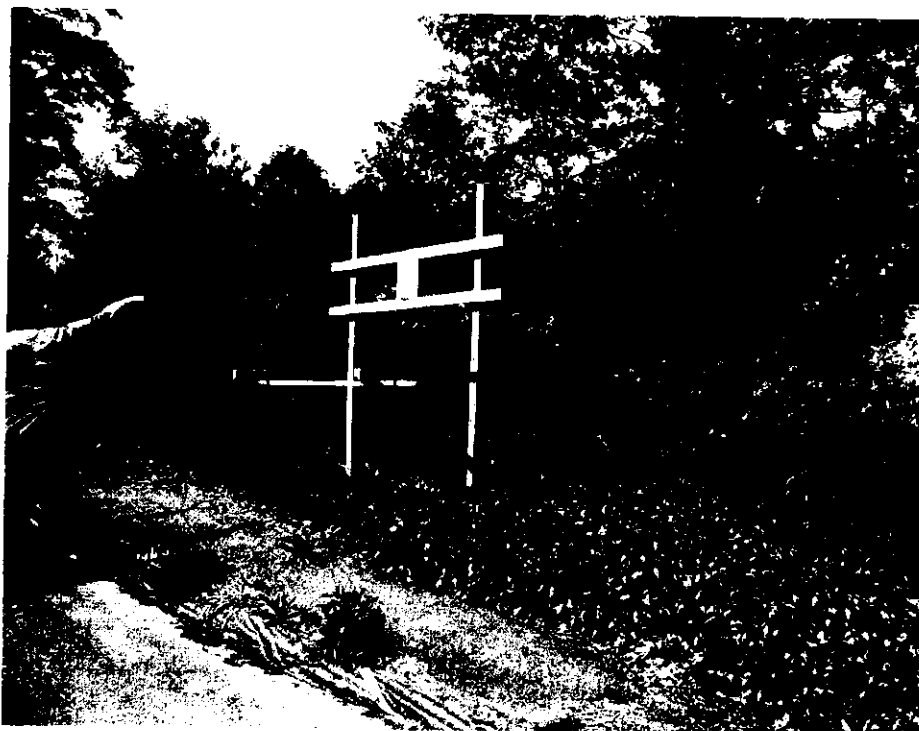
Photograph No. 7 - Typical canoe rest structure along portage trail.

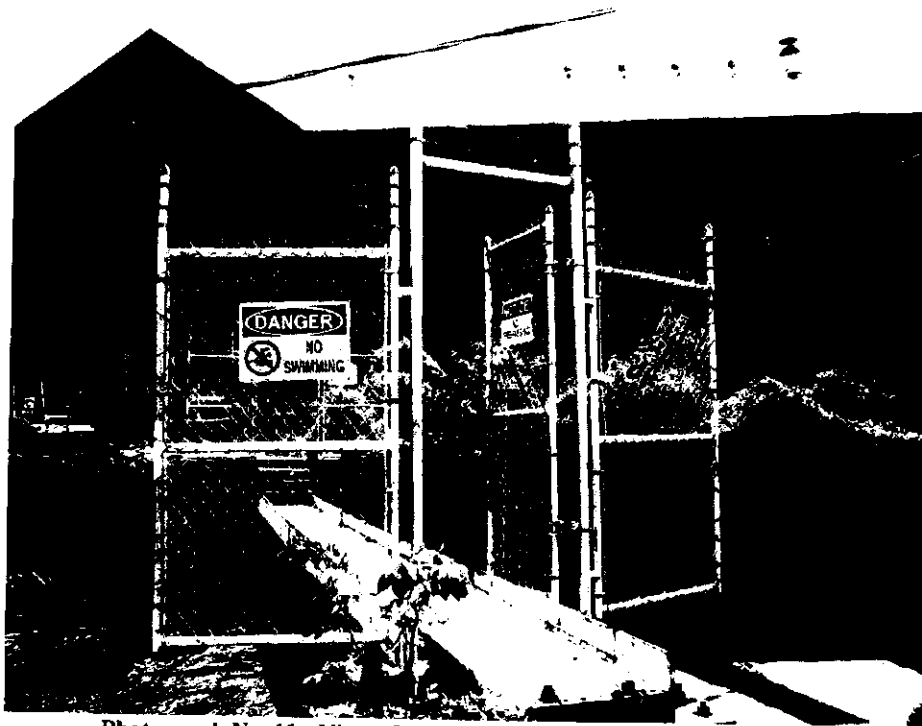
Photograph No. 11 - View of recent fence and locking gate at forebay.

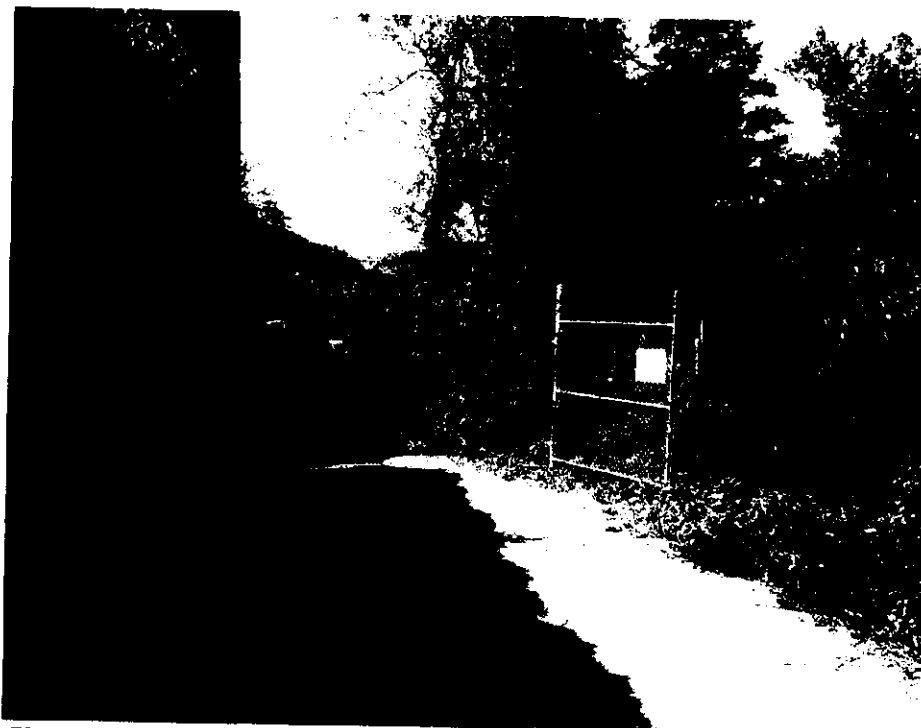
Photograph No. 12 - View of locking gate and perimeter fencing at entrance to project.
