**Pierce Mills hydroelectric generating station (FERC No. 2396 VT)  
Arnold Falls hydroelectric generating station (FERC No. 2399 VT)  
Gage hydroelectric generating station (FERC No. 2397 VT)  
Passumpsic hydroelectric generating station (FERC No. 2400 VT)  
St. Johnsbury, Waterford and Barnet, Caledonia County, Vermont**

**2010 Annual CRMP Report**

December 6, 2010

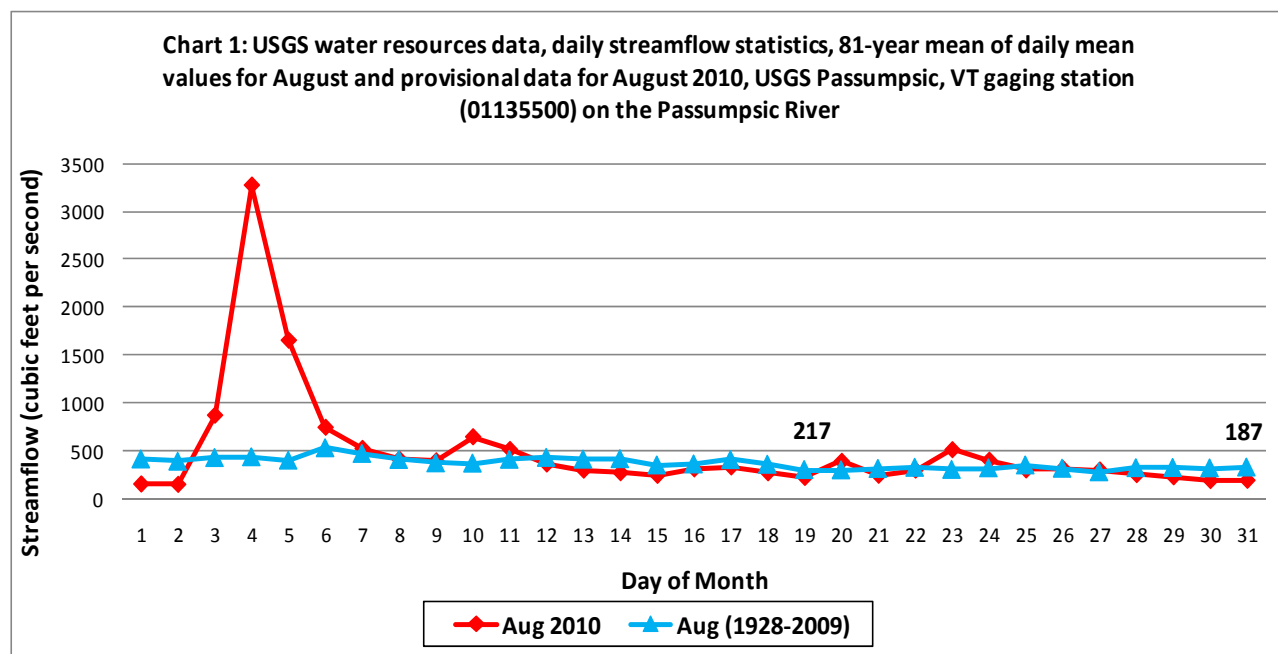
Provisional 2010 data from the U.S. Geological Survey Passumpsic River gaging station at Passumpsic, Vermont (01135500) indicates that the mean discharge was 217 cubic feet per second (cfs) on August 19 and 187 cfs on August 31. Daily streamflow statistics for 81 years

of record (Chart 1) indicate that this volume at the Passumpsic gaging station was below the mean of daily mean values for both August 19 (295 cfs) and August 31 (322 cfs).

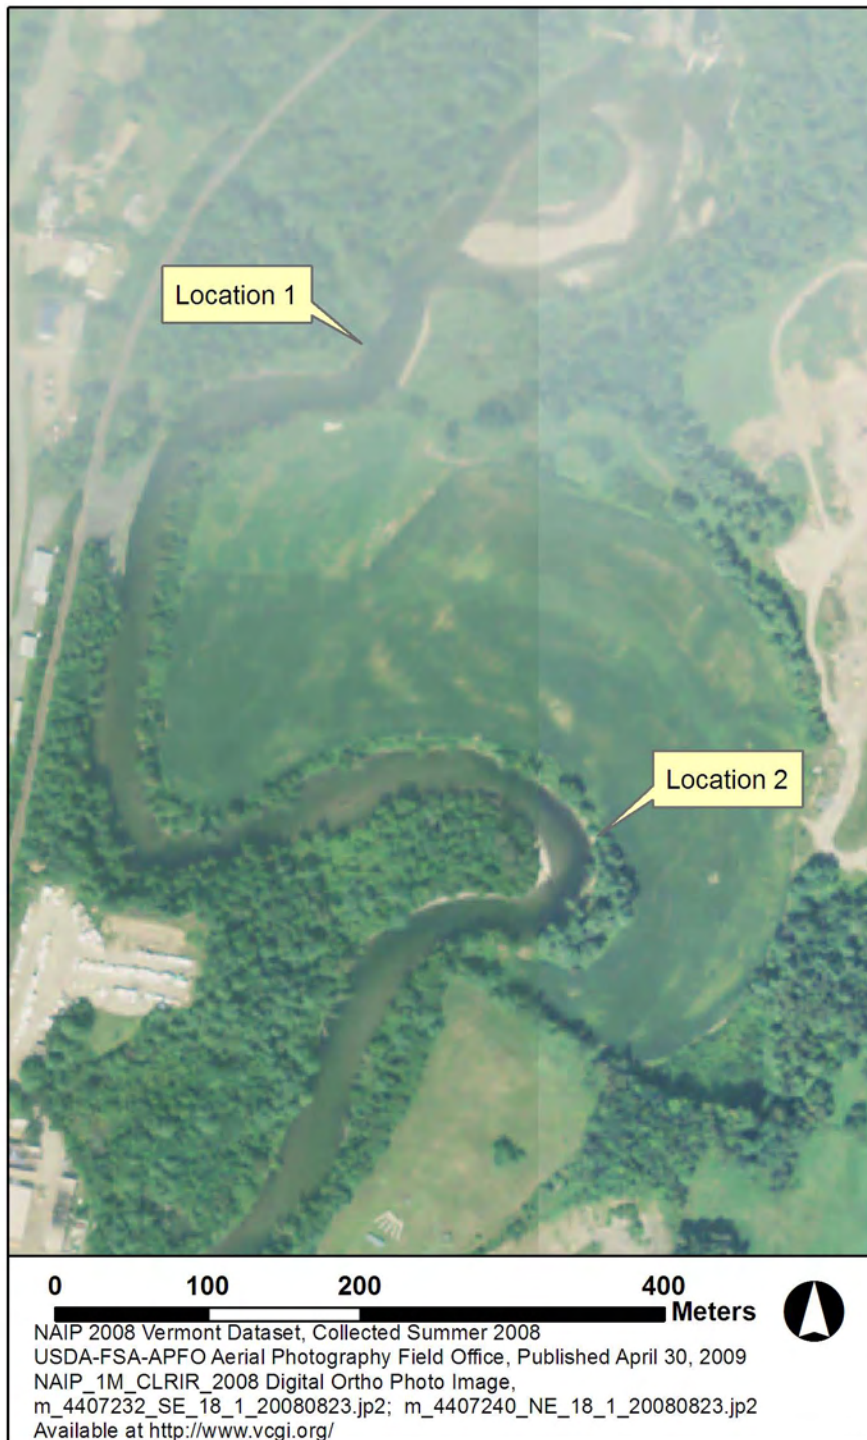
**Location 1: Erosion near powerline at upper limit of the Project, looking southwest. August 19, 2010.**

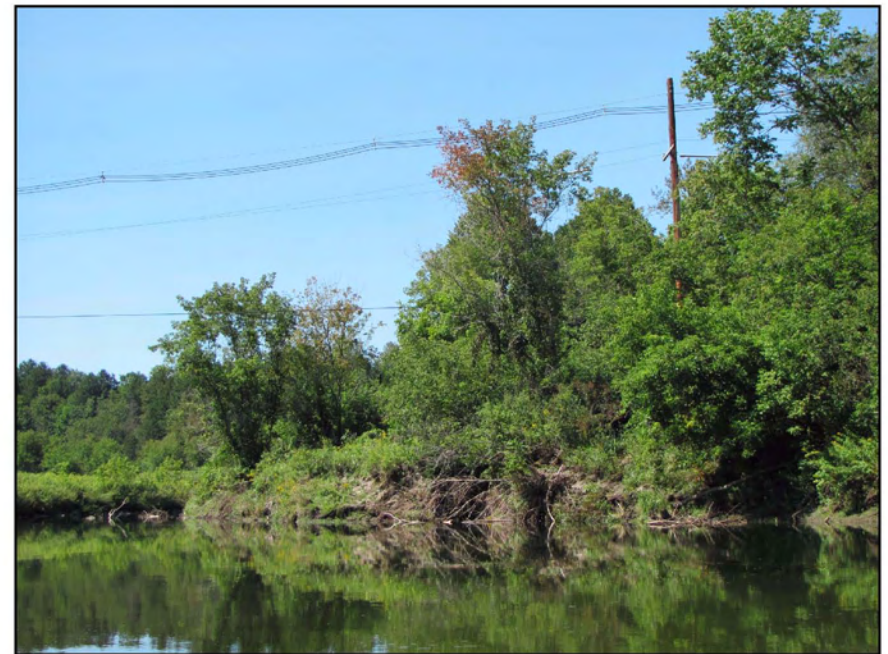
From the upper Project limit, below Great Falls Dam and just north of the St. Johnsbury–Lyndon town boundary, to Pierce Mills Dam, the river channel remains relatively unchanged since prior inspections. The right bank just above the limits of the project continues to slump in the vicinity of a power pole that was reset after erosion documented during past inspections (Location 1). The eroding bank, pictured as Location 2, and noted in past annual reports has remained stable during the past several years. No archaeological information was observed during the surface inspection of exposed soils. Several weeks after the 2010 inspection, the generating station at Pierce Mills was vandalized. For additional details, please see Appendix A that includes the architectural historian’s description of the event.

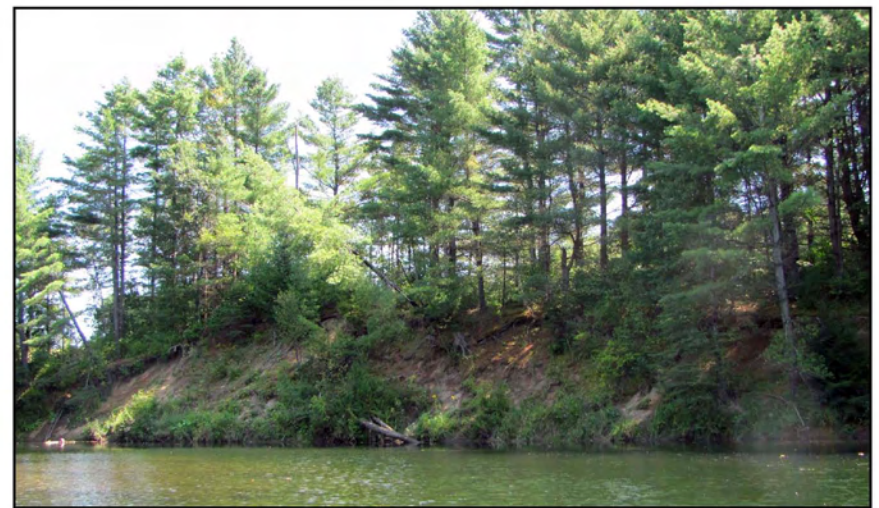
**Location 2: Erosion on left outer bend within the Pierce Mills impundment, looking northeast. August 19, 2010.**

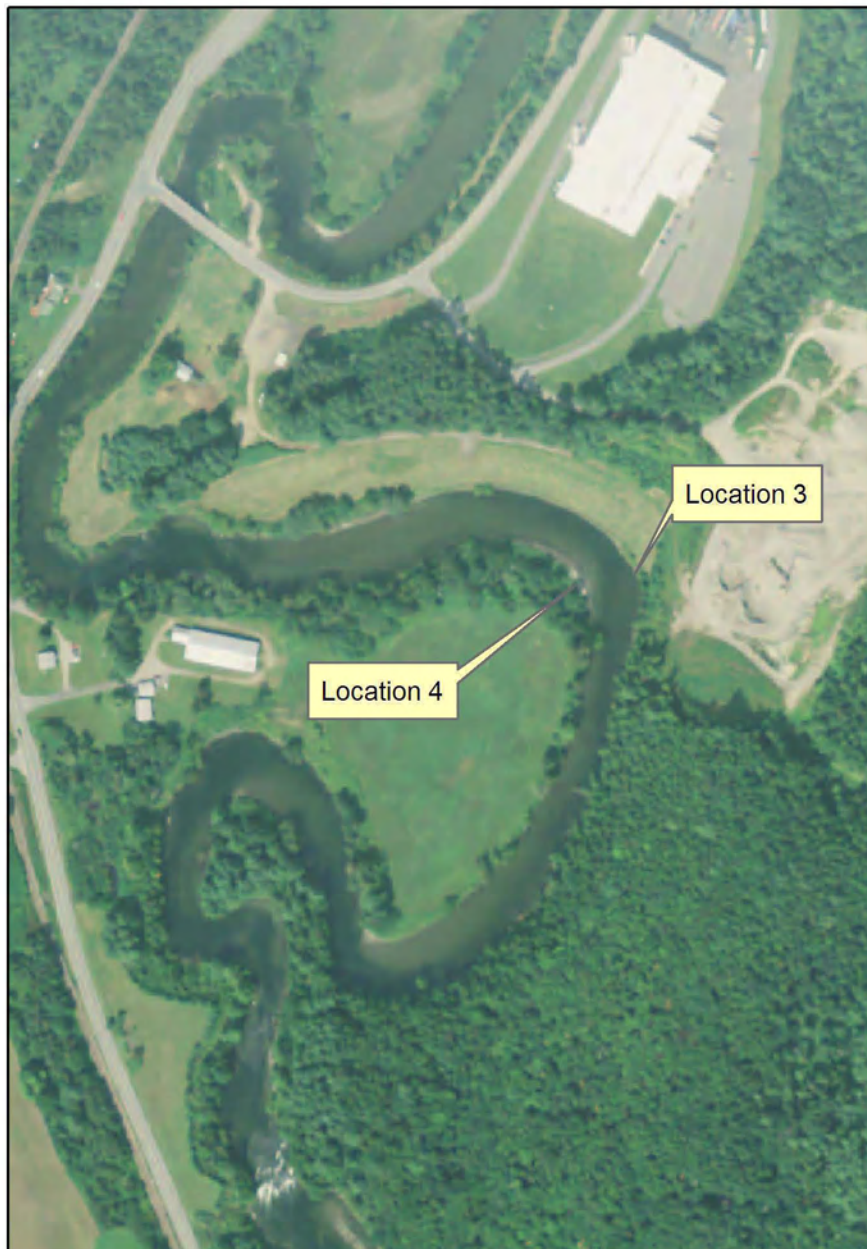
Between the Pierce Mills and Arnold Falls dams, a gravel pit expansion adjacent to the left bank continues to compromise the riparian zone. Moderate bank erosion has been observed at this location since 2000 (Location 3). Sediments from the left bank are accumulating on the opposite bank (Location 4) to form a sand bar protecting the Native American site designated as FS 3 (CA). No archaeological information was observed during the surface inspection of exposed soils. The majority of the lower shorelines of the Arnold Falls impoundment is constricted by railway beds, US Route 5 highway, and associated commercial and residential development. The long-term use of this area by car dealerships is reflected by current businesses (Location 5) and the presence of old cars imbedded in the riverbank below US Route 5 (Location 6).

**Location 3: Erosion on left outer bend of the river adjacent to gravel pit within the **Arnold Falls** impoundment, looking southeast, August 19, 2010.**

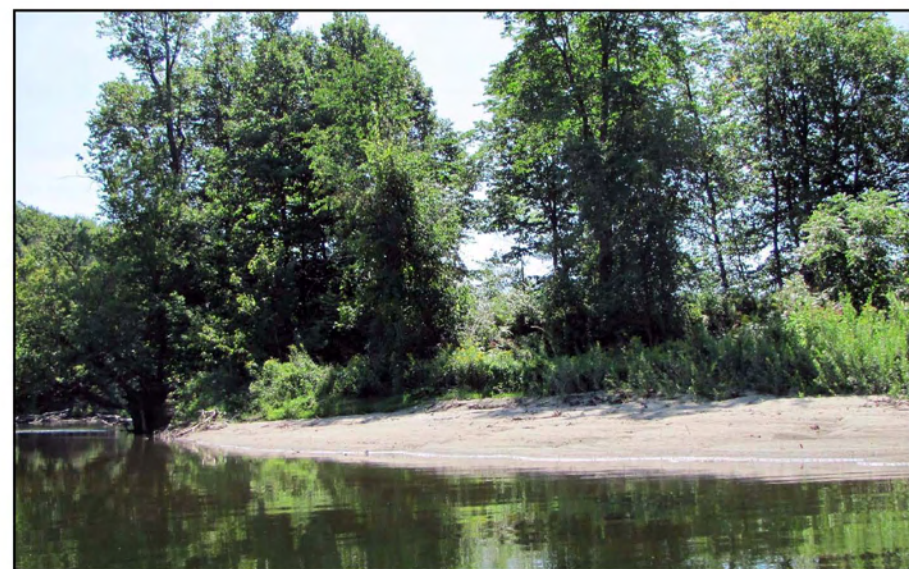
**Location 4: Sand bar protecting Native American site designated as FS 3 (CA) looking south. August 19, 2010.**

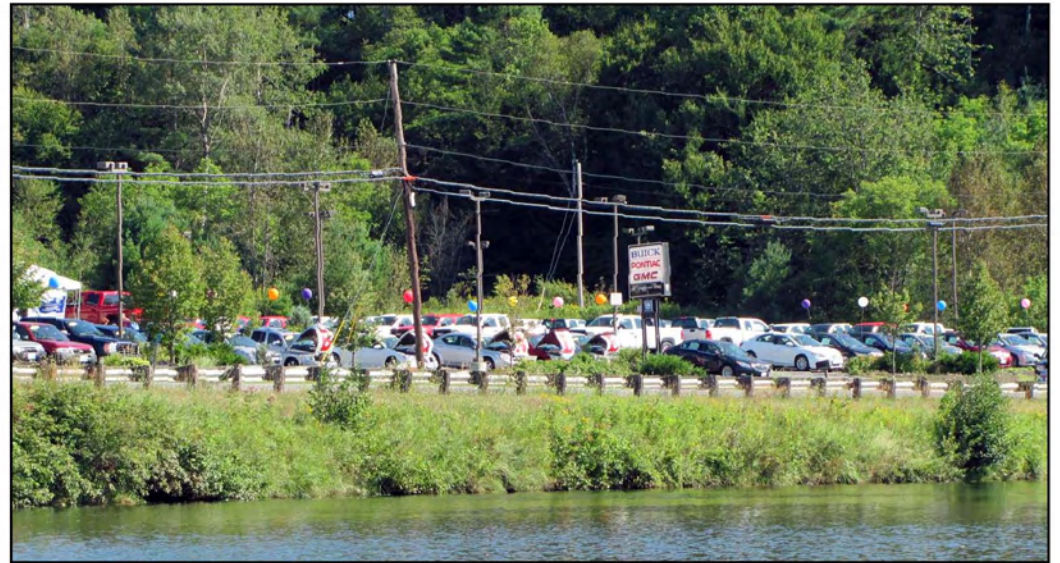
**Location 5: Typical shoreline along the Arnold Falls impoundment adjacent to US Route 5 highway, looking southeast, August 19, 2010.**

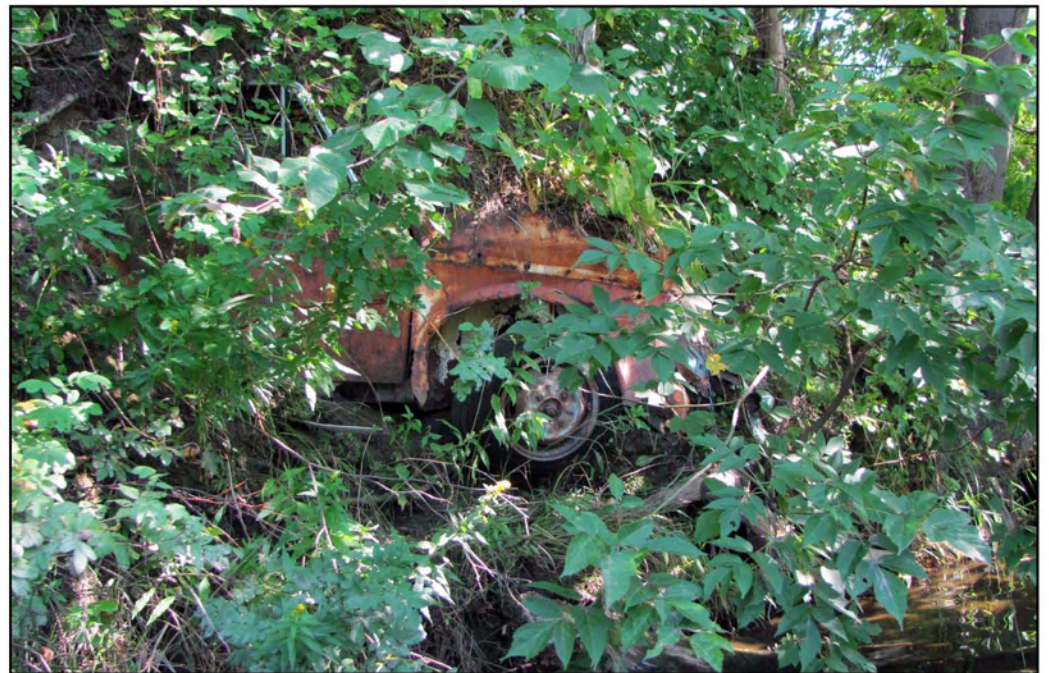
**Location 6: Old car embedded in left riverbank below US Route 5 highway, looking east. August 19, 2010.**

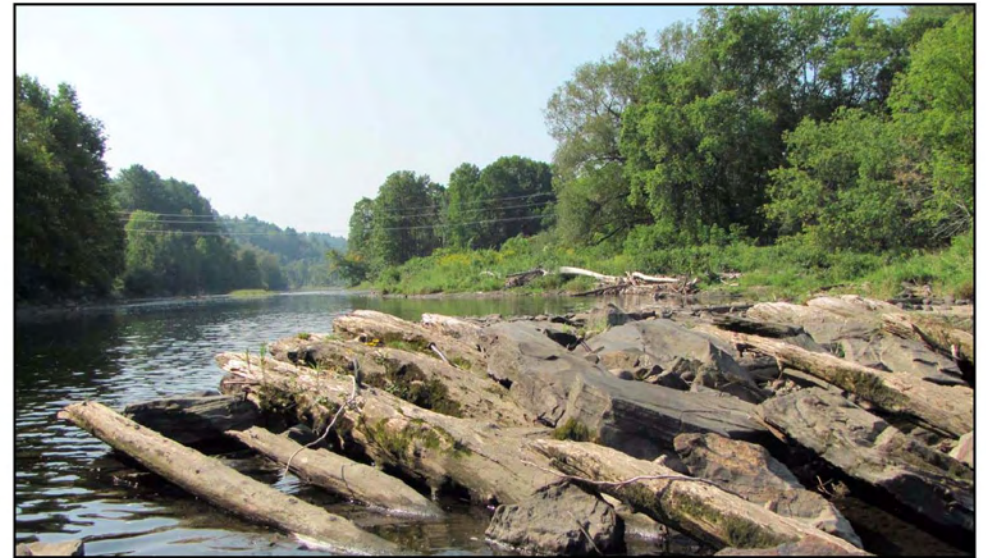
2010 exposed the timber crib dam remains associated with the Twin State Gas & Electric Co. No. 2 plant (operated between 1912 and 1944) (Location 7). As noted in past annual reports, stone rip-rip installed by VTrans on the left bank adjacent to US Route 5 upstream from the Gage generating station has slowed the rate of erosion on the steep bank. This section of the riverbank is the most severe example of erosion in the Gage impoundment, although it has not noticeably deteriorated during the past year (Location 8).

**Location 7: Exposed timber crib dam ruins associated with Twin State Gas & Electric Co. No. 2 plant (1922-1944) within the Gage impoundment, looking south. August 31, 2010.**

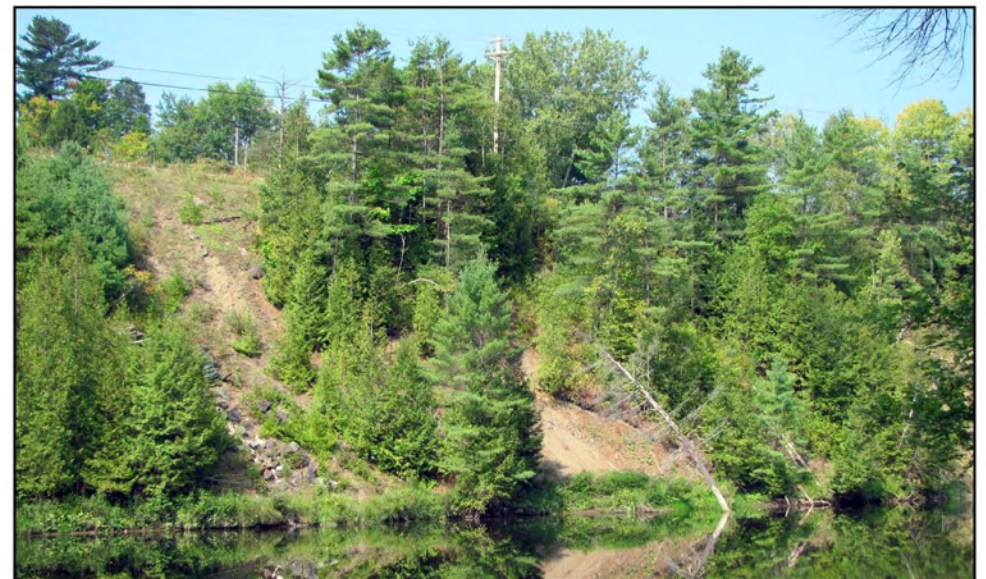
**Location 8: Stone rip-ripped right bank adjacent to US Route 5 upstream of the Gage generating station, looking northwest, August 31, 2010.**

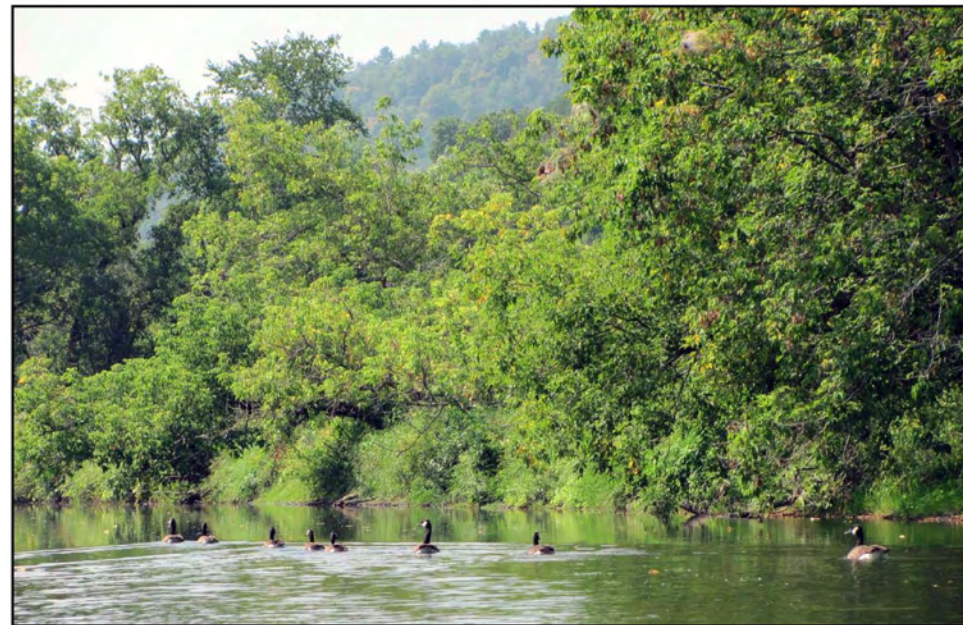
Few changes were observed within the Passumpsic impoundment since the 2009 inspection. The majority of the shorelines are bound by agricultural fields and well-developed riparian growth (Location 9). The left bank between the Passumpsic generating station and the railroad bridge approximately 300 meters downstream has remained stable since the 2008 inspection. The steep sandy bank appears to have reached a stable angle of repose (Location 10).

**Location 9: Stable right bank above Passumpsic generating station, looking southwest. August 31, 2010.**

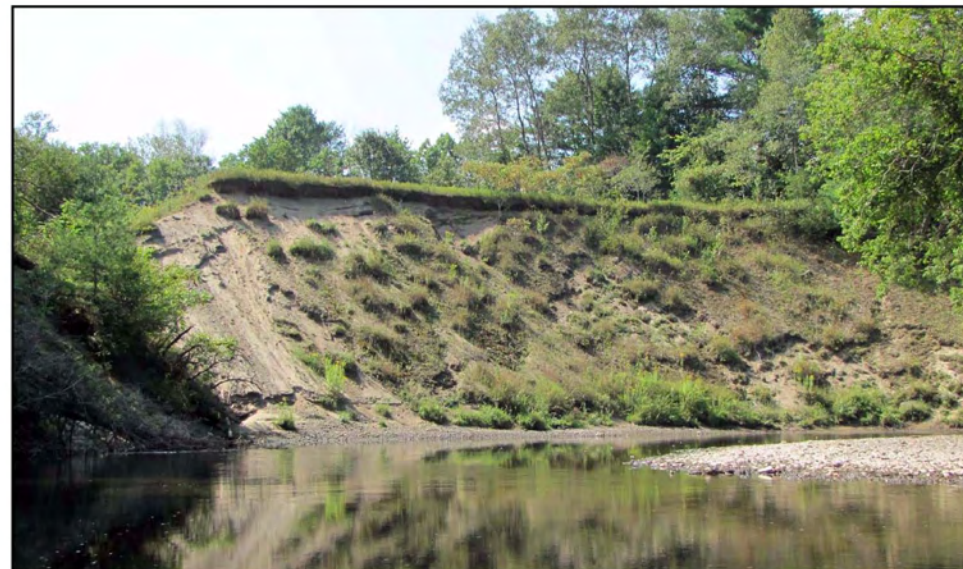
**Location 10: Steep eroded bank below Passumpsic dam has remained relatively stable in past several years, looking south, August 31, 2010.**
