LIST OF ATTACHMENTS FROM LIHI RE-CERTIFICATION APPLICATION FOR RED BRIDGE PROJECT

1. Aerial Photographs of Red Bridge Project.
2. Aerial Photograph of Red Bridge Impoundment ZoE.
3. Aerial Photograph of Red Bridge Bypassed Reach ZoE.
4. Aerial Photograph of Red Bridge Tailrace Zoe

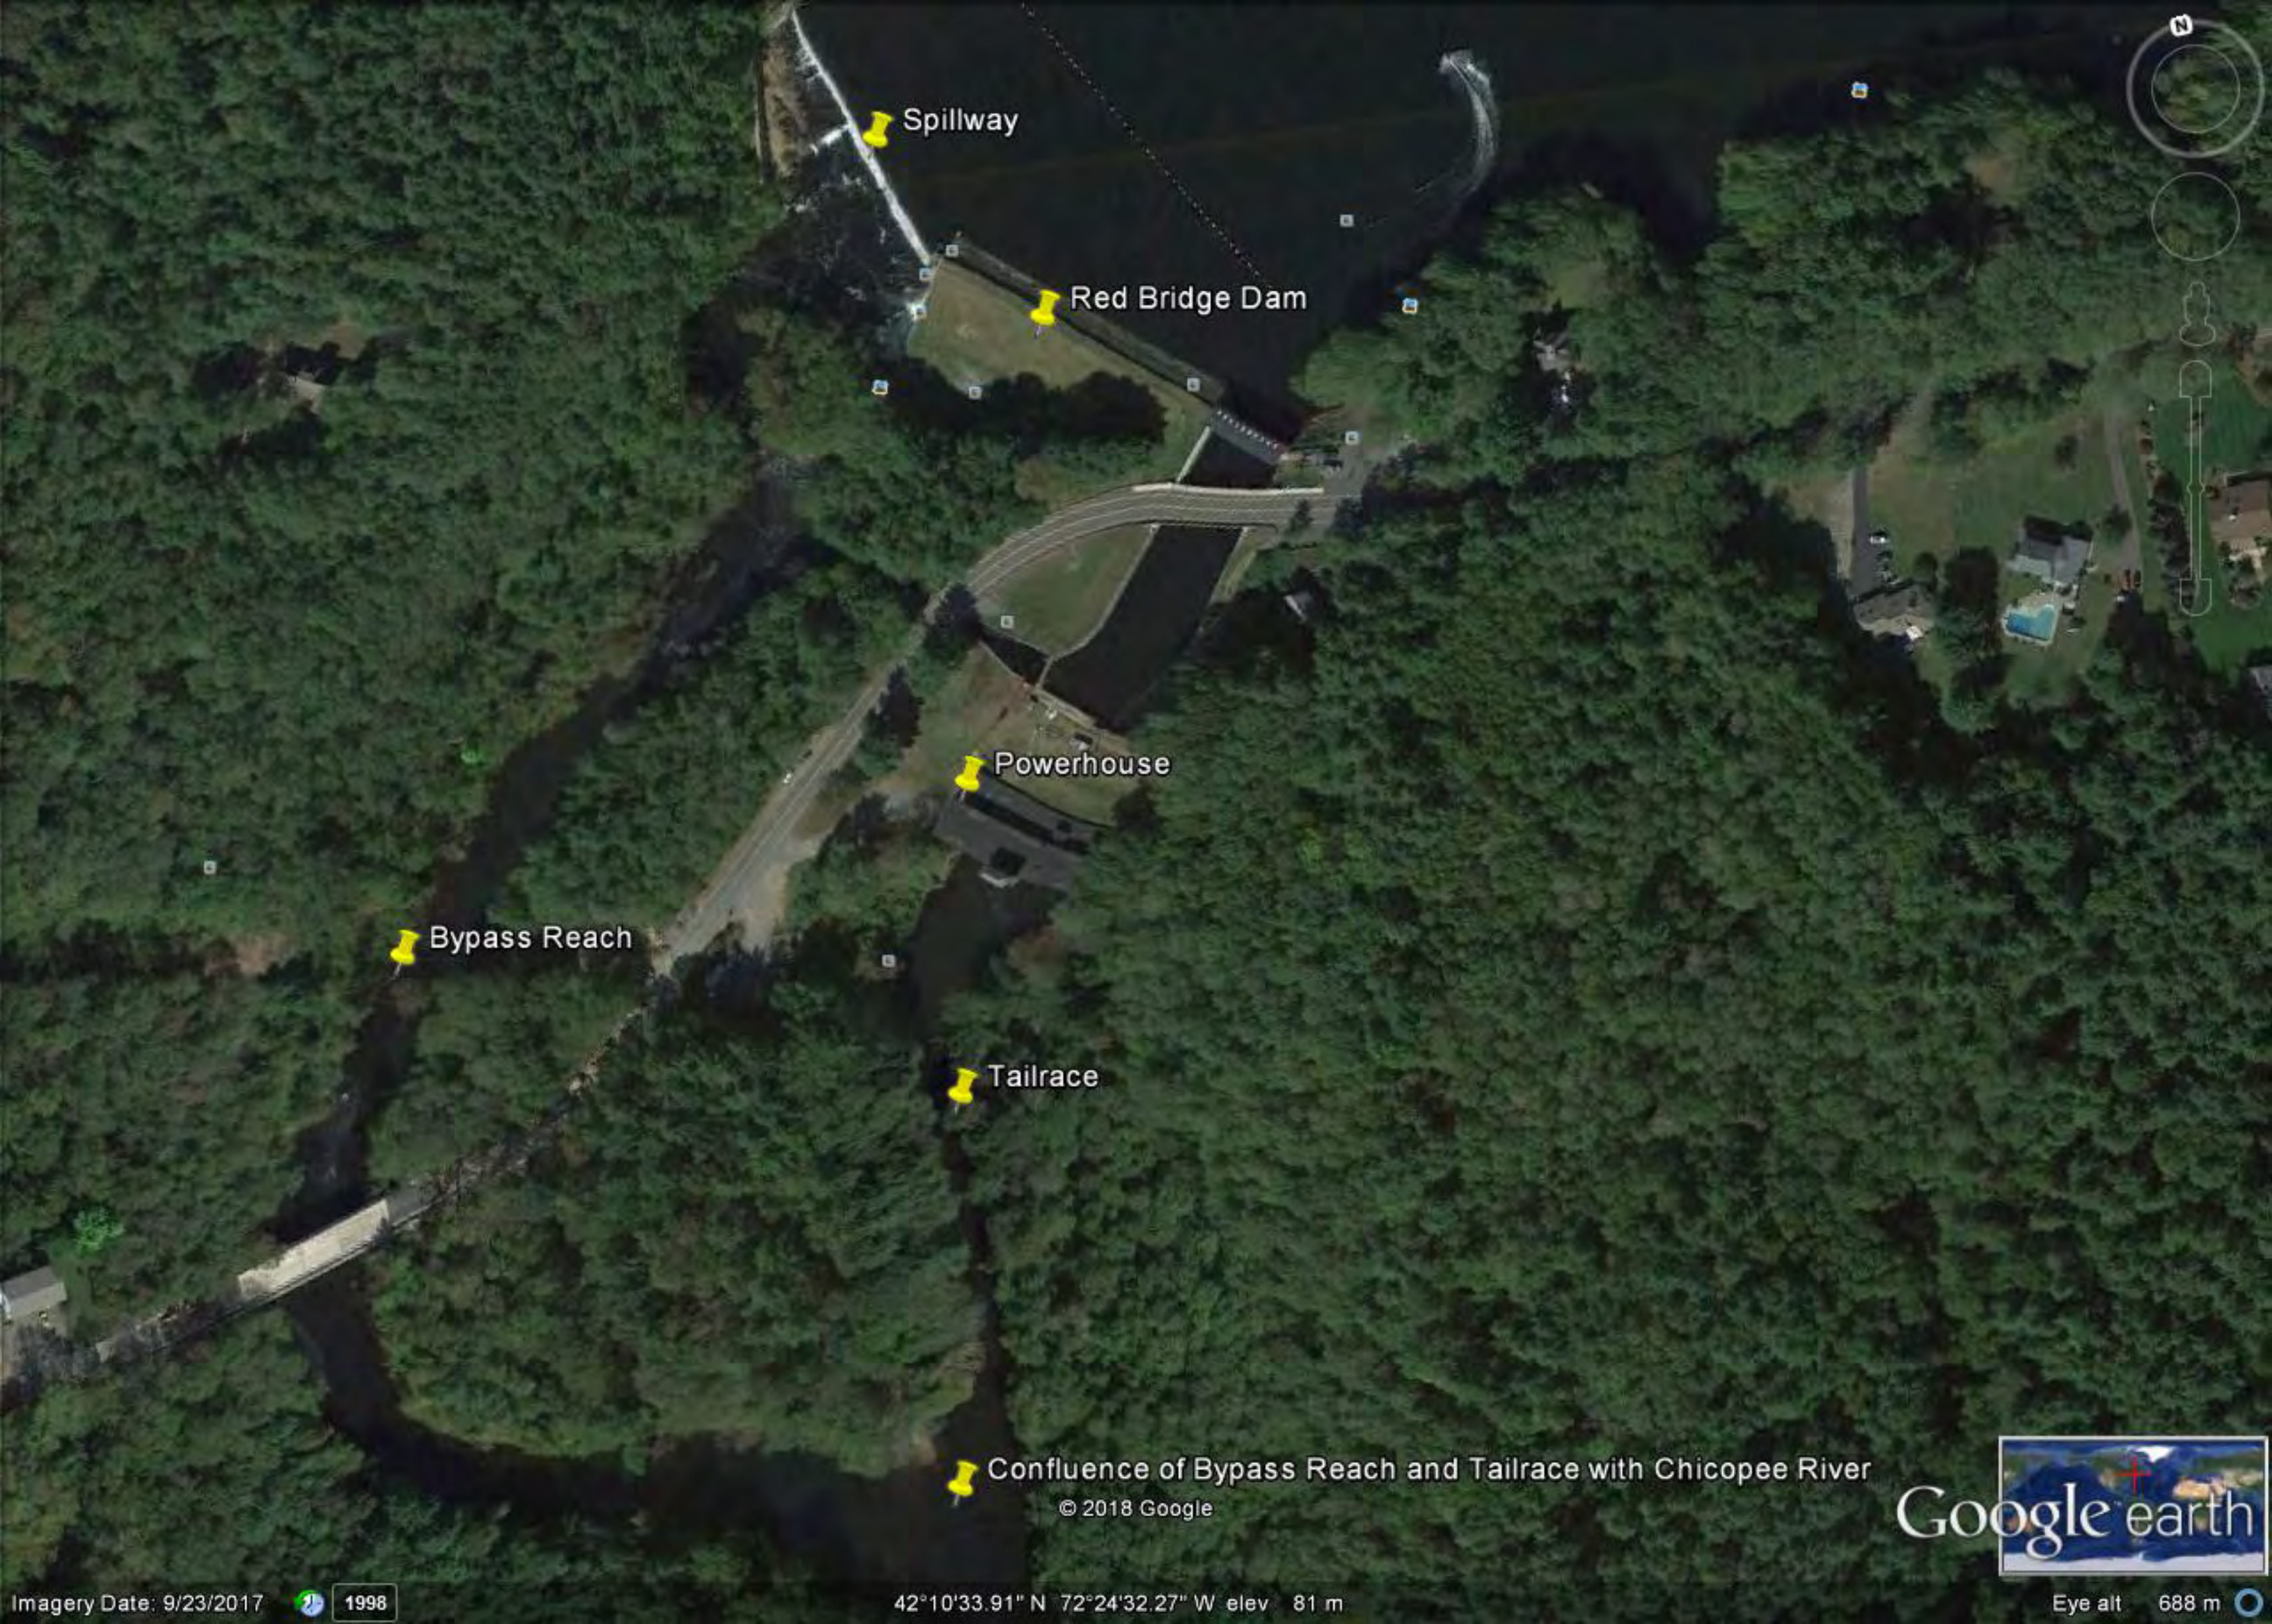
Spillway

Red Bridge Dam

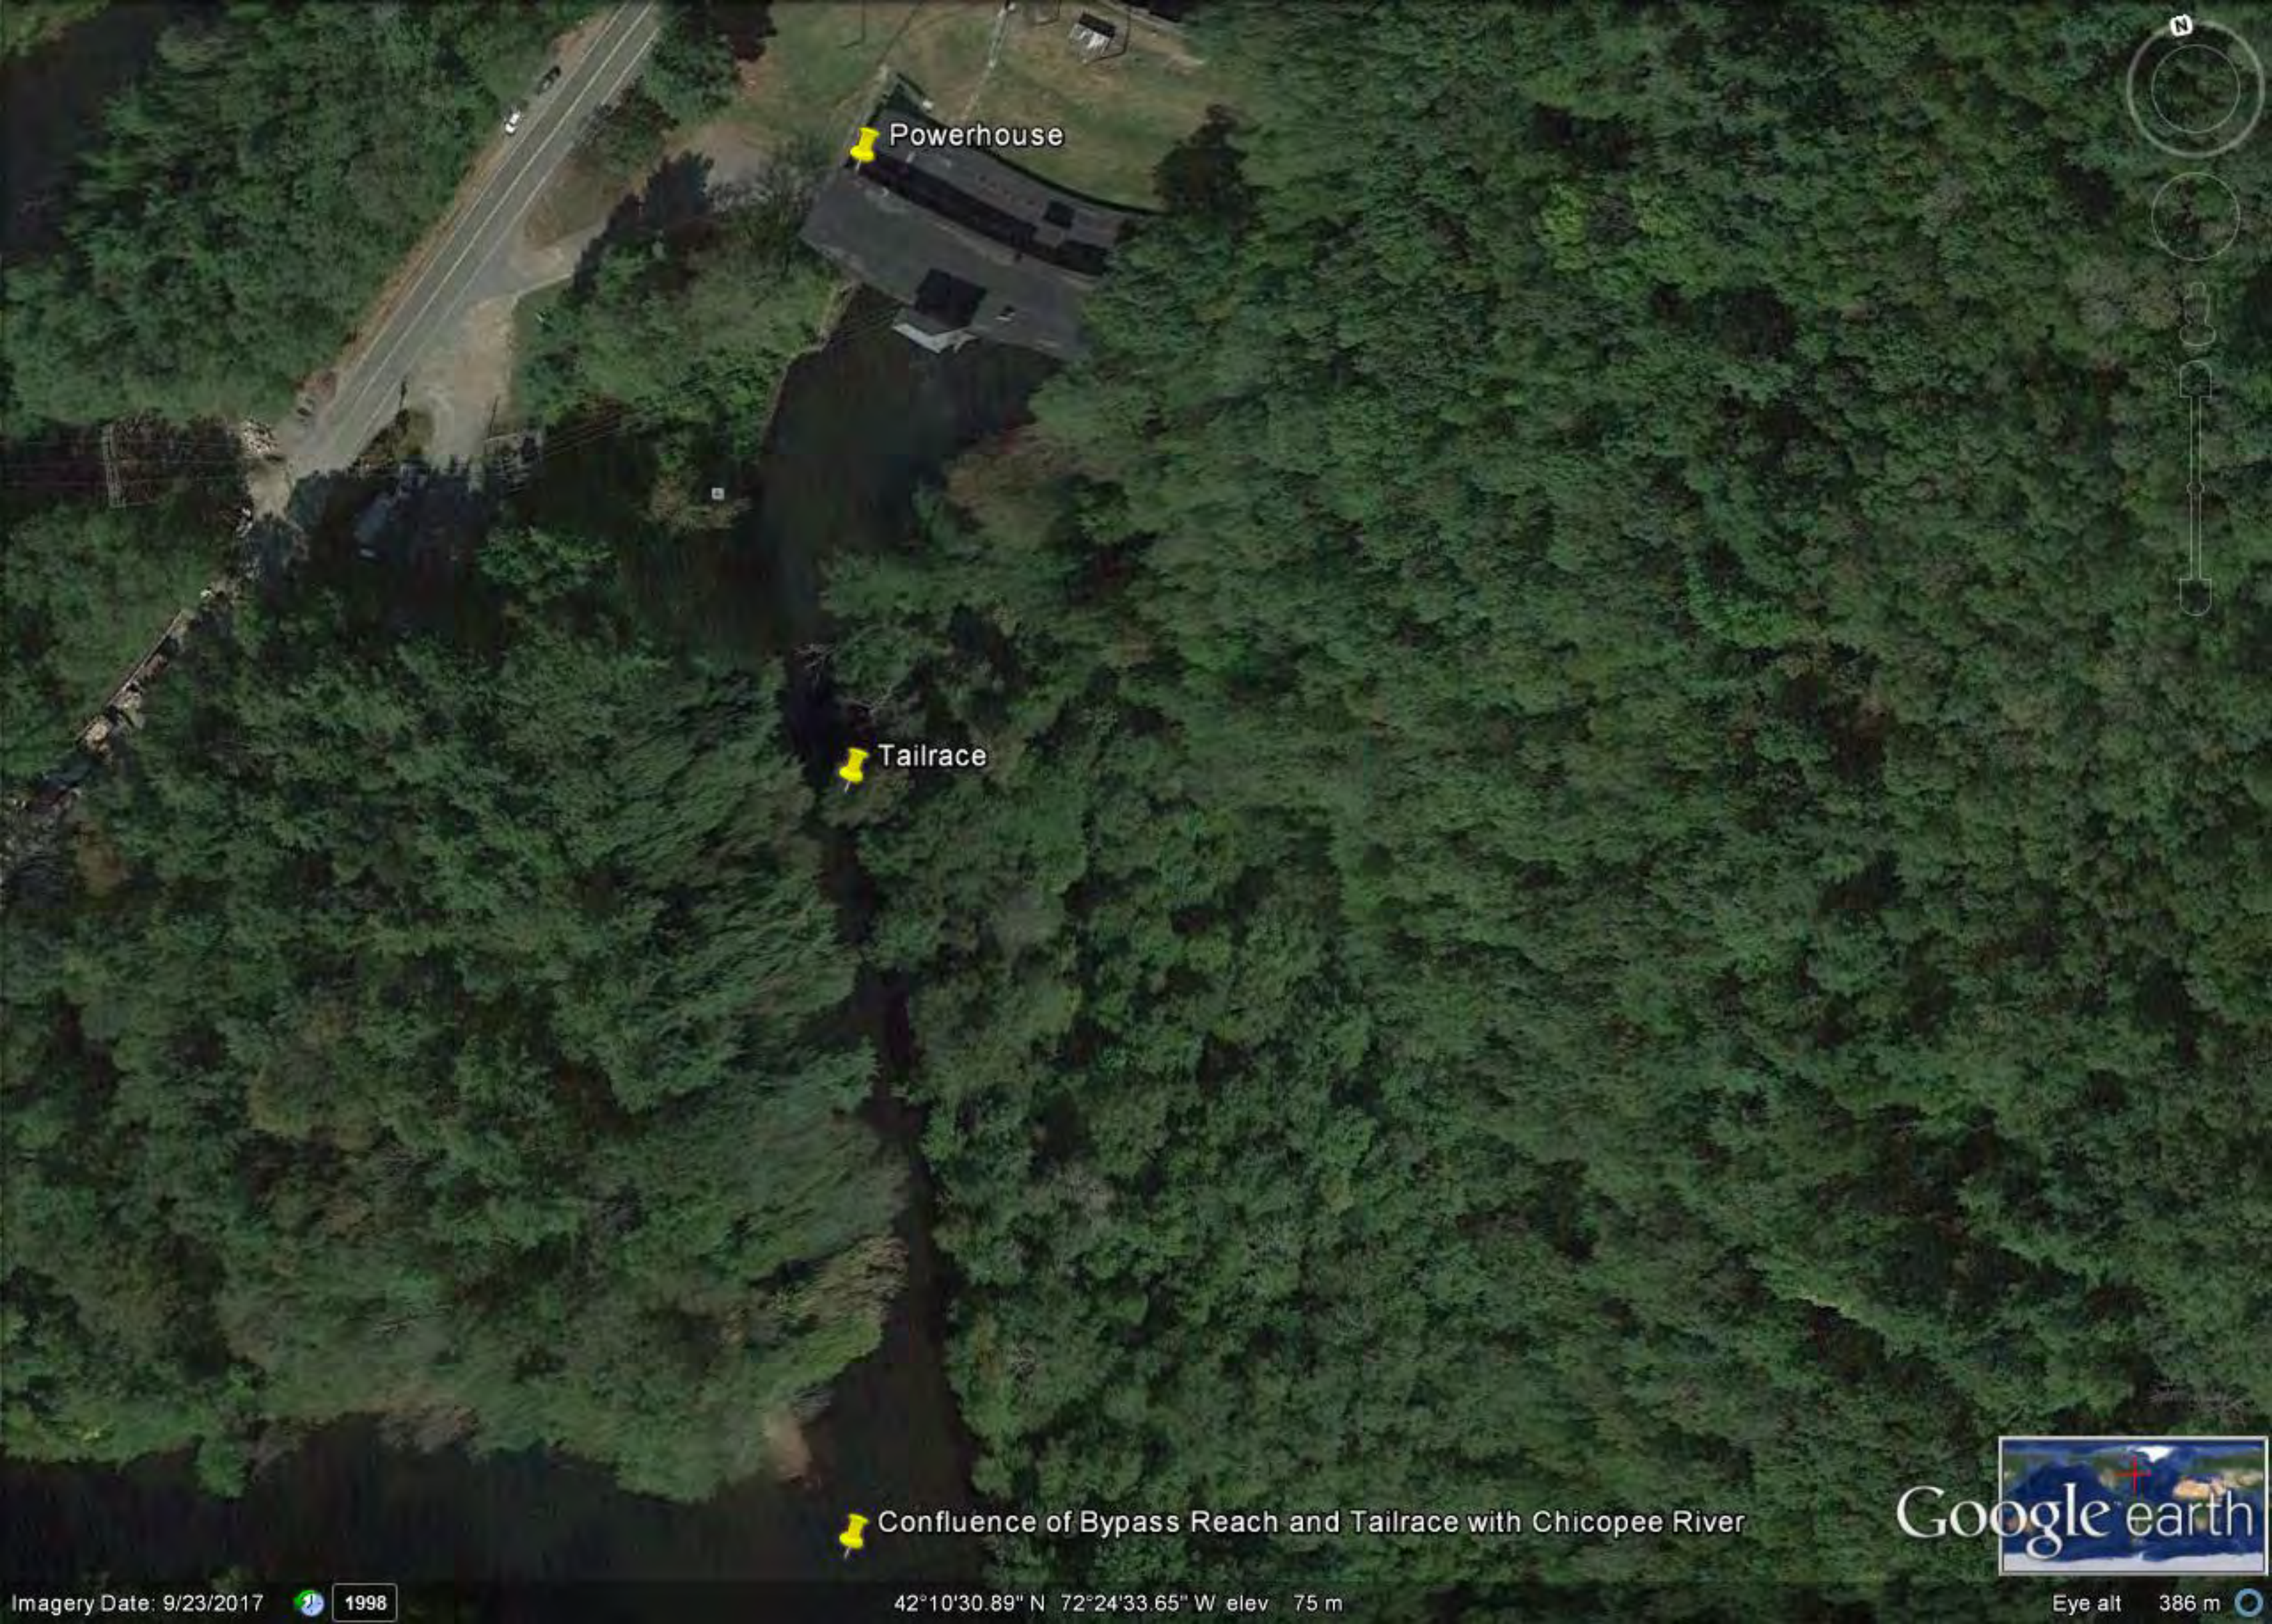
Powerhouse

Tailrace
