Subject: Bonny Eagle Comments

2017 Saco River Diadromous Fish Passage Report

**A Report on the Operation of
Brookfield White Pine Hydro LLC Fish Passage Facilities at the
Cataract East and West Channel Projects (FERC No. 2528)
Springs and Bradbury Projects (FERC No. 2528)
Skelton Fish Project (FERC No. 2527)
Bar Mills Project (FERC No. 2194)
West Buxton Project (FERC N0. 2531)
Bonny Eagle Project (FERC No. 2529)**

FIGURE 1 HIRAM PROJECT LOCATION MAP

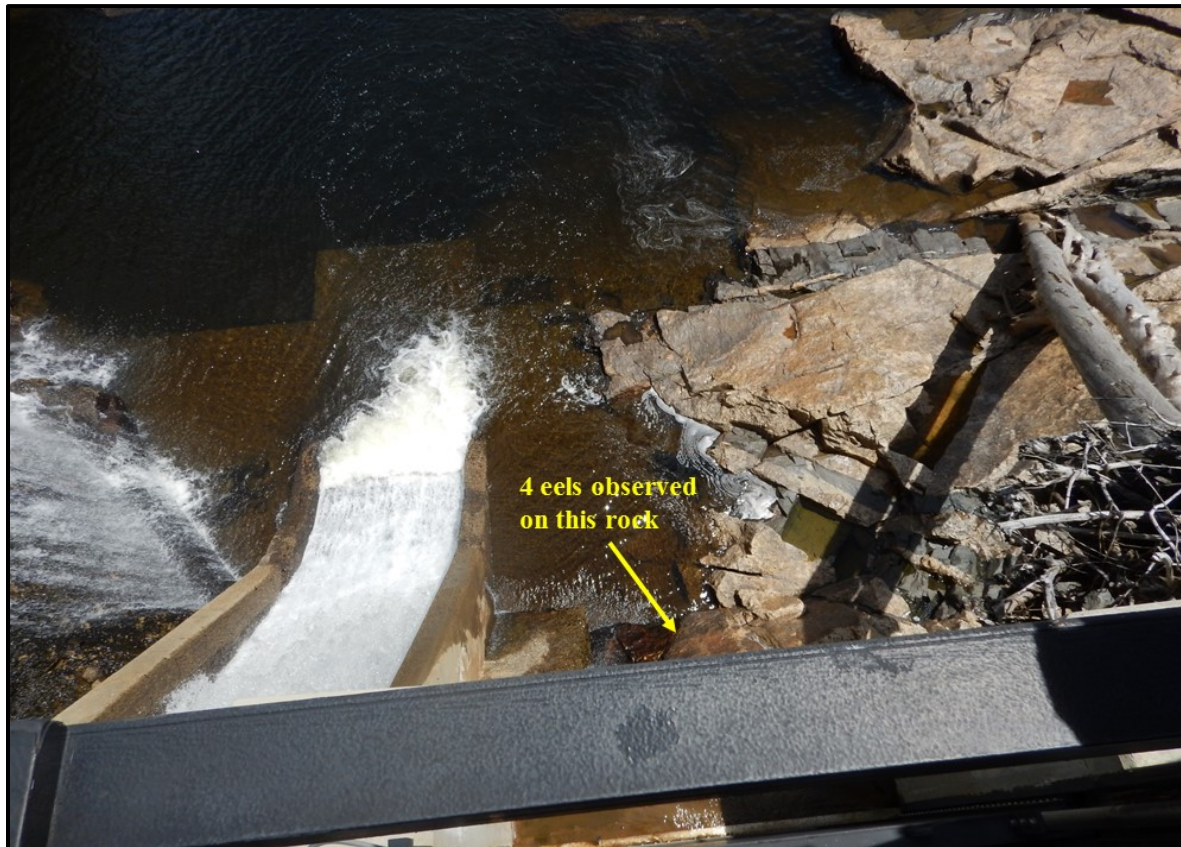
PHOTO 1 LOCATION OF JUVENILE AMERICAN EELS ON BEDROCK ADJACENT TO THE SPILL GATES AT THE HIRAM PROJECT DURING THE 2018 NIGHTTIME SURVEYS

Five eels were observed throughout the monitoring period. Four eels were observed on bedrock to the right of the spill gates (Figure 2, Photo 1) and one eel was seen on the concrete downstream of a debris gate (Photo 2). The number of eels observed during each survey ranged from 0 to 2; eels were observed on June 7 (1), July 5 (2), July 12 (1), and July 24, 2018 (1) (Table 1). The lengths of eels ranged from approximately 3 to 5 inches (75 to 125 mm). No eels were observed at the tailrace. One or both units were operating during each survey. There was no spill during the monitoring except during the August 1, 2018 survey (Table 1); however, there was leakage through the debris gates during every survey.

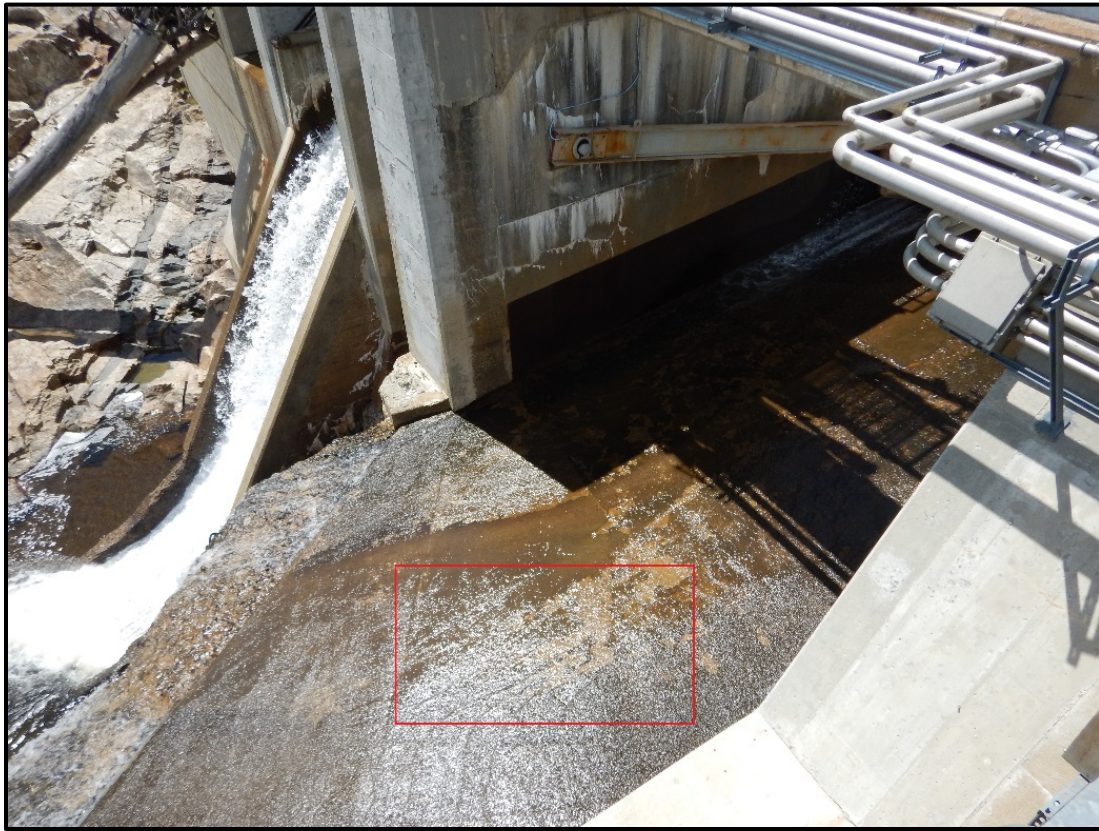
PHOTO 2 **LOCATION OF A JUVENILE AMERICAN EEL DOWNSTREAM OF A DEBRIS GATE AT THE HIRAM PROJECT DURING THE 2018 NIGHTTIME SURVEYS**
