**Penacook Lower Falls Hydroelectric Project  
(FERC No. 3342)**

**Penacook Upper Falls Hydroelectric Project  
(FERC No. 6689)**

**Rolfe Canal Hydroelectric Project  
(FERC No. 3240)**

**Application for Subsequent License  
Major Water Power 5 Megawatts or Less**

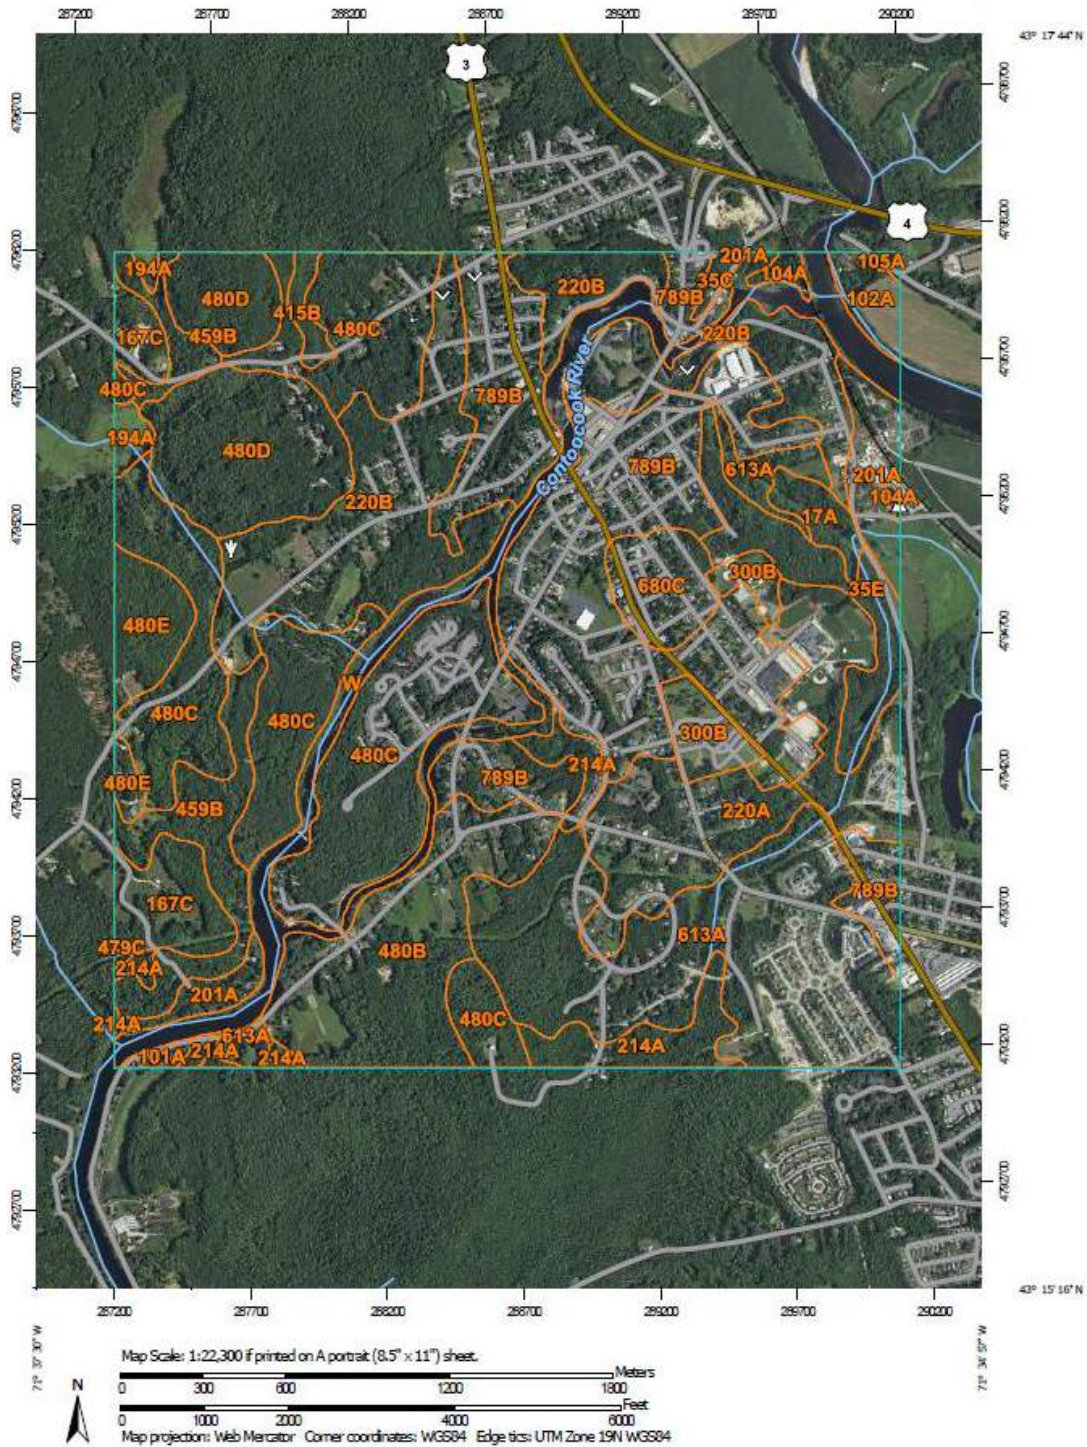
Figure E.5. Soils in the vicinity of the project area showing areas of Millsite-Woodstock-Henniker Complex (480 B and 480 C), Boscawen Fine Sandy Loam (220B), and Champlain Urban Land Complex (789B).

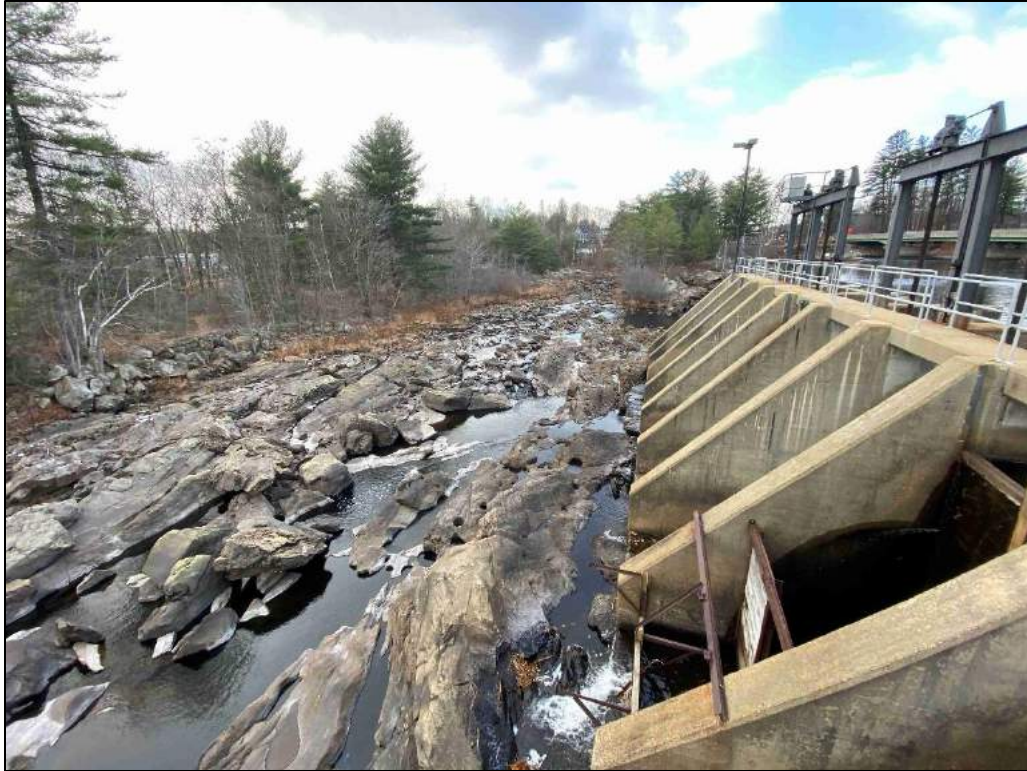
The PLF Bypass is a steep (3%-4%), bedrock-dominated reach approximately 680 ft in length bordered by a forested bank on the east and the spillway on the west bank.

Figure E.8 Photo of the Penacook Lower Falls bypass reach.

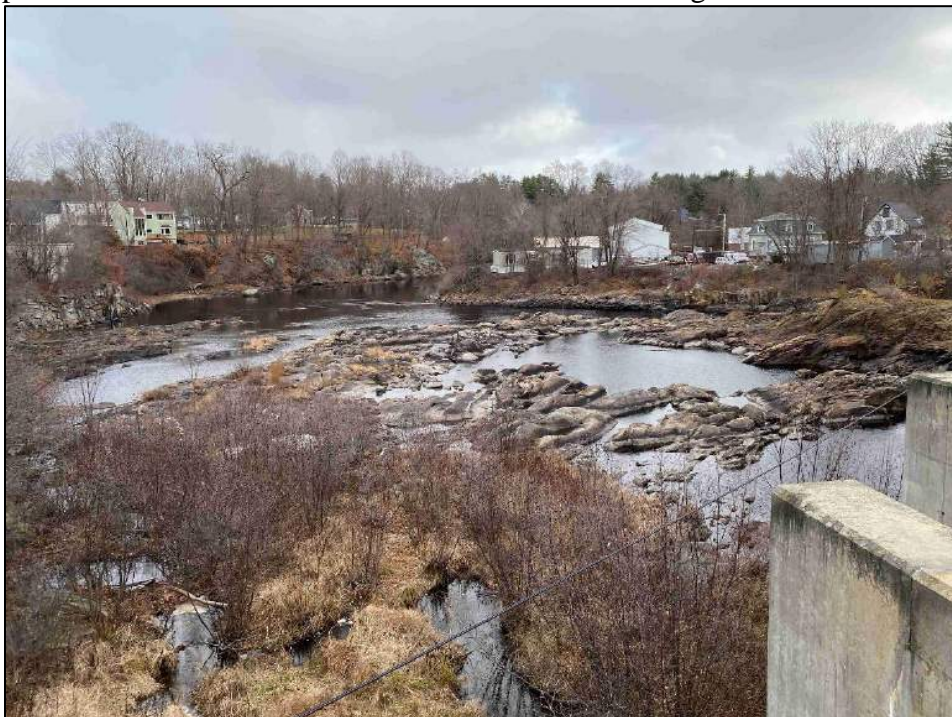
The PUF Bypass is a steep (3% -4%), bedrock-dominated reach 250 ft in length bordered by the powerhouse on the east bank and a warehouse building on the west bank.

Figure E.9 Photo of the Penacook Upper Falls bypass.

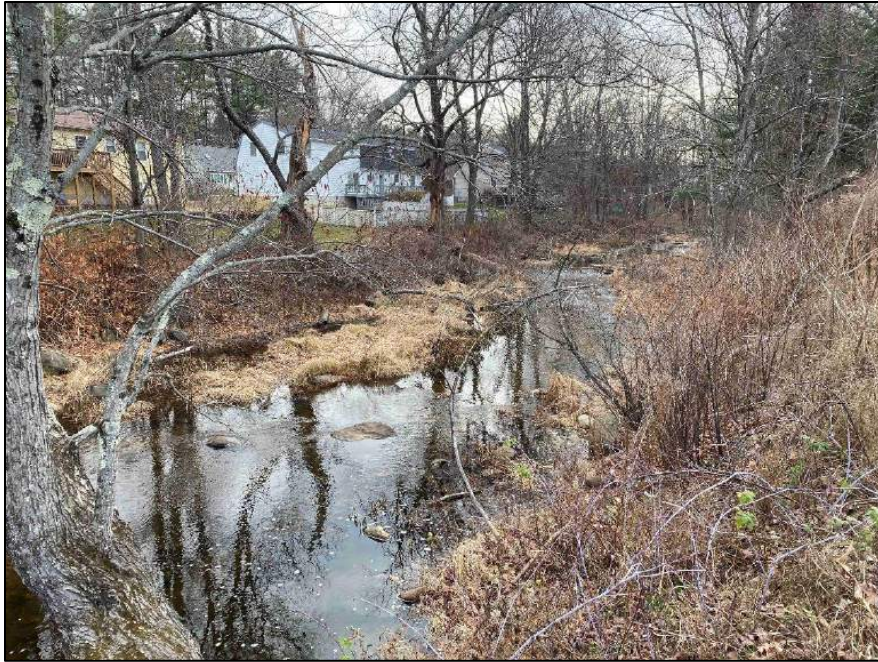
The Rolfe Canal bypasses a short, narrow Historic Channel approximately 1,800 ft in length (Figure E.10). The upper one-third of this Historic Channel is a deep, backwater pool habitat; the lower two-thirds is a narrow (~20 ft wide) low gradient channel bordered by dense riparian vegetation (Figure E.10).

Figure E.10 Photo of the Rolfe Canal Penstock Bypass reach or Historic Channel bypass.

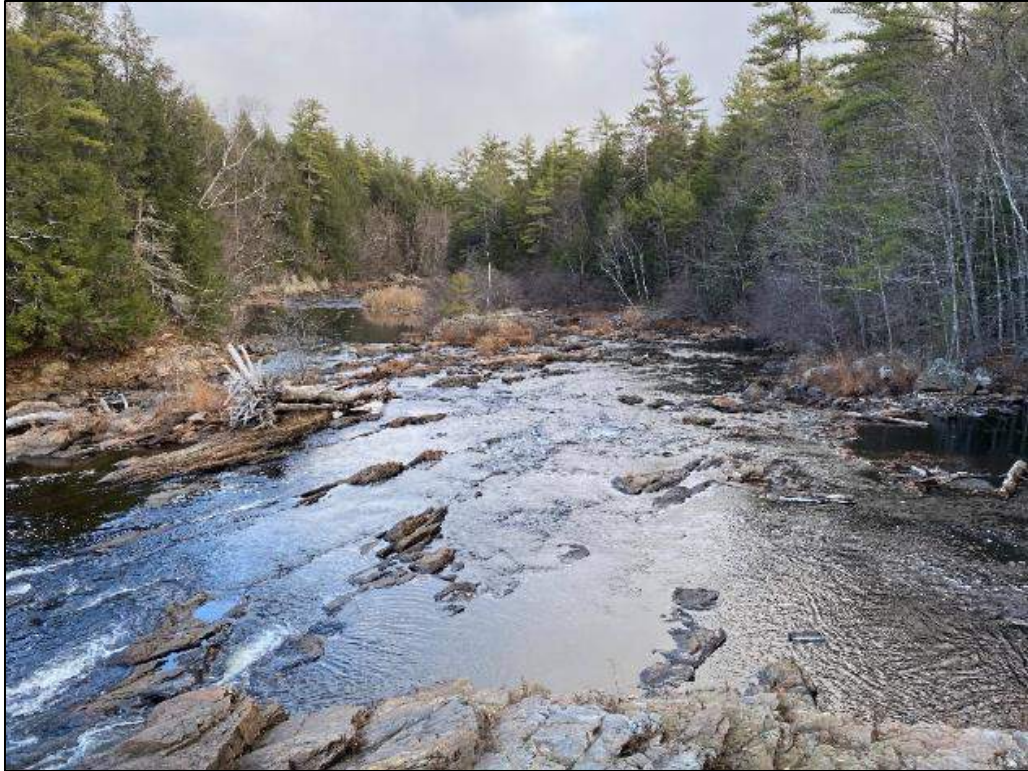
The Rolfe Canal project also includes the York Dam bypass which was the primary study area for this instream flow study (IFS) from York Dam downstream approximately 4,000 feet to its confluence with the PUF headpond. This reach drops approximately 28 feet for an average gradient of 0.7%. The upper half of the Rolfe Bypass is composed of alternating short sections of bedrock ledge and rapids habitat and deeper pool/run habitat (Figure E.11). The lower half of the bypass is predominantly composed of shallow, cobble/boulder-dominated riffle and run habitat. Channel widths range from 50 feet to over 150 feet. Both banks are lined with mature deciduous and coniferous riparian trees, with limited shrub vegetation on exposed bedrock ledges.

Figure E.11 view of the York Dam bypass channel downstream of the dam

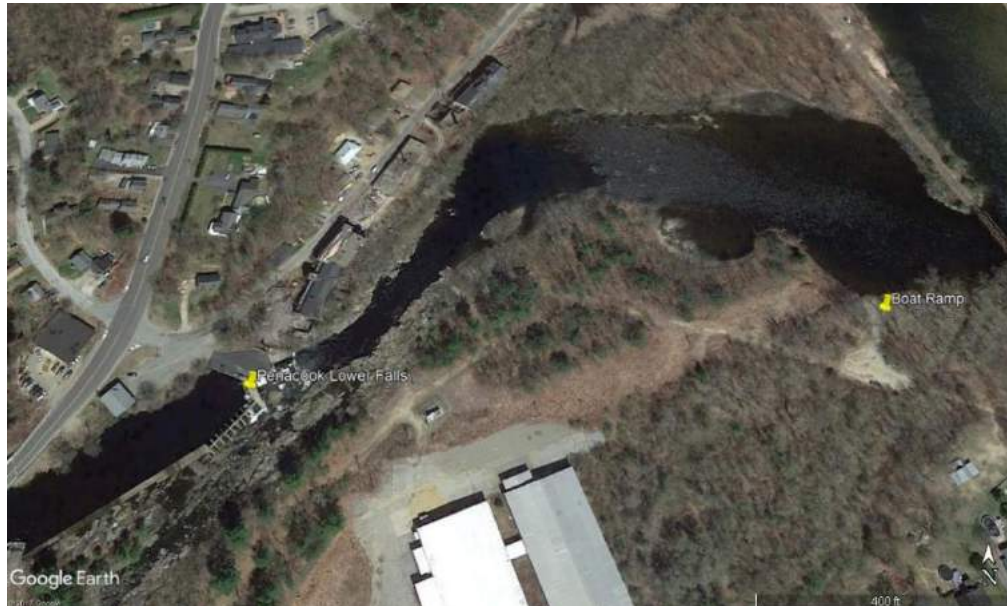
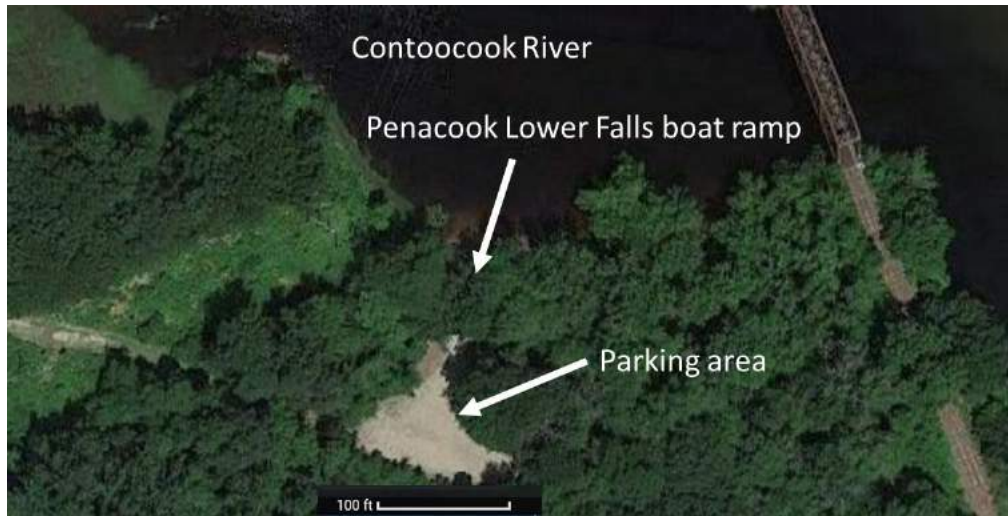
Parking at the boat launch is available in a cleared dirt area approximately 100 ft by 100 ft which does not have striped parking spaces. If we assume that only half of that area is available for parking (5,000 sq ft) with the remaining space for drive and turnaround lanes and that the parking space per vehicle is 250 sq ft (10ft x 25ft), we can estimate there is enough space to park upwards of 20 vehicles. Since the parking is haphazard and some vehicles may have trailers the actual parking capacity may be less than that estimate in practice. See Figure E.14 for a map of the boat launch and closer aerial view of the parking area.

Figure E.14 Map showing the location of Penacook Lower Falls Boat Ramp and closer aerial view of the parking area.

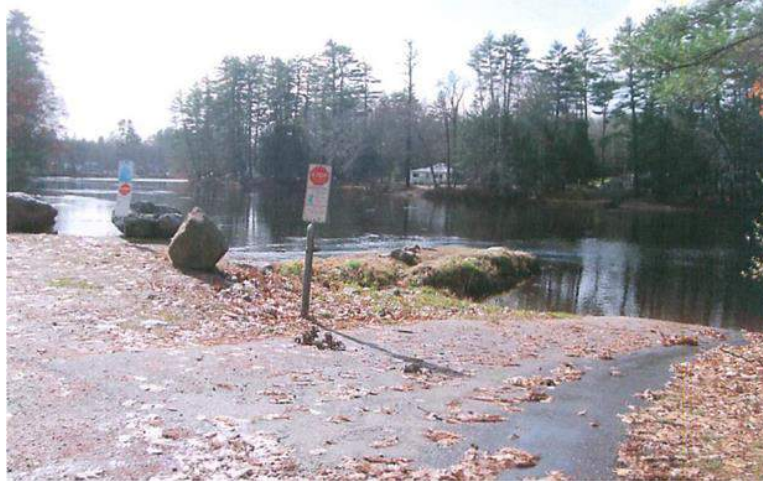
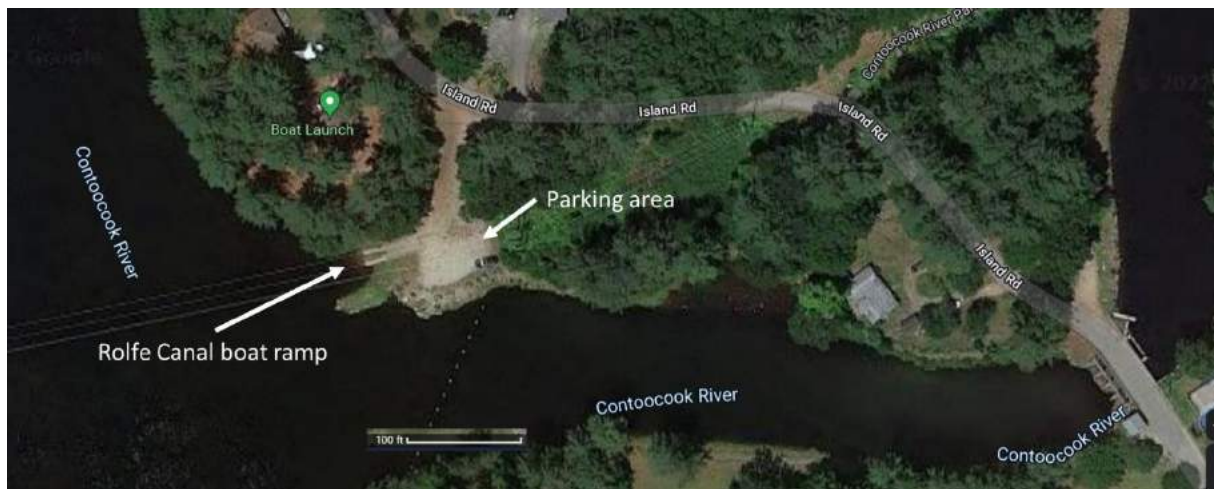
The current boat launch has an unpaved parking area approximately 70ft by 35 ft sufficient for approximately 6 or 7 head-in parking spaces. There is also additional space for parking along the access from Island road to the ramp that is suitable for vehicles with trailers (approximately 2-3) see figure E.18.

Figure E.18 Picture of Rolfe Canal Boat Launch and aerial view of the parking area.

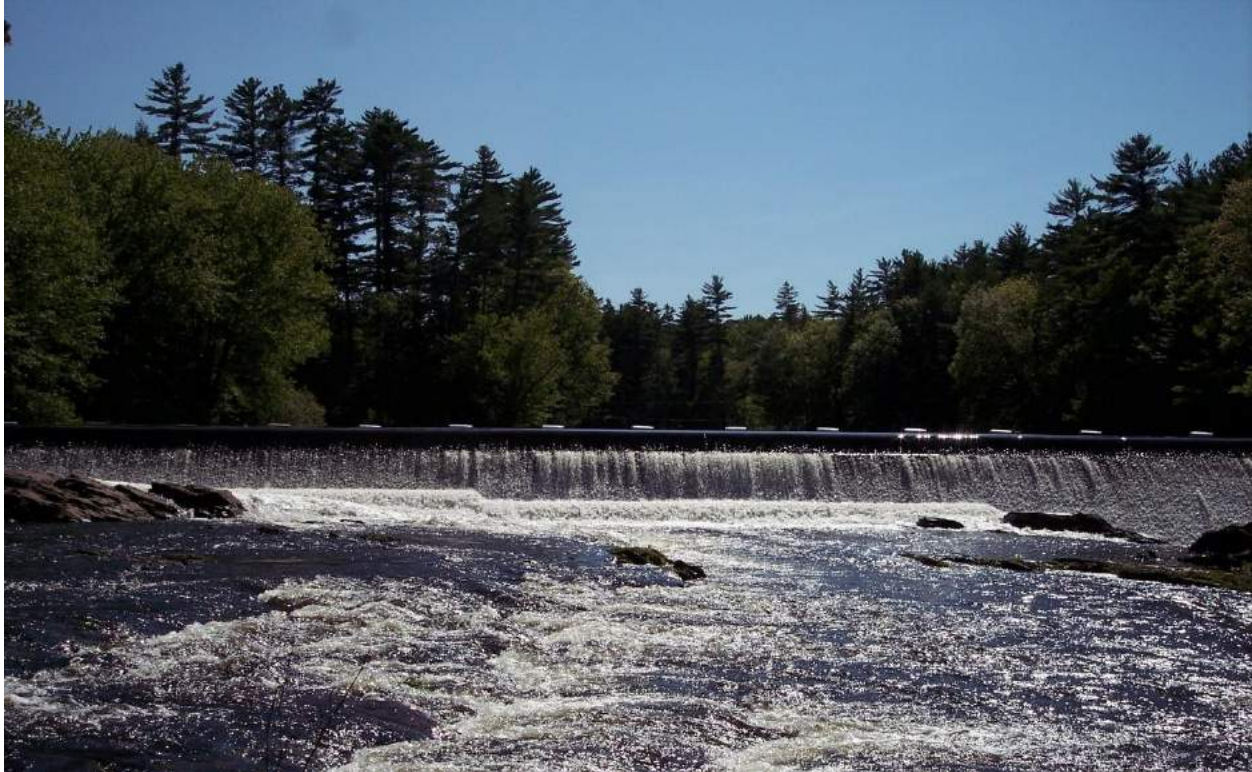
Figure E. 19 Photo showing a view of York Dam

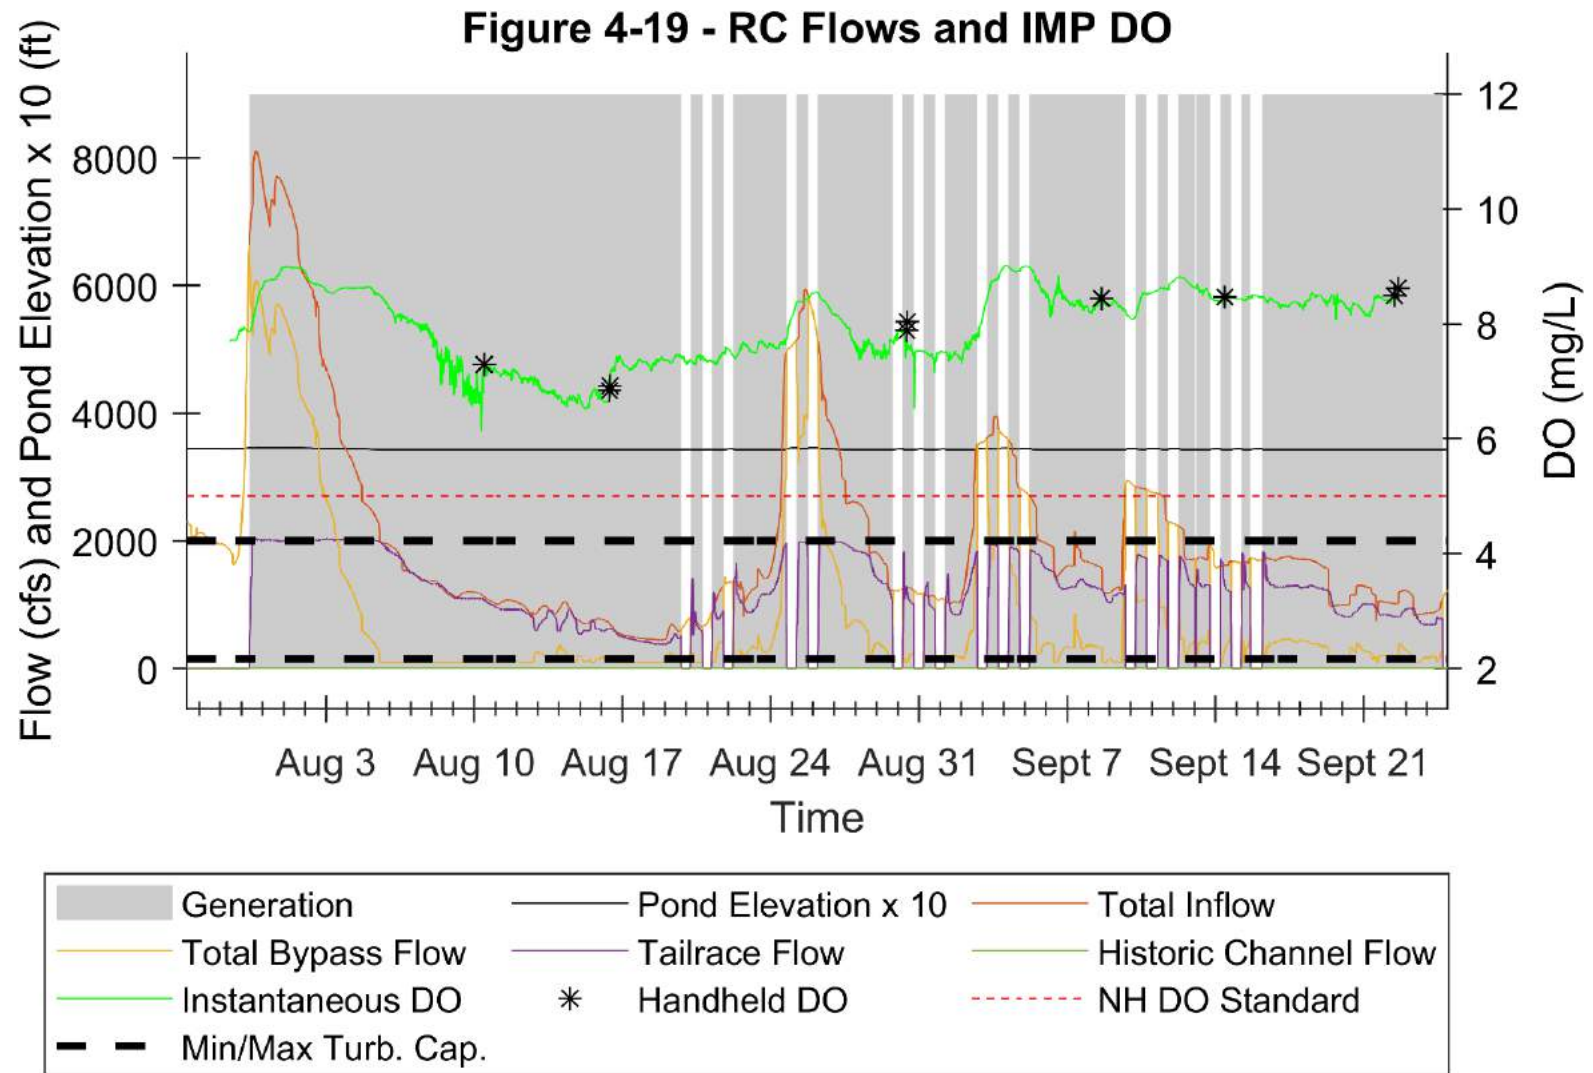
Figure 14–19. RC-IMP. Pond elevation (ft x 10, for clarity), total inflow (cfs), total bypass flow (cfs), tailrace flow (cfs), datasonde DO (mg/L), and handheld meter DO observed during 2021 study. NH instantaneous DO water quality standard shown at 5 mg/L. Minimum and maximum turbine capacity (cfs) shown as solid dotted lines along the horizontal x-axis. Periods of power generation shaded.

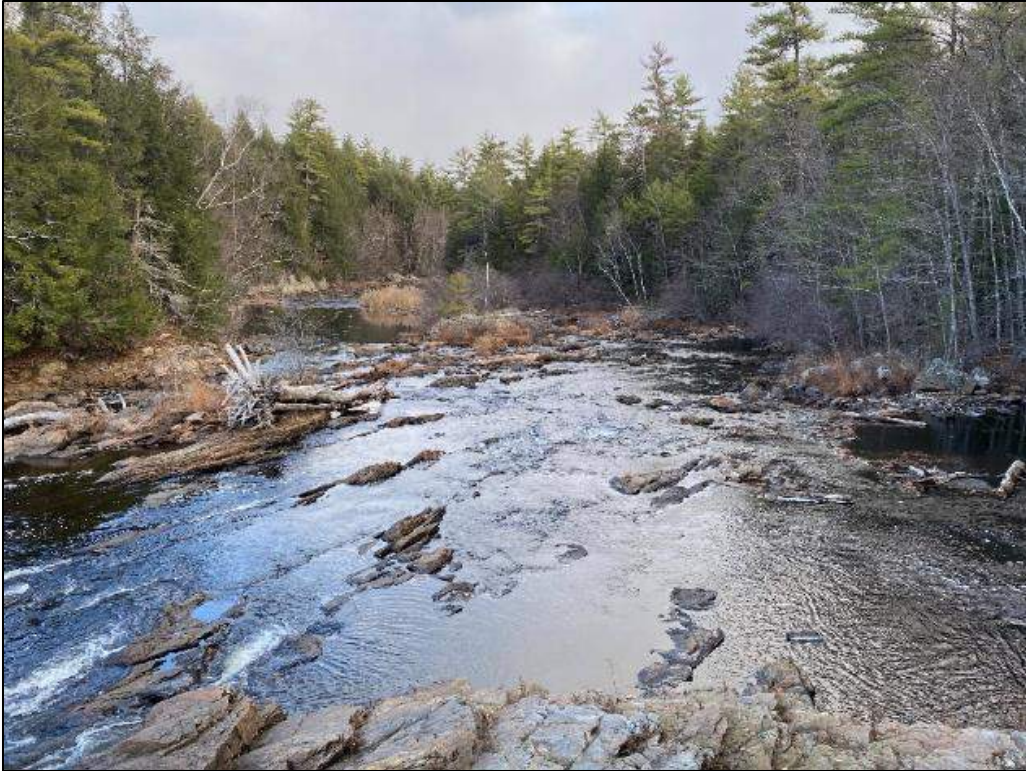
Figure 28–2. Example of bedrock habitat immediately below York Dam.

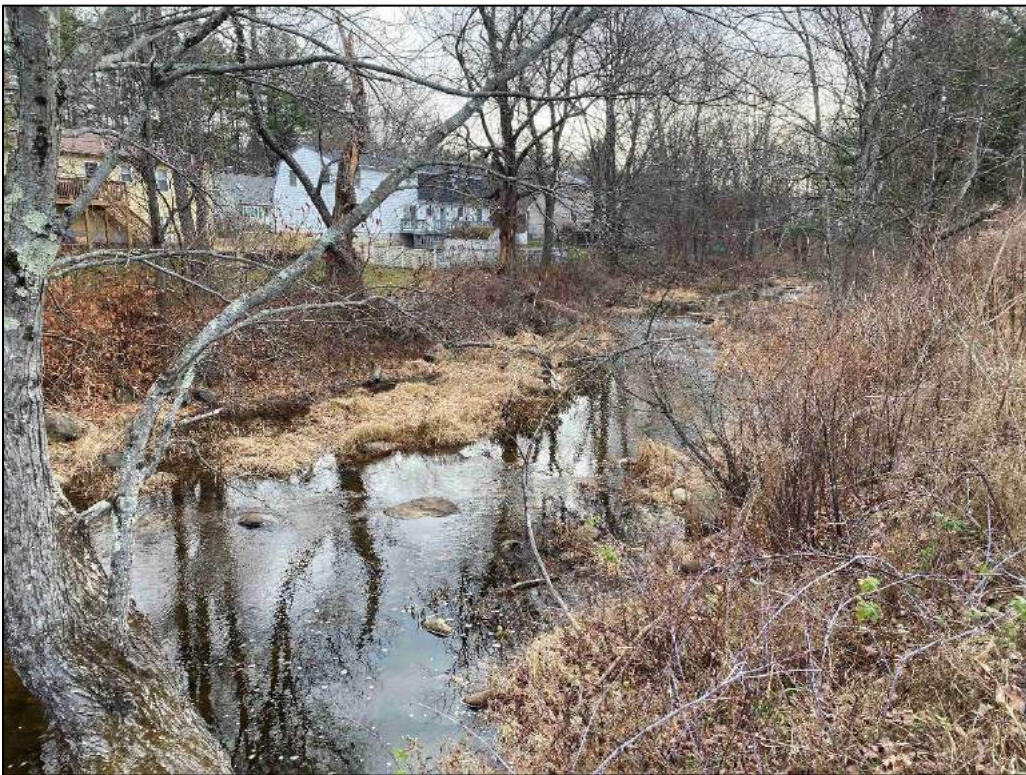
Figure 28–3. Historic Channel Bypass reach.

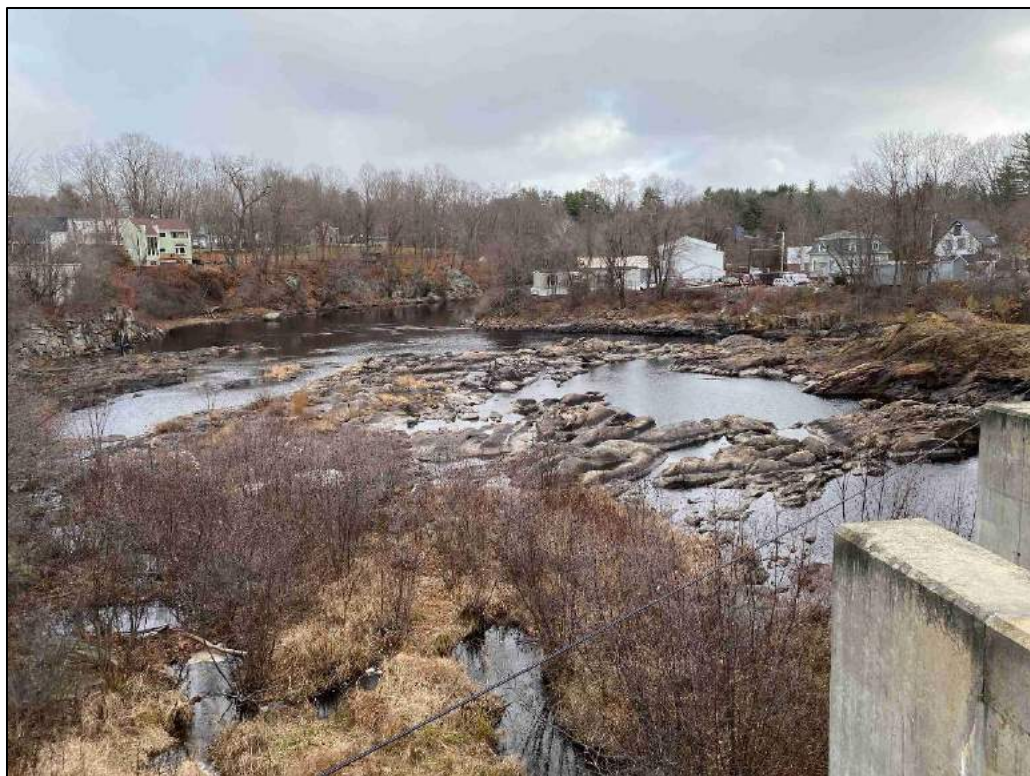
Figure 28–4. PUF Bypass reach.

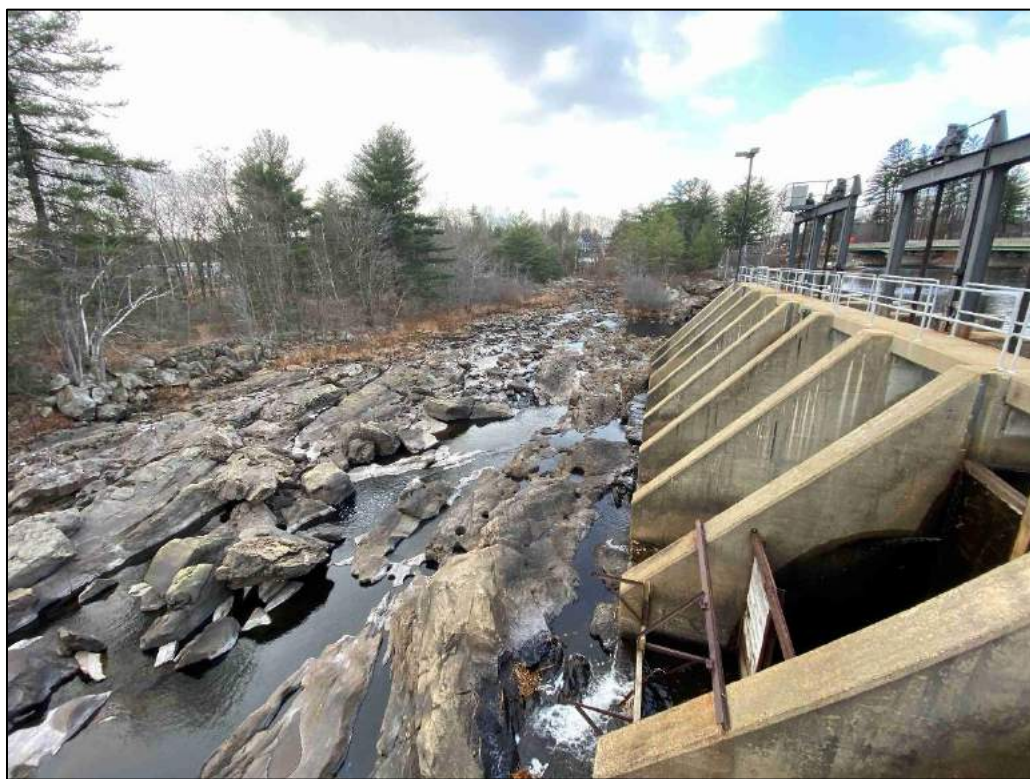
Figure 28–5. PLF Bypass reach.

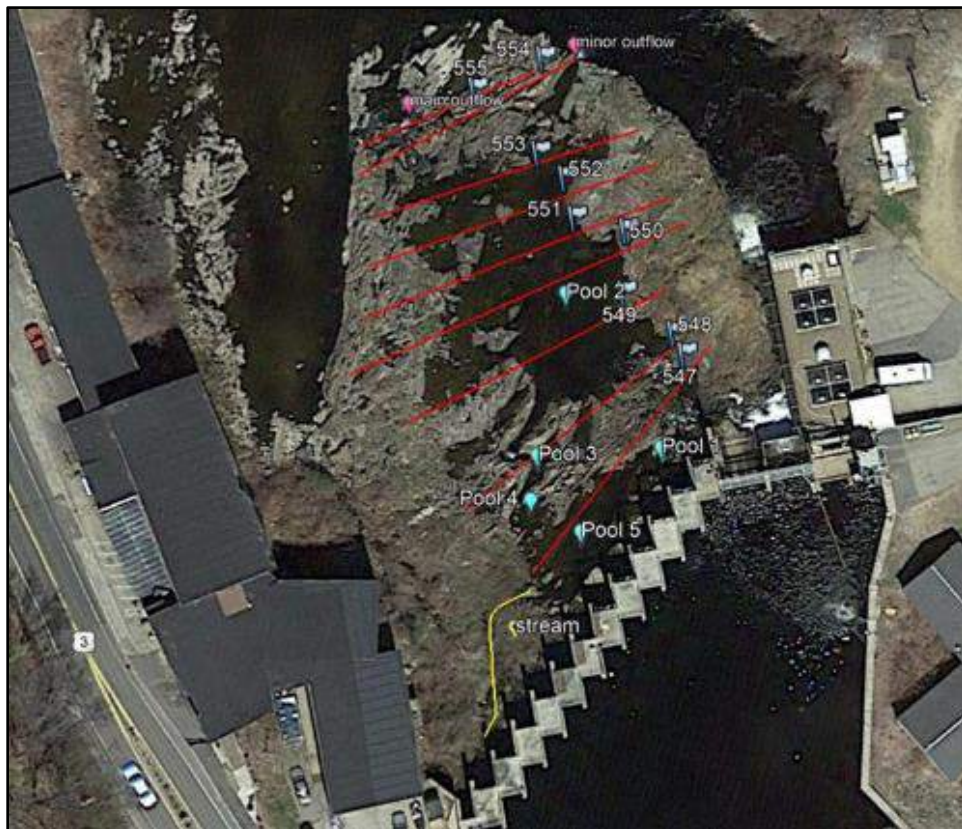
Figure 29–2. The PUF Bypass showing locations of width transects, pool units, outlet flows, and the riparian stream channel.

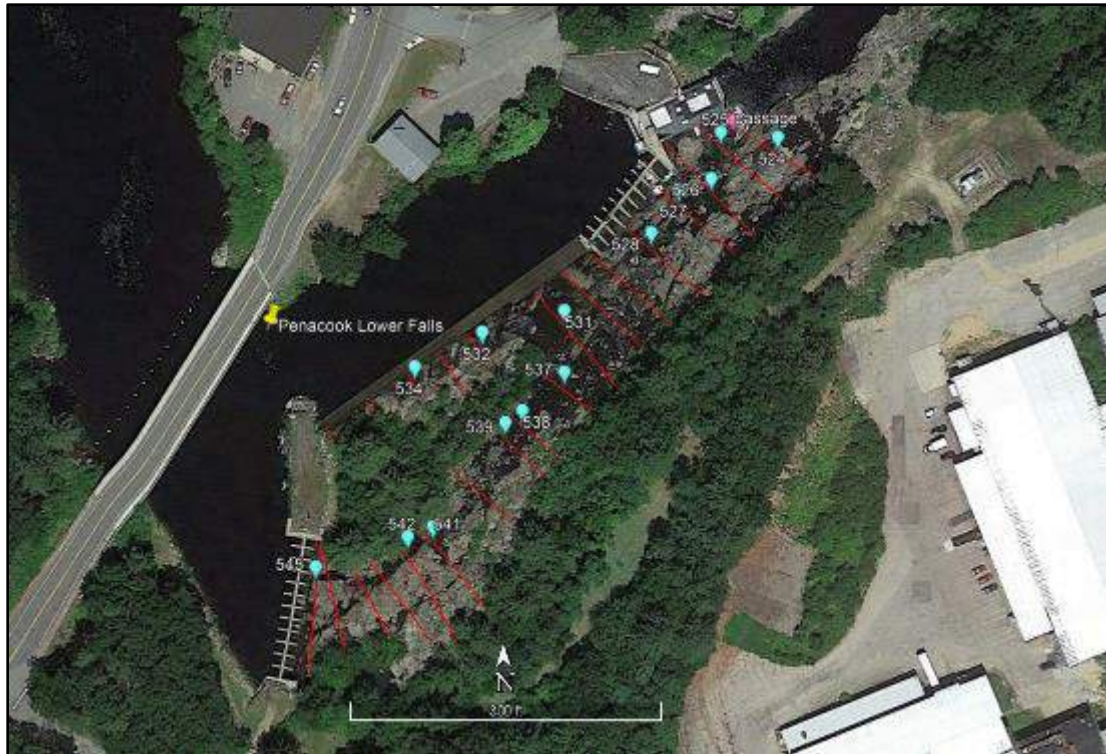
Figure 29–3. The PLF Bypass showing locations of width transects, pool units, and the passage outlet chute.

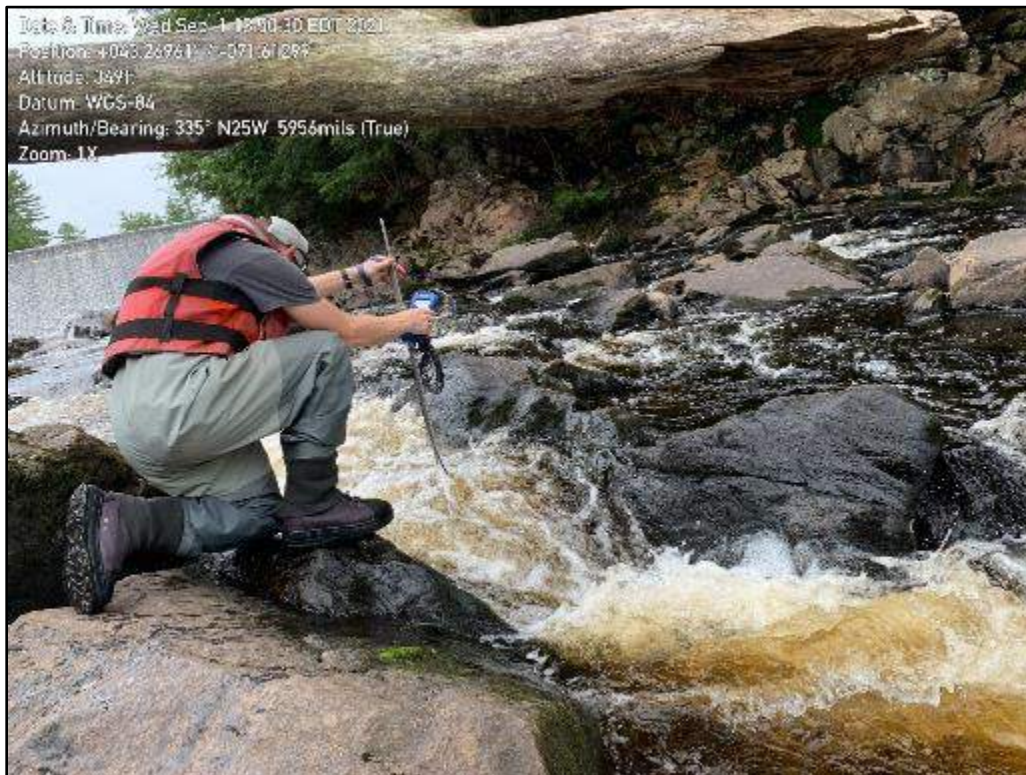
Figure 29–5. Measuring depths and velocities at potential migration barriers in the Rolfe Bypass reach.

A qualitative assessment of passage impediments to upstream migrant river herring and American shad was conducted under low flow conditions in each of the four bypass reaches. Depths and mean column velocities were measured at the lowermost locations thought to represent a likely barrier to migrating fish (Figure 4-5). These measurements were compared to published passage criteria for adult alosines (USFWS 2019); those criteria are listed in Table 4-2.

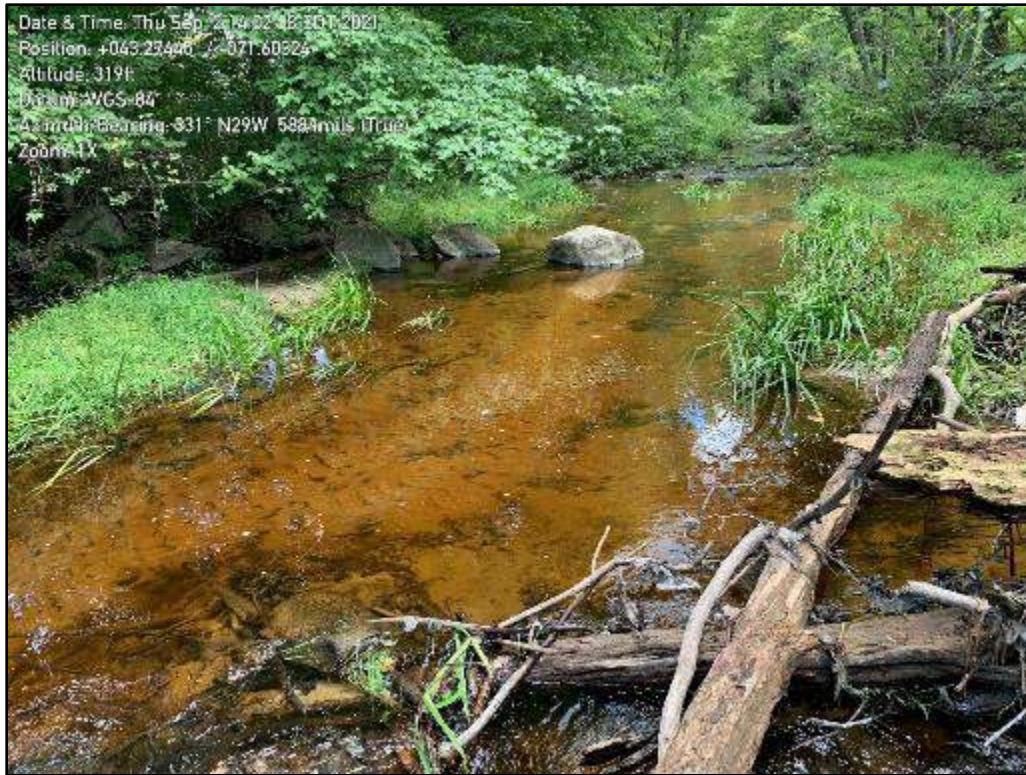
Figure 44–4. Representative photo of the Historic Channel, showing silt substrate, emergent vegetation, woody debris, and riparian canopy.

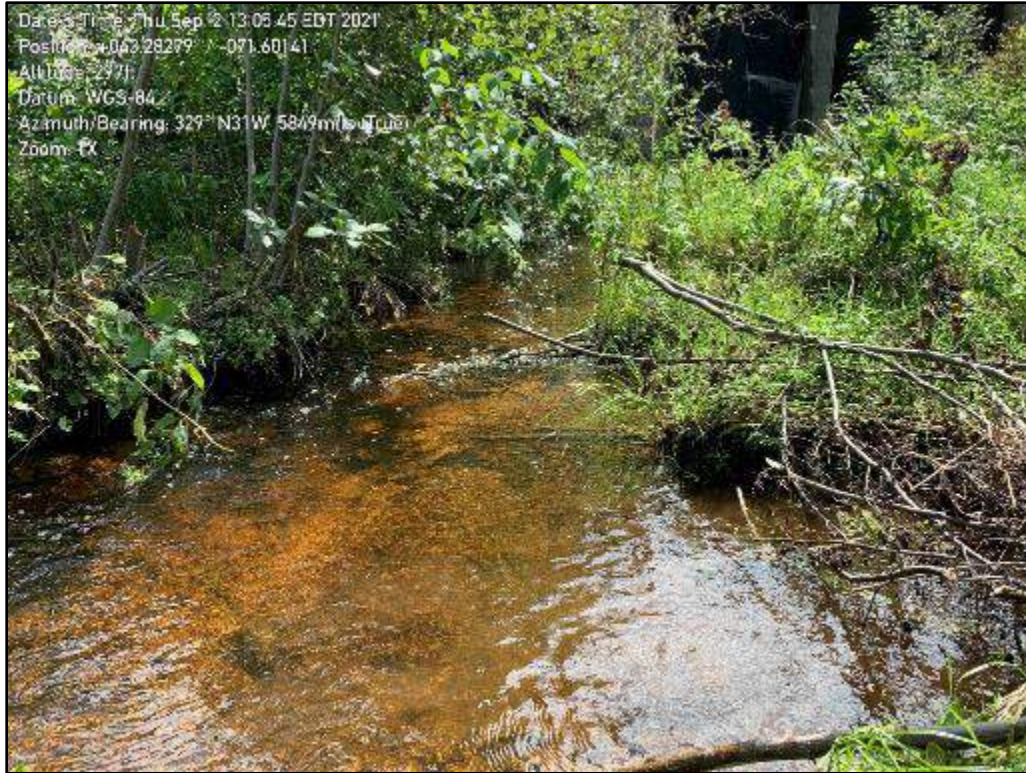
Figure 44–5. Small stream channel below PUF dam.

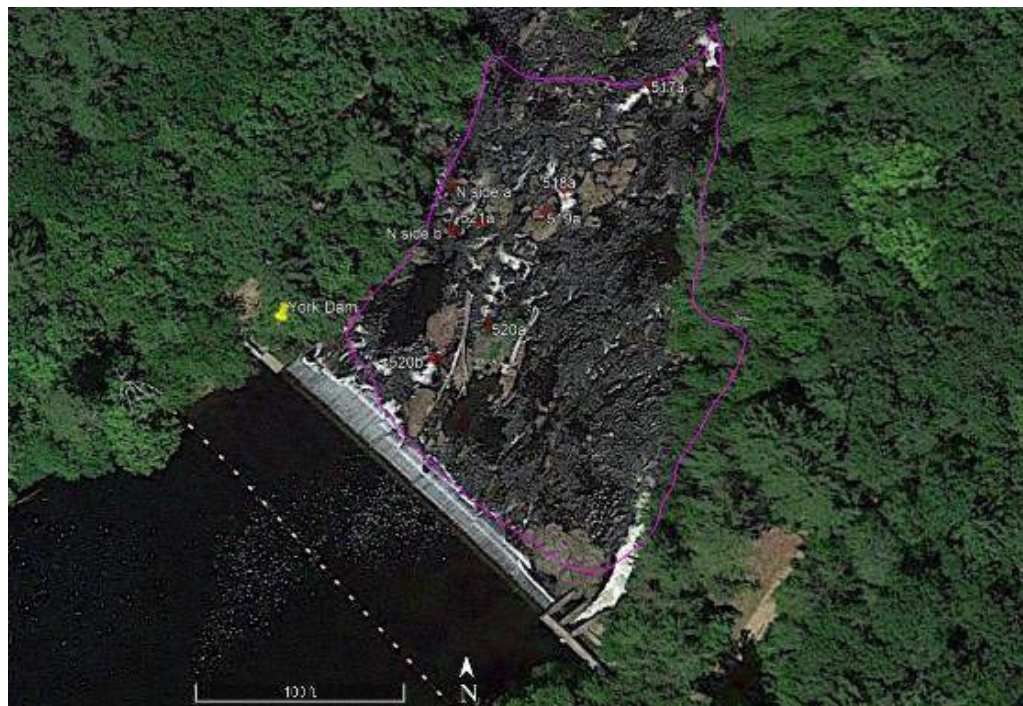
Figure 44–7. Approximate locations of passage measurements in the terminal bedrock.

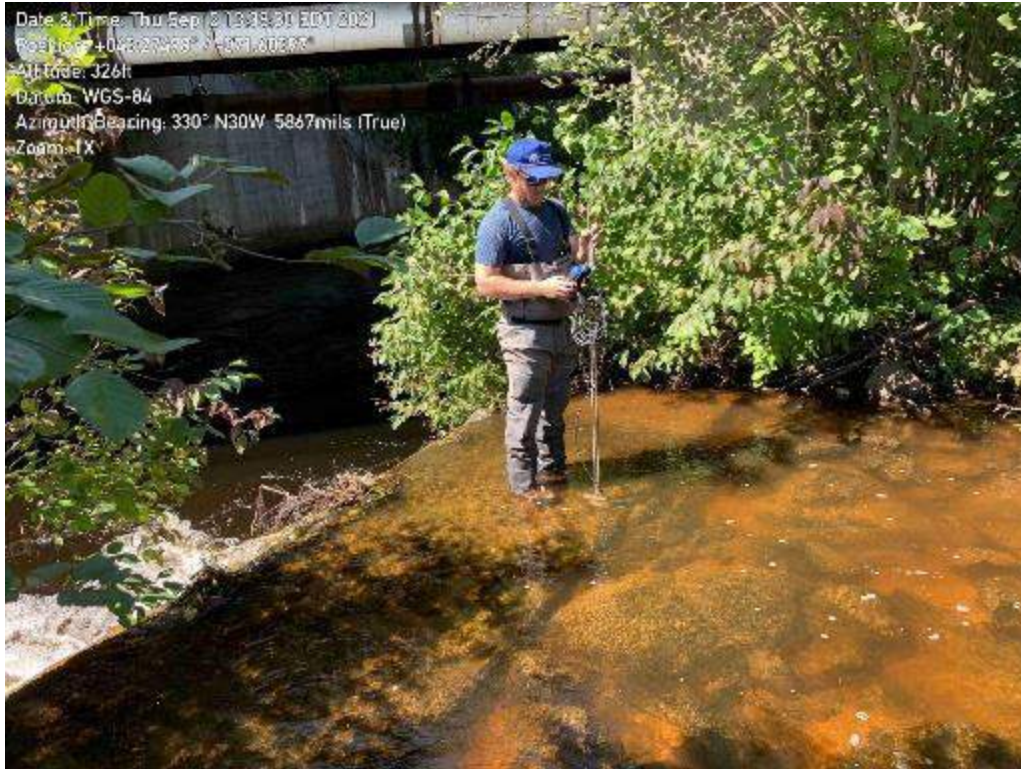
Figure 44-9. Concrete sill where Historic Channel drops into Rolfe power canal.

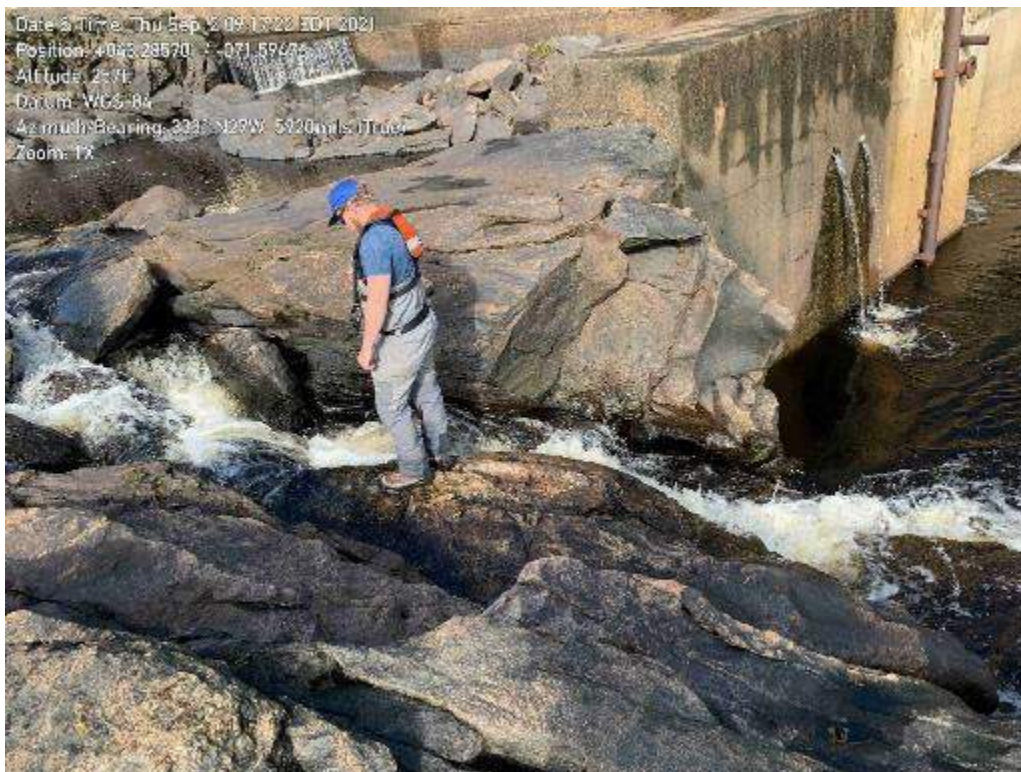
Figure 44-10. Passage chute at bottom of PLF Bypass.

The most limiting passage location in the PLF Bypass occurred at the steep whitewater chute at the very bottom of the bypass (Figure 5-10). The chute was approximately 10 ft in length with a vertical drop of approximately six ft. Depths ranged from 0.25 ft to 0.6 ft with velocities of 1.59 fps to 4.56 fps. Although chute depths would increase with spill flows the velocities are likely to quickly exceed the passage limits for shad and river herring, thus upstream passage into the PLF Bypass reach appeared unlikely.

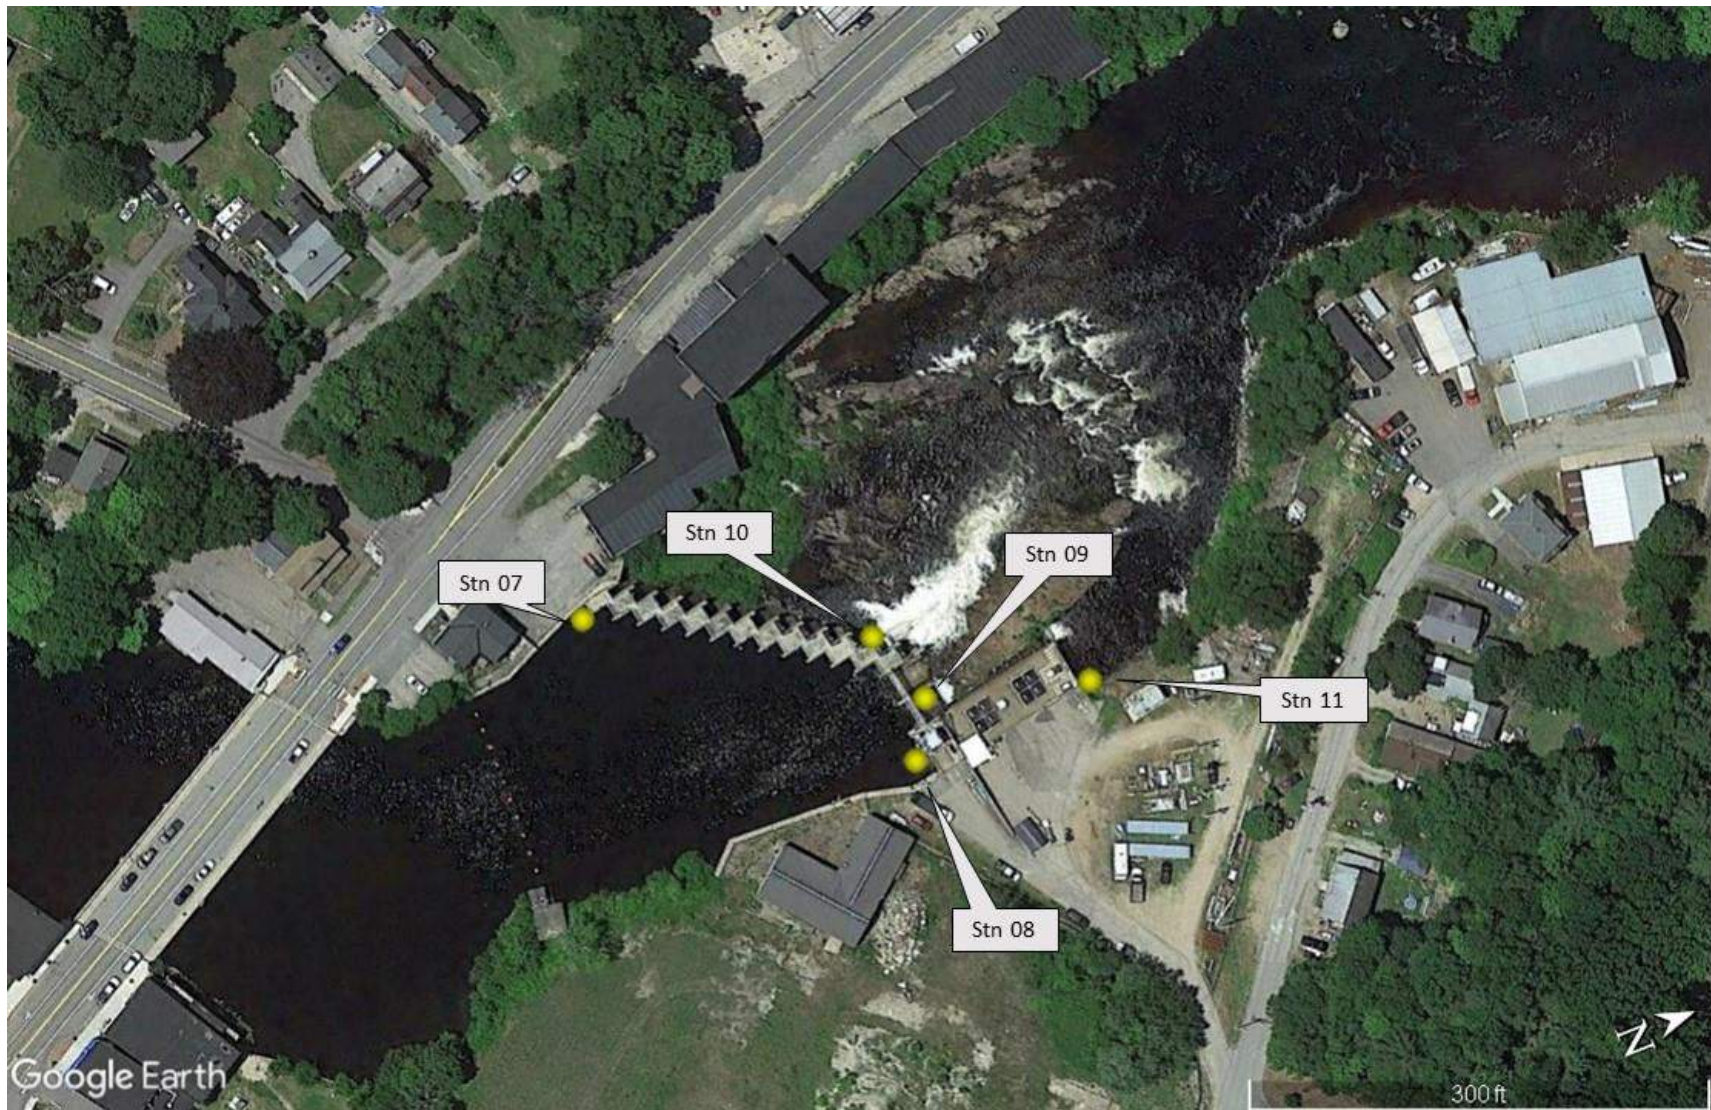
**Figure 60–2. Final stationary receiver placement at PUF for the adult river herring downstream passage study, May 24 – June 30, 2021.**
