**Penacook Lower Falls Hydroelectric Project  
(FERC No. 3342)**

**Penacook Upper Falls Hydroelectric Project  
(FERC No. 6689)**

**Rolfe Canal Hydroelectric Project  
(FERC No. 3240)**

**Application for Subsequent License  
Major Water Power 5 Megawatts or Less**

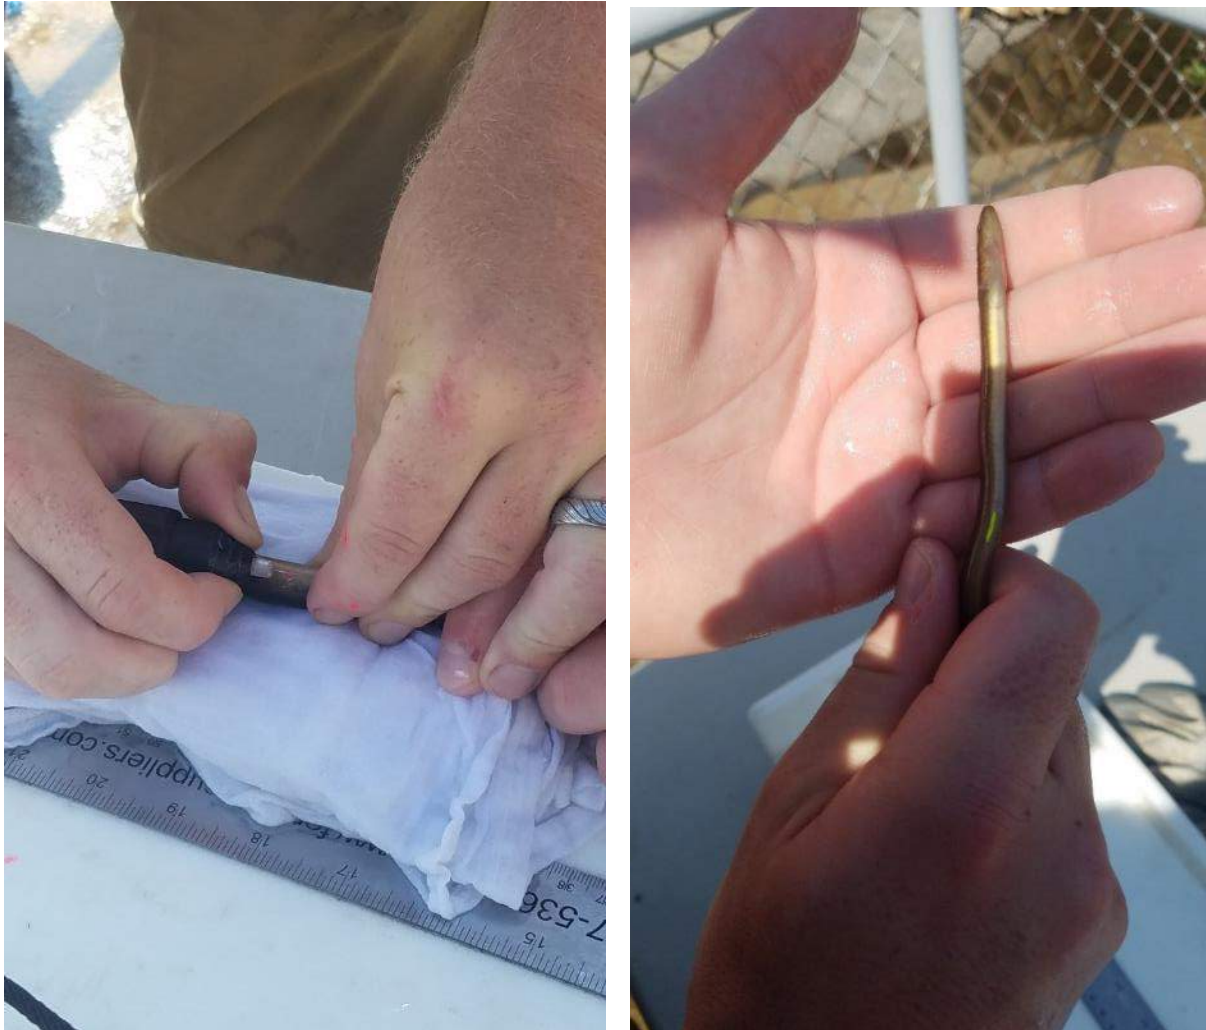
**Figure 60-28. VIE tagging juvenile American eel at Penacook Upper Falls, 2021.**

Briar Hydro conducted a mark-recapture study to evaluate effectiveness of the existing permanent upstream juvenile eel passage facility installed at PUF. Prior to the onset of the mark-recapture study Briar Hydro operations staff collected juvenile eels captured in the PUF eel lift hopper and maintained them in a holding tank supplied with recirculating Contoocook River water. Following the initial collection period, 100 juvenile eels were marked using Visual Elastomer (VIE) tags in July and August. To mark these individuals, eels were lightly anesthetized to allow for safe handling. The nearest size class (i.e., 0 to 6 inches, 6 to 12 inches, greater than 12 inches) of each individual was recorded and a colored VIE mark was inserted at the base of the ventral fin margin (Figure 4-4).

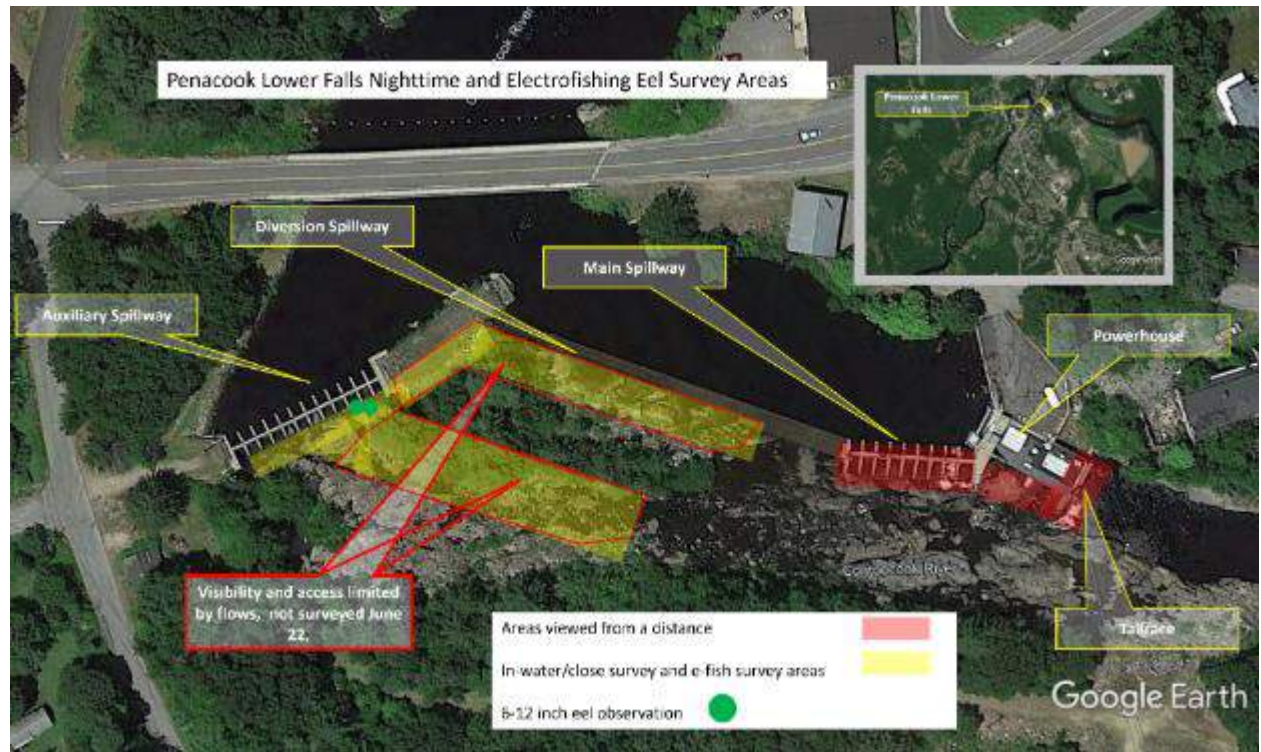
**Figure 60-31. Survey and electrofishing areas at PLF during 2021 including the location of eels observed on the July 7 nighttime survey.**

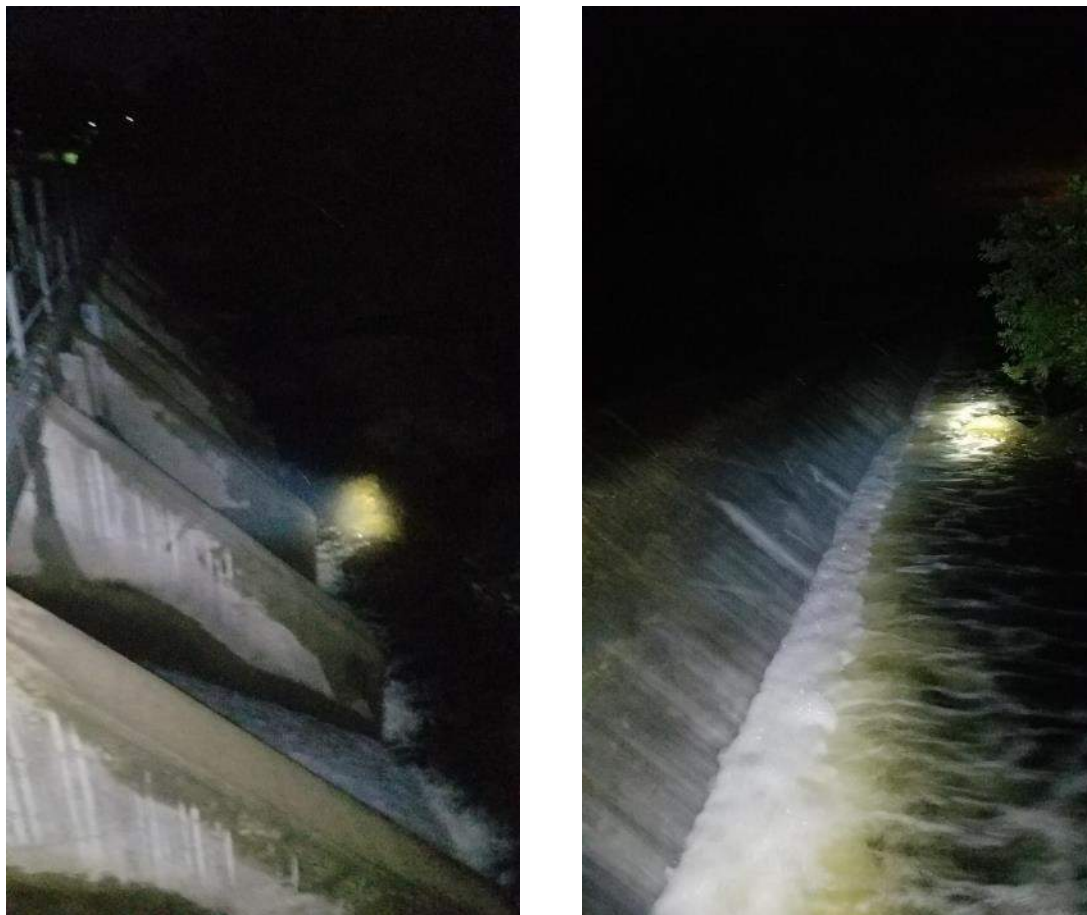
**Figure 60-33. Typical conditions below the auxilliary spillway (left) and diversion spillway (right) at PLF showing where leakage/spill created potential attraction areas for migrating juvenile eels.**

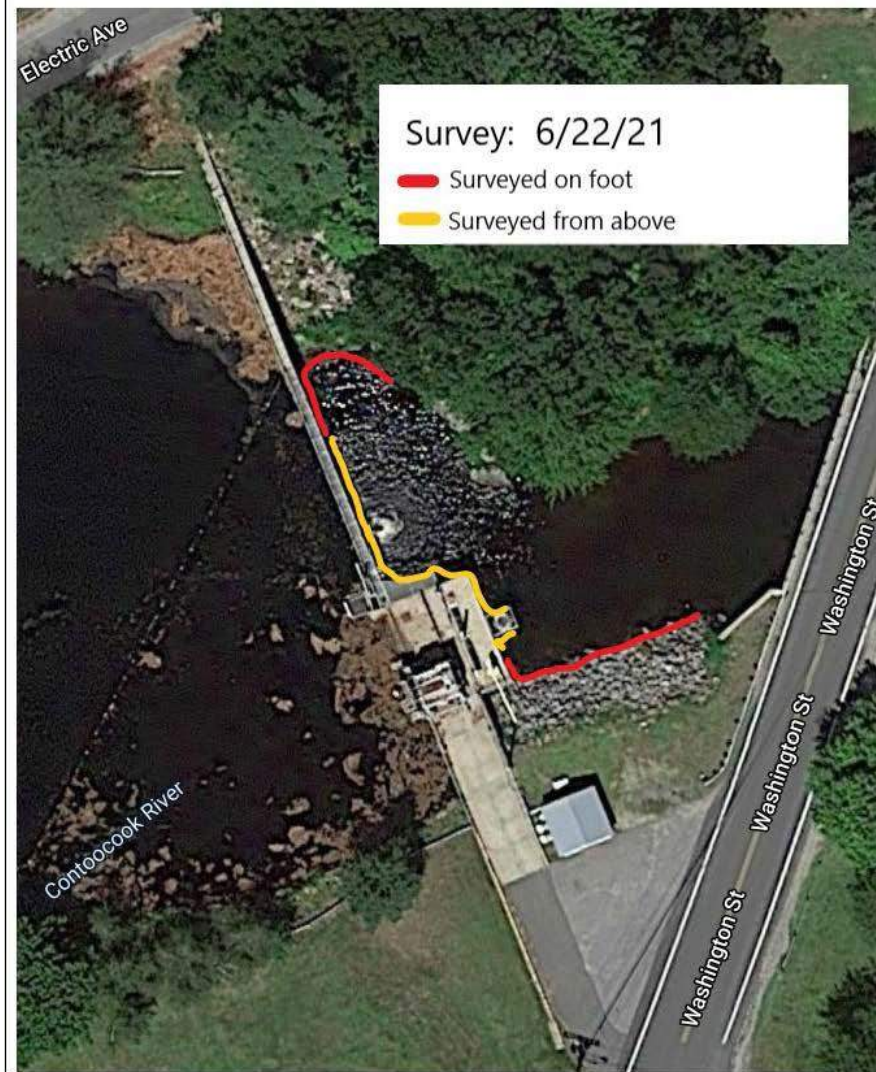
*Conditions:* Light rain most of the day. Overcast at time of survey. Only water entering historic channel is from "minimum flow pipe" (whitewater seen on image below). CNG & SS.

*Search Summary:* Surveyed 21:12-21:18. Survey rip rap shores on both sides of channel by foot. Surveyed remaining areas from above. Rip rap closest to Electric Ave and the wetted concrete wall of the dam look the most promising for eels. NO EELS OBSERVED.

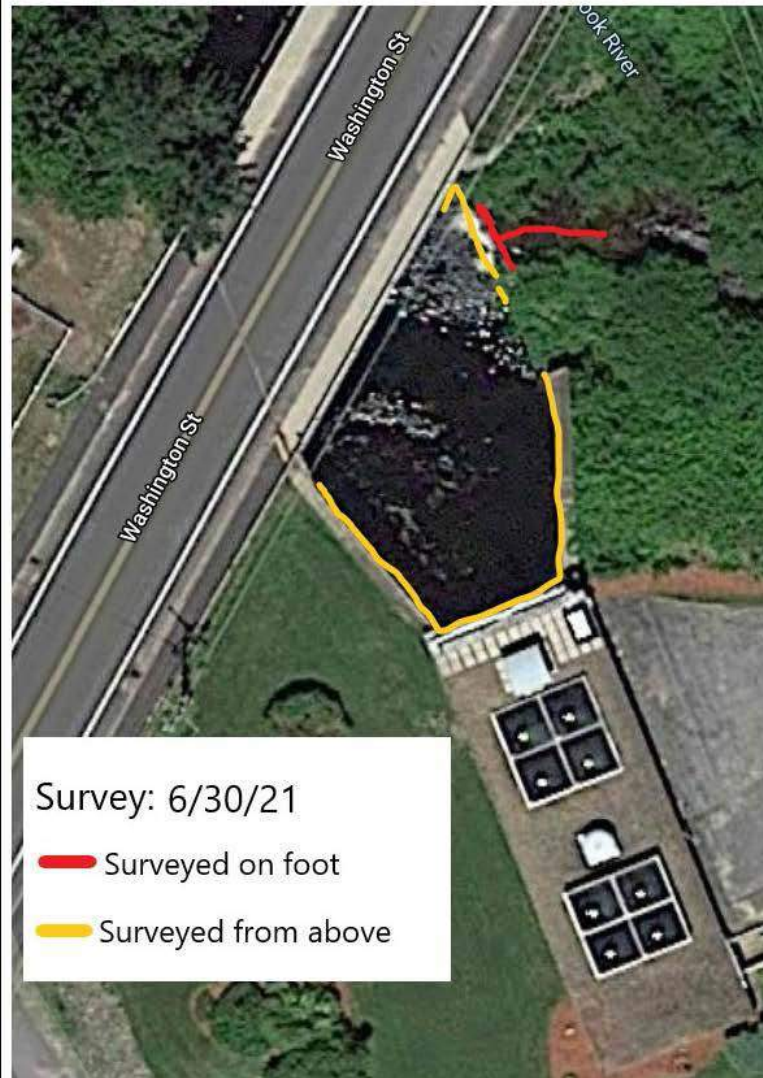
**PLF Diversion Spillway, Auxiliary Spillway, Main Spill and Tailrace**

*Conditions:* Very hot weather all day, cold front moving through bringing rain. Just finished raining and overcast for survey. Conditions similar to last week, slightly less spill. CNG, SS

*Search Summary:* Diversion & Auxiliary Spillways surveyed on foot 22:10-22:27. Less spill at Auxiliary, enabling a more thorough survey by wading. Surveyed the Diversion spillway same as last week. NO EEL OBSERVED. Main Spillway and Tailrace surveyed 22:35-22:45 from above. Still relatively ineffective. Tailrace impossible with flow boil coming from bypass reach. Units not generating. NO EELS OBSERVED.

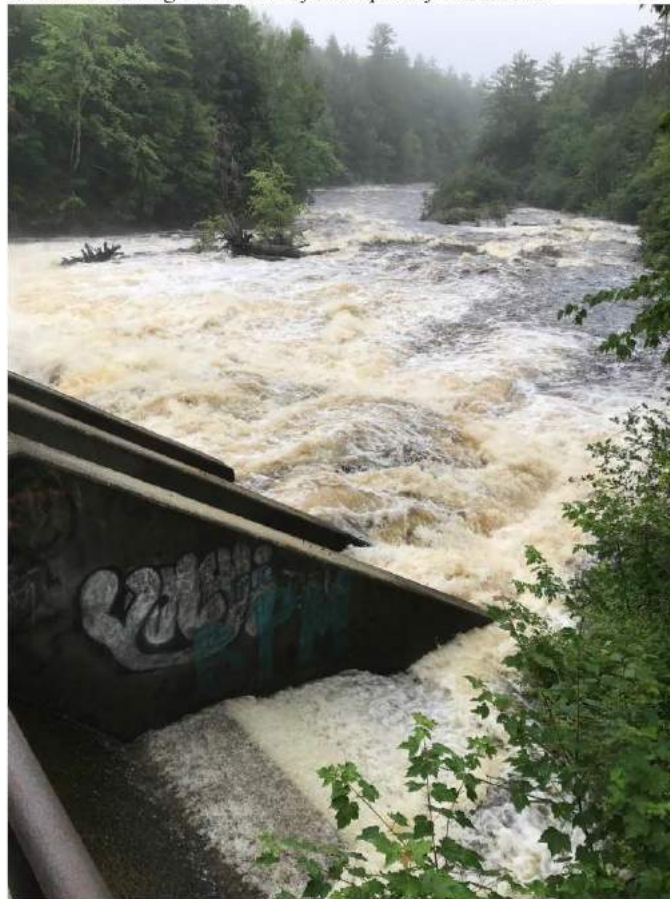
York Dam

Nighttime eel surveys postponed until flows decrease. Spill is very high at all survey locations making visual surveys completely ineffective.

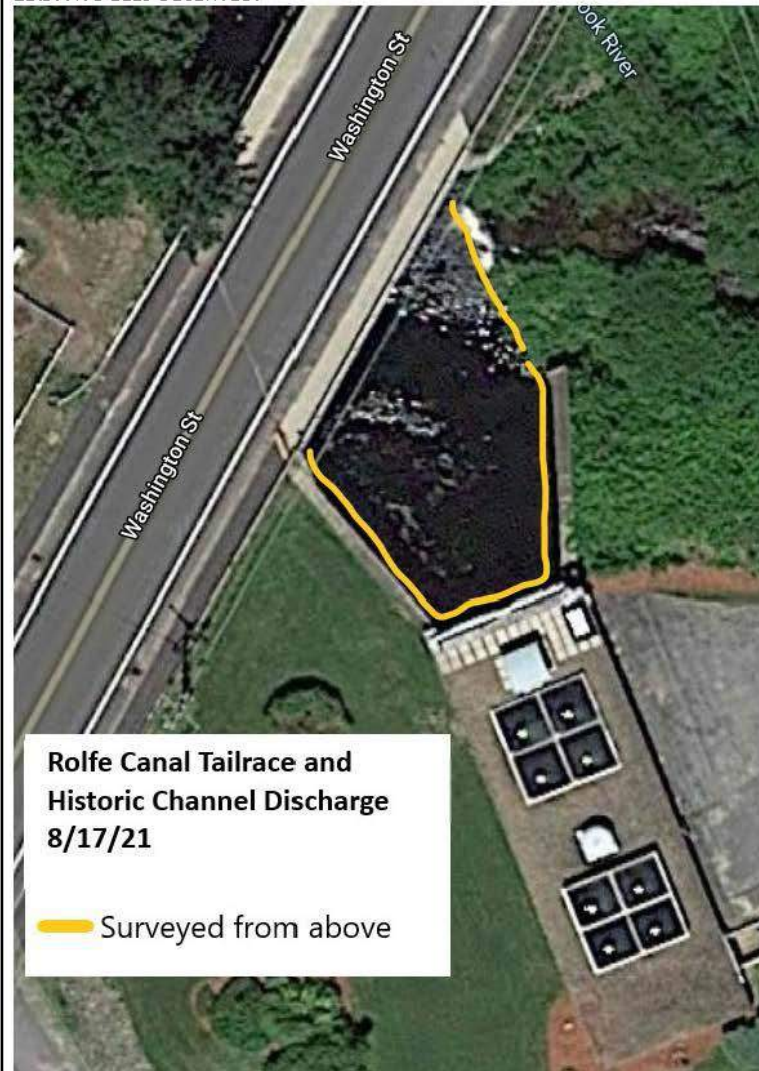
**PLF Diversion Spillway, Auxiliary Spillway, Main Spill and Tailrace**

*Conditions:* Weather today was partly cloudy. High temperature was 92. Moon was a waxing crescent with new moon on 8/8/21. 17% lunar illumination. Short heavy rain prior to survey. All normal survey areas were accessible as in previous surveys. TP, JC

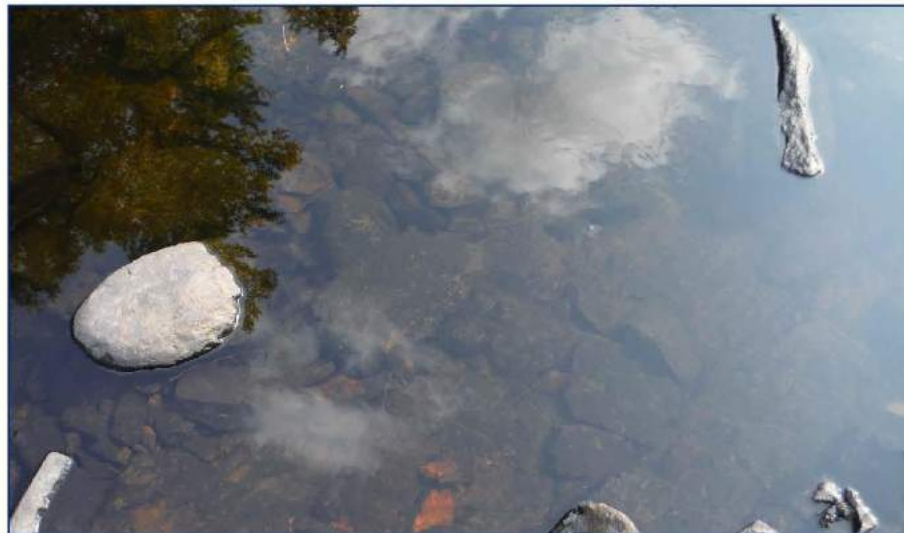
Photo # 14 Representative photo of substrates at Transect 10.  
Date: 09/14/2021

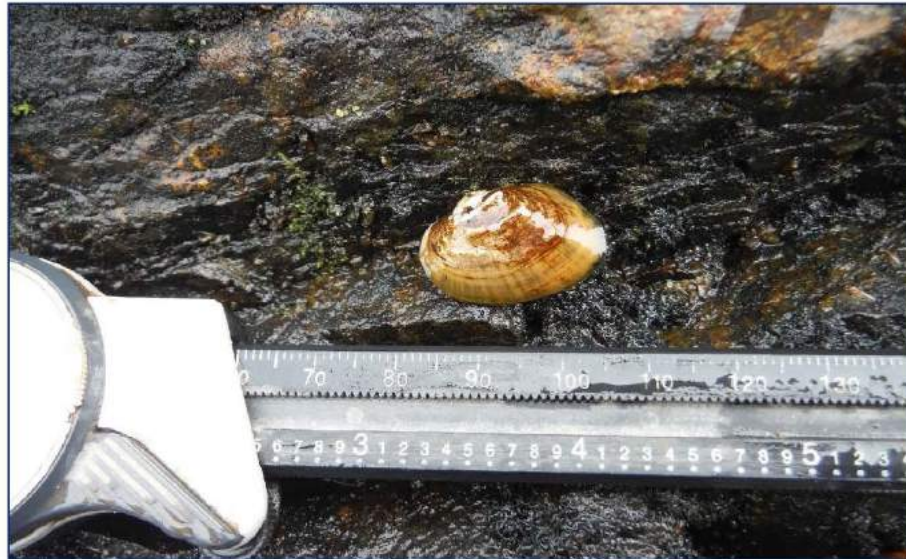
Photo # 32 Representative photo of eastern floater, dorsal view.

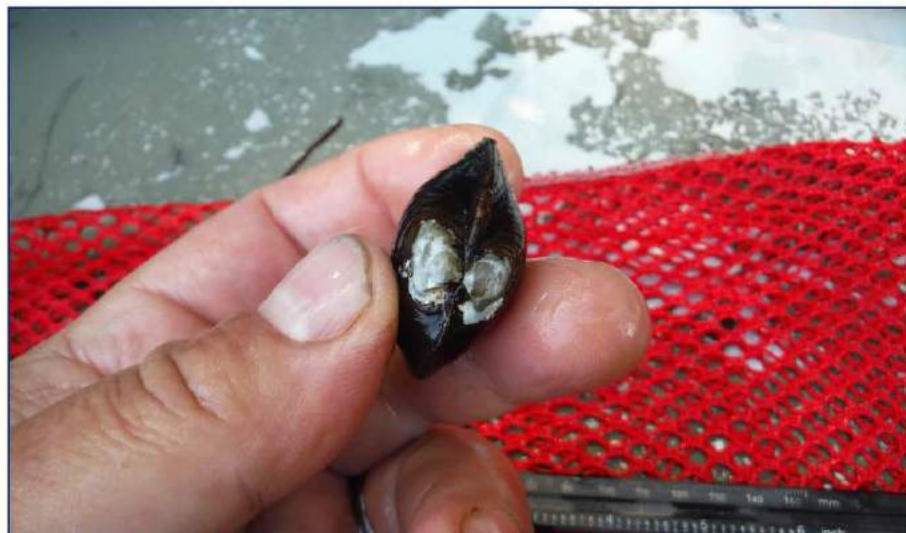
Photo # 33 Representative photo of *Alasmodonta undulata* (triangle floater), lateral view.

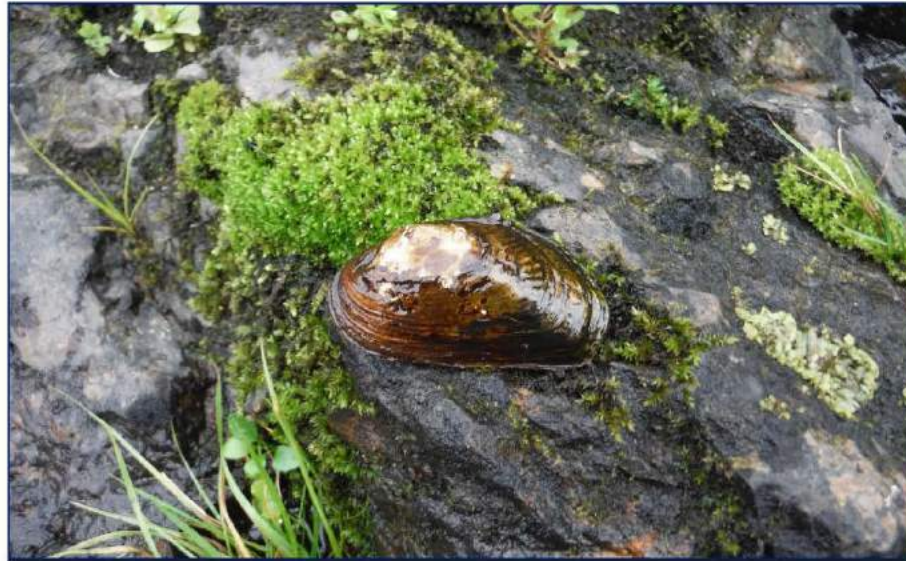
Photo # 34 Representative photo of triangle floater, dorsal view.

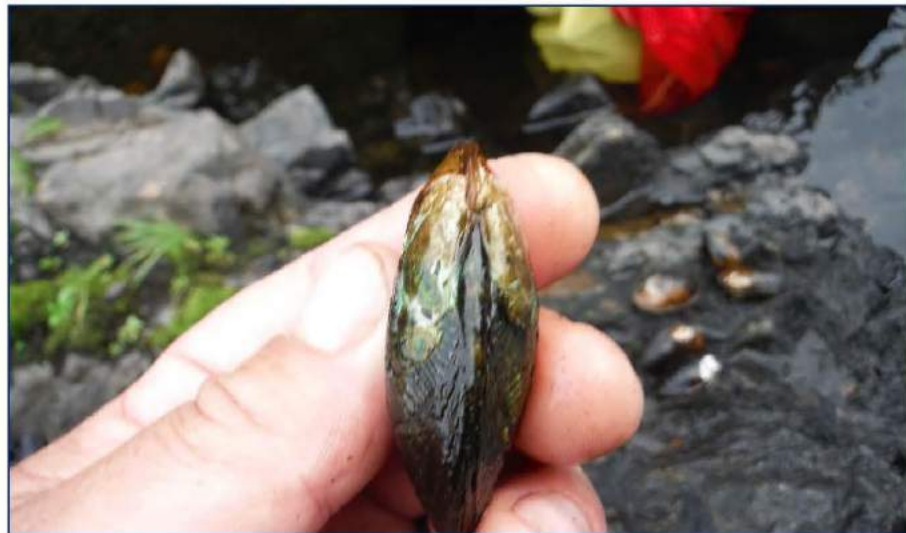
Photo # 35 Representative photo of *Alasmodonta varicosa* (brook floater), lateral view.

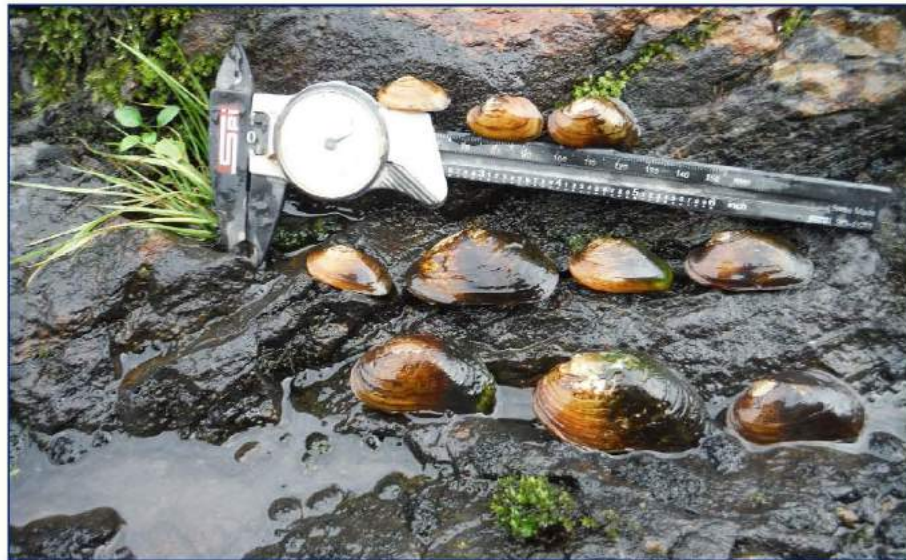
Photo # 36 Representative photo of brook floater, dorsal view.
