Chapter 3 River Environmental Survey

(II) Results of river pattern survey

II. River habitat survey and analysis

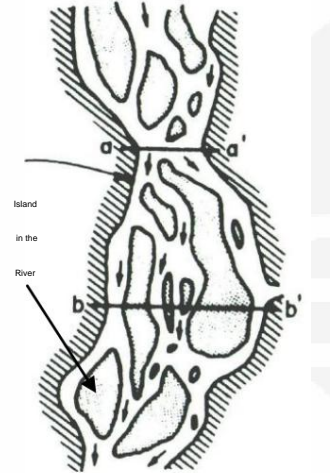
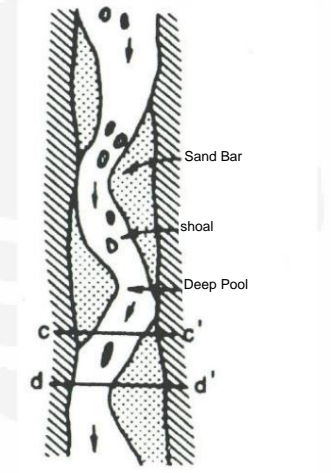
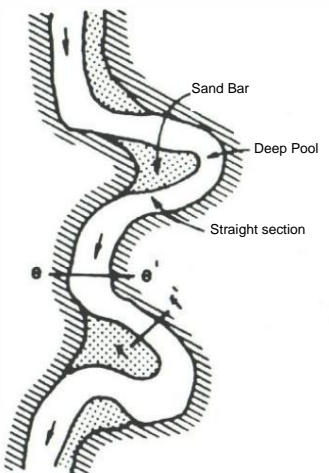
category	Braided river	Straight river section Winding river section	Gentle slope
Flow Path Characteristics	sections: wide river width, unstable river banks and Not obvious Steep slope, shallow water, bifurcated flow path Unstable riverbed, flow path changes due to water level And changes	of deep pools with stable river banks and not easily eroded to form a triangle-like deep and low-water flow path. The sections have a rectangular cross-section The straight sections have steeper slopes and are easily eroded. The gentle slopes cause river banks to silt up and the water flow	Short straight sections connect the concave banks into sandbars when hitting the banks, while the straight sections have steeper slopes and are easily eroded. The gentle slopes cause river banks to silt up and the water flow
Cause	The upstream sand and gravel supply is greater than the sand transport capacity of the river The steep slope and shallow flow form an island in the river	The flow is slow and the scouring force is small. The river bank is hard and not easily scoured.	Redirection Geological control causing water flow to change direction

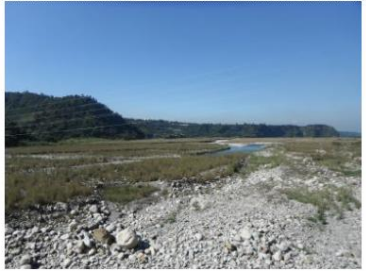
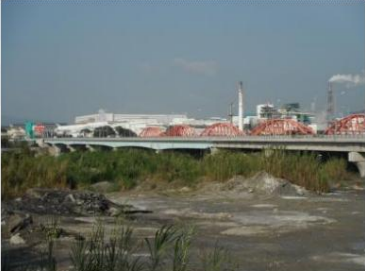
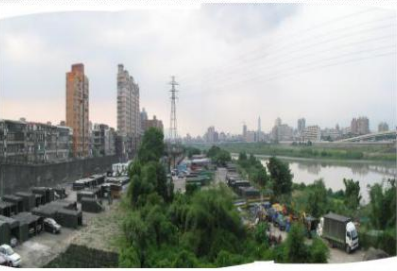
Figure 3-2 Overview of river section location characteristics

<div>Mountainous river sections</div> <div><div>Narrow valley, steep slopes and fast currents</div><div>Riverbed with large rocks or pebbles</div><div>There are often rapids and deep pools</div><div>Often trees and shrubs</div><div>The water quality is not polluted</div><div>Excellent ecological habitat</div></div>	<div>Hilly river sections</div> <div><div>Wide valleys form flood plains</div><div>Sand bars, gravel beaches and pebble riverbeds</div><div>Vegetation gradually changes to trees and shrubs</div><div>Ecological habitats affected by artificial structures</div><div>Water quality is gradually polluted</div><div>Occasionally the ecological habitat is destroyed</div></div>	<div>Prototype river section</div> <div><div>The flood plain is wide and the water flow is gentle</div><div>Silt and sand riverbed</div><div>Low water meanders</div><div>Riverside land is often used as farmland</div><div>Serious water pollution</div><div>Poor ecological habitat</div></div>

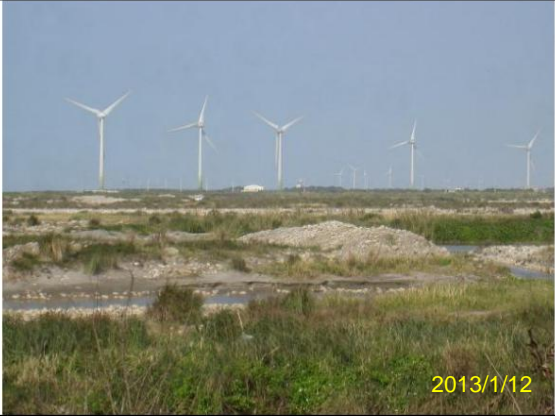
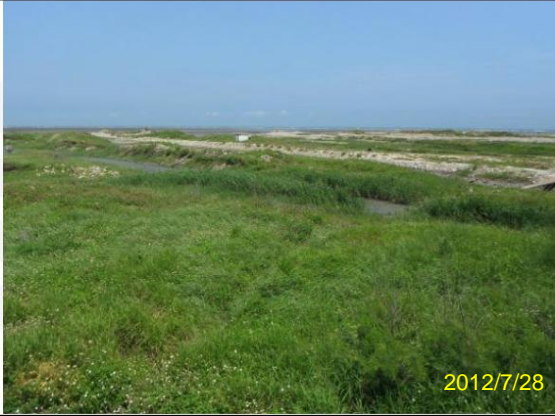
From photos 3-1~3-2, it can be clearly seen that during the flood season, due to the abundant water, the water bank

The vegetation on both sides is richer and denser than in the dry season.

Photo 3-1 Dajia River estuary (dry season 102/1)	Photo 3-2 Dajia River estuary (flood season 101/7)

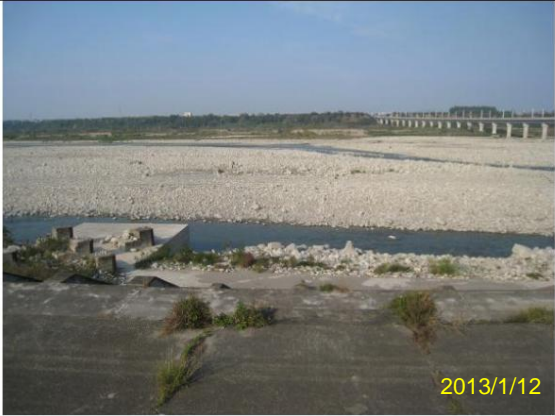
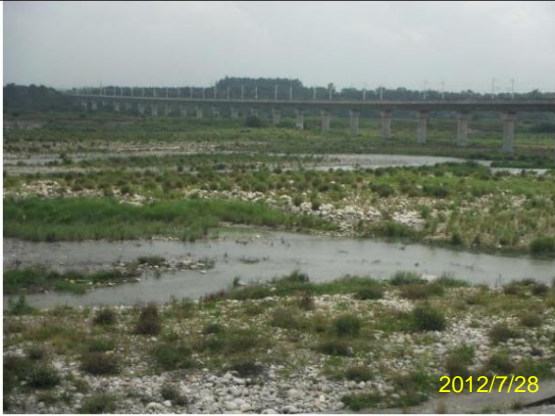
There are embankment facilities on the left bank, but collapse often occurs.

The habitat environment here changes dramatically during the wet and dry seasons, see photos 3-3~3-4 for details.

<p>2012/7/28</p>
Photo 3-3 High-speed railway bridge (dry season 102/1)	Photo 3-4 High-speed railway bridge (flood season 101/7)

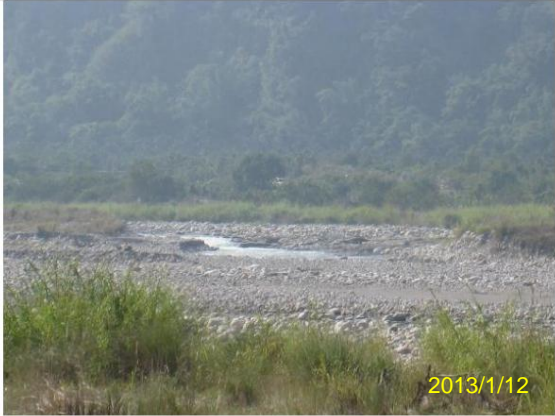
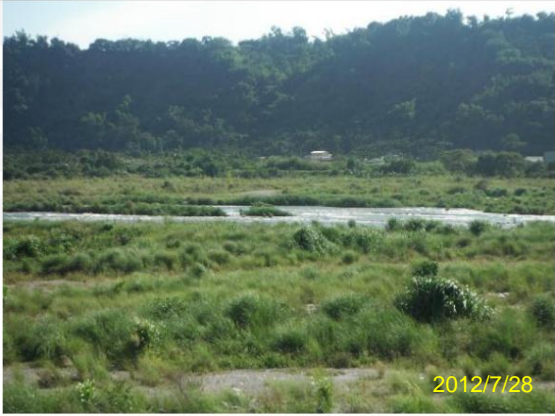
The area is mainly composed of round gravel and muddy sand. During the flood season, the streamside plants are quite abundant and the vegetation coverage is good.

Well, parts of the river banks are made of cement embankments, see photos 3-5~3-6.

<p>2012/7/28</p>
Photos 3-5 Dongshi Bridge (dry season 102/1)	Photos 3-6 Dongshi Bridge (Flood Season 101/7)

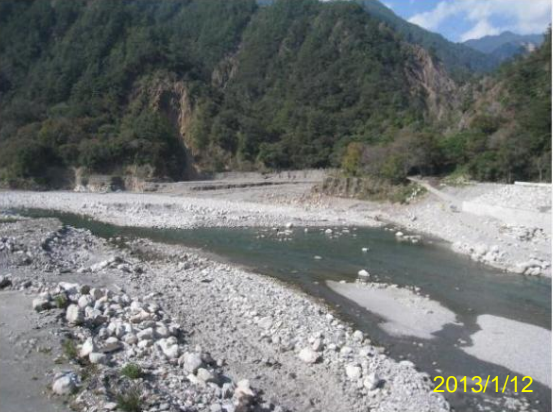
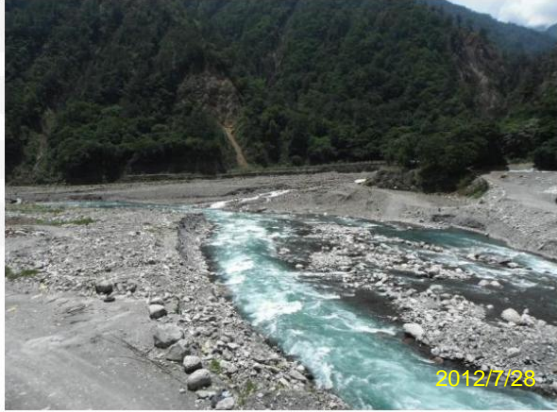
The water pattern is mainly deep currents, with shallow currents and shallow currents mixed in.

Slow flow near the bank. The riverbed is mainly gravel and pebbles, with some small gravels. Except for the river section near Taipower Qingshan Office, which has revetments, the rest of the river sections are natural slope protection with good vegetation coverage. Slope collapse often occurs. See photos 3-9~3-10 for details.

Photo 3-9 : Piasang River confluence (dry season 102/1)	Photo 3-10 : Piasang River confluence (flood season 101/7)

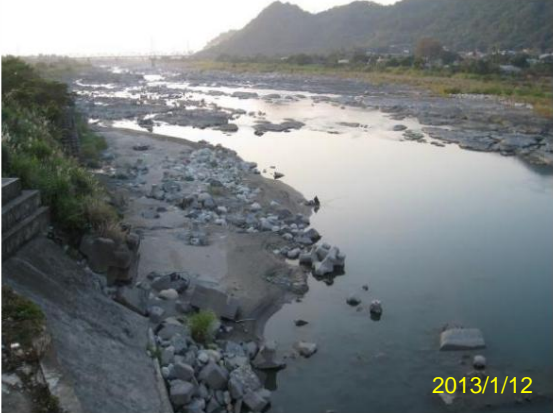
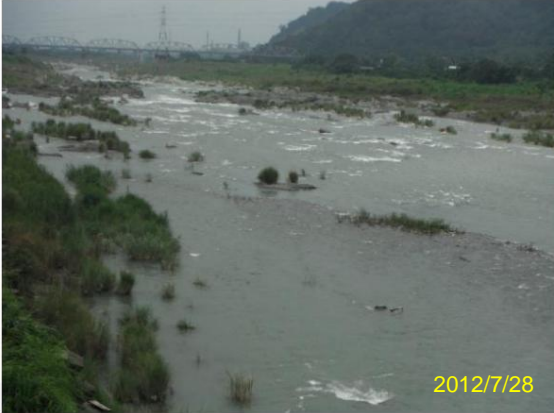
and lost. In less than a year, the habitat here was

The environment has undergone considerable changes.

<p>2012/7/28</p>
Photo 3-11 Downstream of Shigang Dam (dry season 102/1)	Photo 3-12 Downstream of Shigang Dam (Flood Season 101/7)

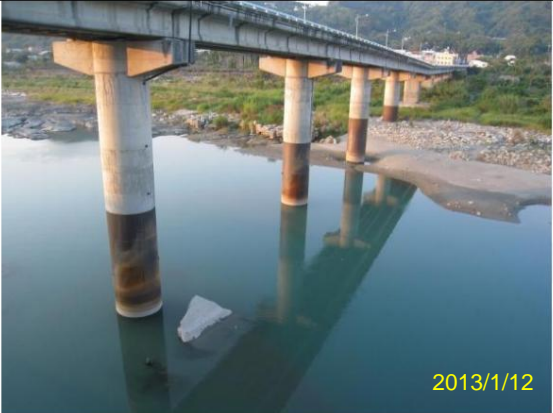
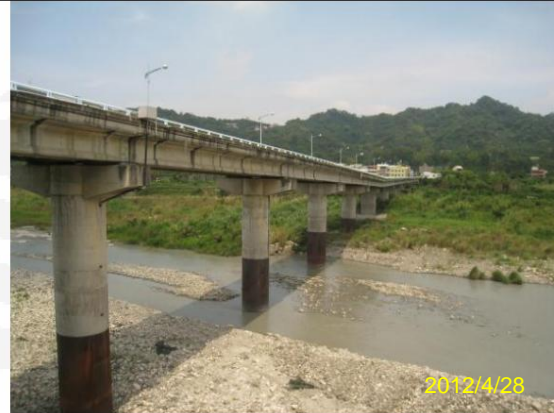
<p>2012/4/28</p>
Photo 3-13 Downstream of Shigang Dam (102/1)	Photo 3-14 Downstream of Shigang Dam (101/4)

The survey (Photo 3-13) was compared with the on-site survey in April 2012 (Photo 3-14). The area around the bridge pier was severely eroded

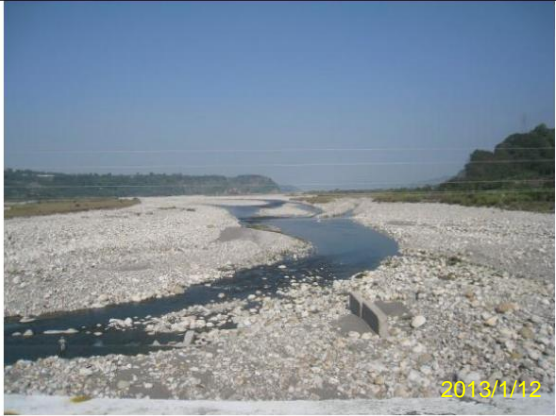
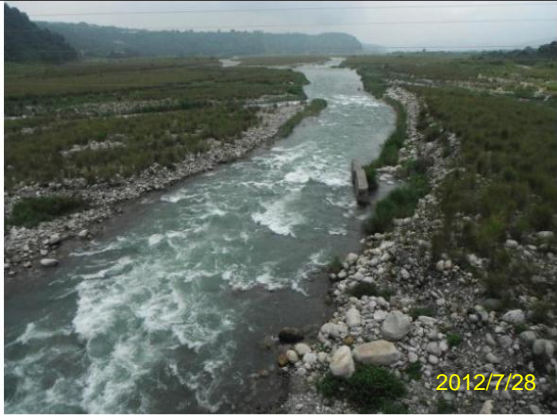
Photo 3-15 Downstream of Longan Bridge (dry season 102/1)	Photo 3-16 Upstream of Longan Bridge (Flood Season 101/7)

Longan Bridge is located in the middle reaches of Dajia River. The river type can be summarized as a winding river.

The water surface is about 30 meters wide, with large and turbulent water volume, transparent and clear water body, and water area type

The water is mainly shallow current and shallow rip current, and there is slow current near the shore. See photos for details.

3-15~3-16. The riverbed is mostly pebbles, mixed with coarse gravel, and the vegetation on both sides is rich.

This river section has entered the valley terrain, and the bank protection is mainly natural slope protection without obvious artificial structures.

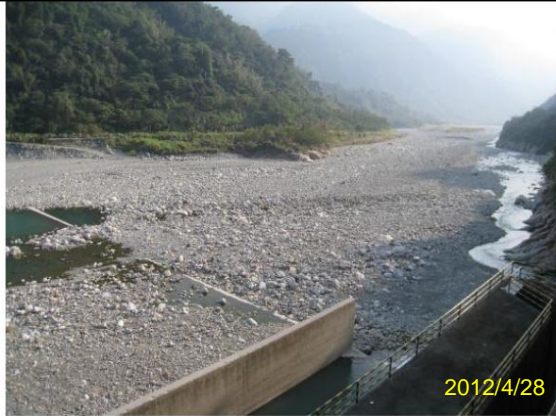
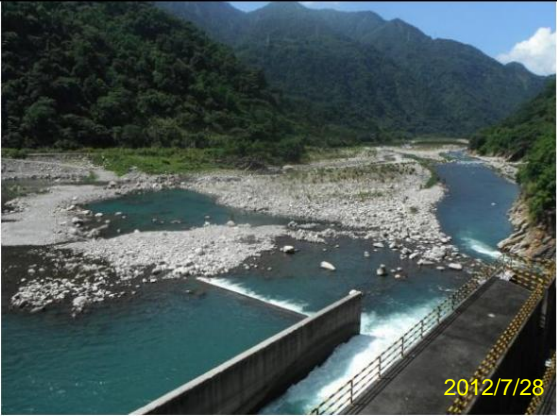
Photo 3-17 Downstream of Ma'an Dam (dry season 101/4)	Photo 3-18 Downstream of Ma'anba (Flood Season 101/7)

Ma'anba is located about 9 kilometers upstream of Long'an Bridge. The river type can be summarized as a meandering

The river has a maximum water surface width of about 30 meters, and the water is transparent and clear.

The amount, depth and flow rate are affected by the Ma'an Dam. The general water pattern is shallow current and shallow rip current.

When the water is released, the water area changes to deep currents and deep pools. The riverbed is composed of gravel and small eggs.

There are many rocks, abundant plants along the river, and valley terrain on both sides, with good vegetation coverage and no

Obvious artificial structures, see photos 3-17~3-18.

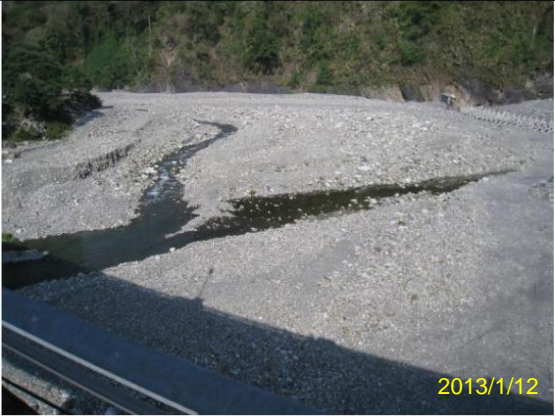
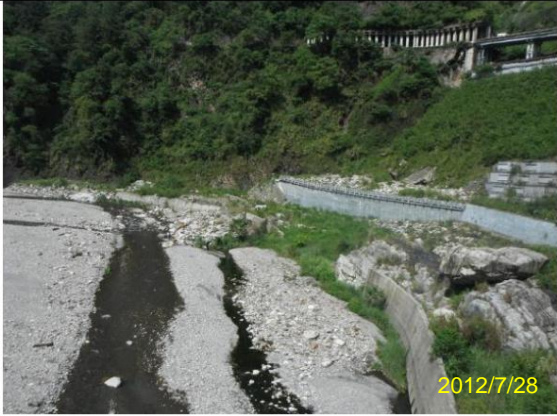
Photo 3-19 Downstream of Tianlun Dam (dry season 102/1)	Photo 3-20 Downstream of Tianlun Dam (Flood Season 101/7)

Tianlun Dam is located in the middle and upper reaches of Dajia River. The river type can be summarized as a meandering river.

The maximum water surface width is about 5 meters, the water is clear and transparent, and the water volume and water level in the flood and dry seasons are

The depth and flow rate are affected by the Tianlun Dam, and the habitat water type is mainly shallow flow or shallow riparian.

The bottom of the river is mostly pebbles and coarse gravel. The left bank is a natural hillside cliff with good vegetation coverage. The right bank is protected by a cement retaining wall in the Guguan Hot Spring Hotel area. This section of the river is a hot spring area.

The area is highly developed, see photos 3-19 and 3-20.

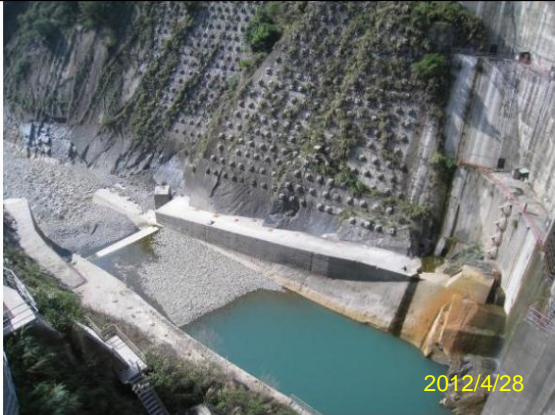
They are all the main structures of Guguan Dam, with poor vegetation coverage, see photos 3-21~3-22 for details.

Photo 3-21 Downstream of Guguan Dam (dry season 101/4)	Photo 3-22 Upstream of Guguan Dam (Flood Season 101/7)

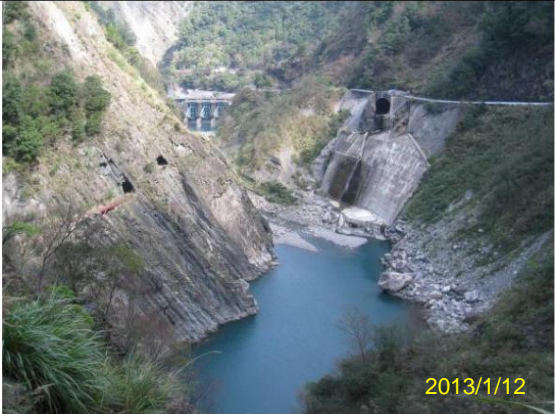
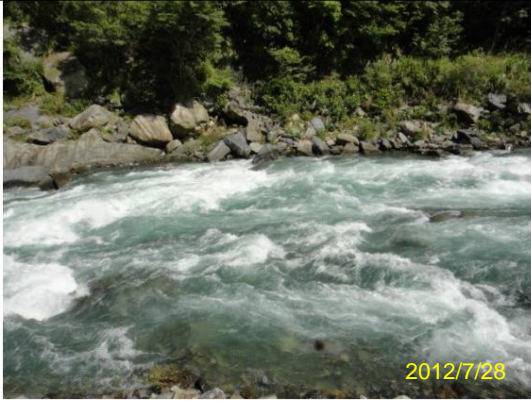
<p>2012/7/28</p>
Photo 3-23 Downstream of Qingshan Dam (dry season 102/1)	Photo 3-24 Downstream of Qingshan Dam (Flood Season 101/7)

Qingshanba is located in the upper reaches of Dajia River. The river type can be summarized as a meandering river.

The water surface is about 20 meters wide, the water is clear and transparent, the water volume is huge, and the water area is

The riverbed is mainly composed of pebbles and boulders.

They are all natural vertical cliffs with good vegetation coverage and little human development.

Tablets 3-23~3-24.

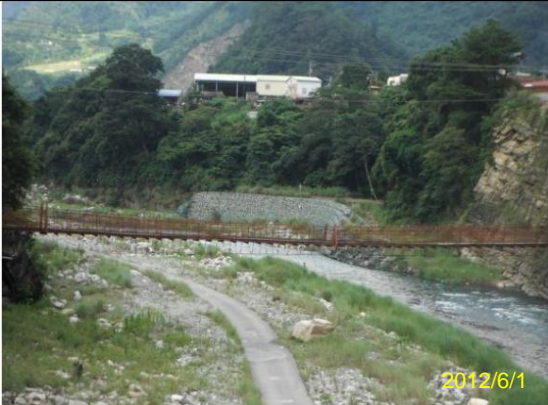
Photo 3-45 Right bank protection downstream of Lileng Bridge	Photo 3-46 Left bank protection upstream of Lileng Bridge

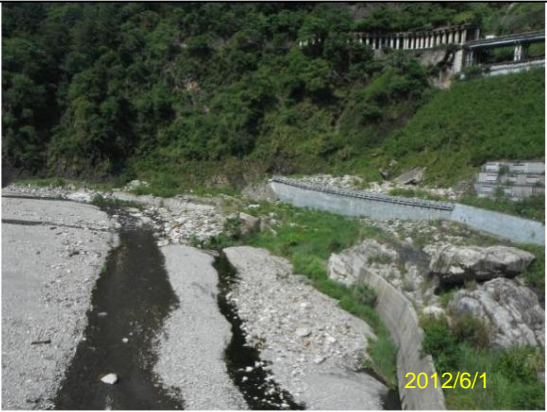
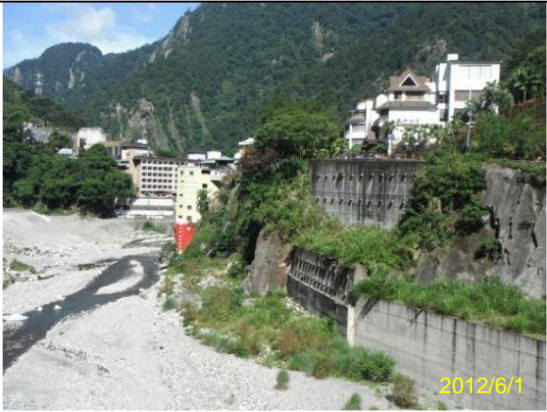
Guguan. There are cement revetments and retaining walls on both sides of the river, see photos 3-43~44 for details.

Photo 3-47 Retaining wall on the left bank upstream of Guguan Bridge	Photo 3-48 Hot spring hotel area downstream of Guguan Bridge

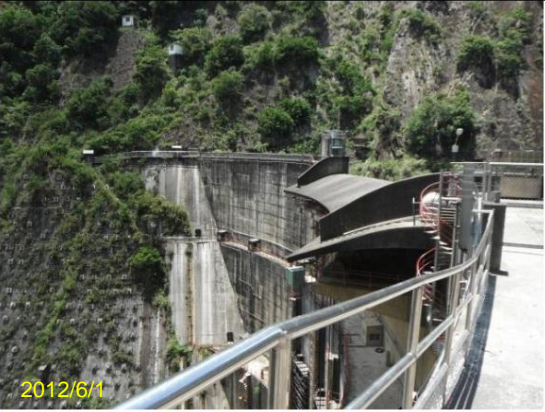
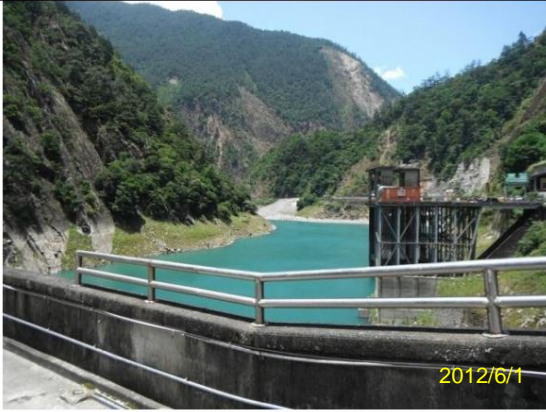
Photo 3-75 Guguan Dam	Photo 3-76 Water space upstream of Guguan Dam

Guguan Dam is a single-purpose hydroelectric dam with two sides close to the mountain wall.

During the investigation, no public use of water space was found. See photos 3-75~76 for details.

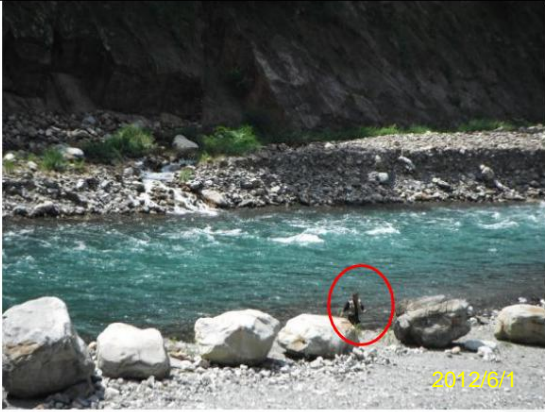
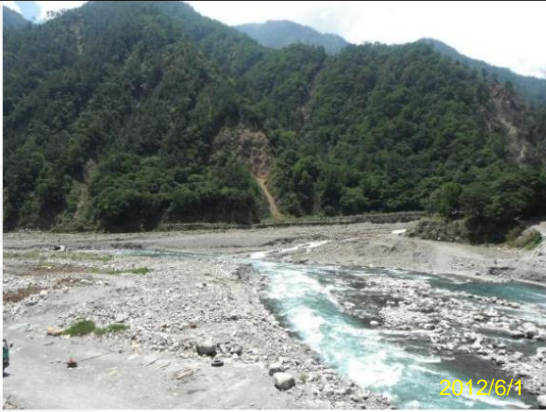
Photo 3-77 People fishing downstream of the confluence of Piasang River	Photo 3-78 Upstream of the confluence of Piasang River

The river section is affected by the dam and the water flow is slow, resulting in siltation.

Only a few people go fishing here on weekdays, see photos 3-77~78 for details.

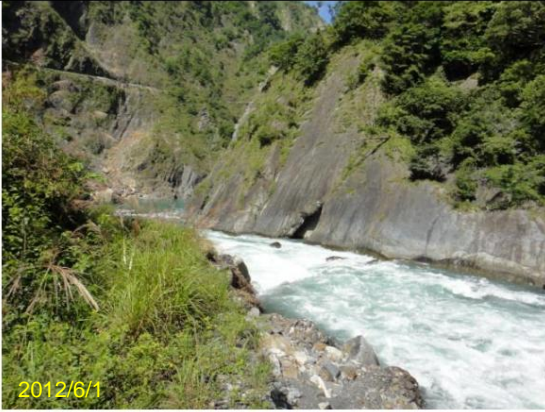
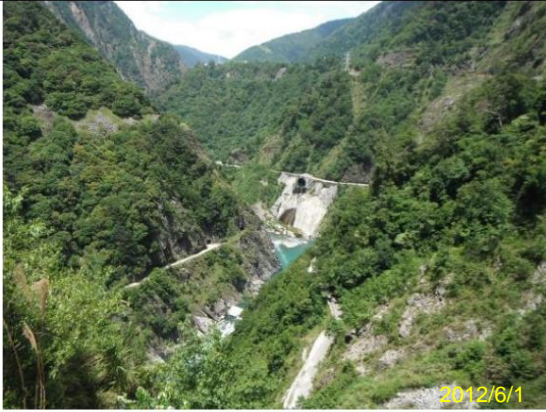
Photo 3-79 Rapid currents downstream of Qingshan Dam	Photo 3-80 Water space downstream of Qingshan Dam

This section of the river is located in the upper reaches of Dajia River, with a relatively steep slope and turbulent water flow.

No water space utilization was found during the inspection, see photos 3-79~80.
