**DAM SAFETY INSPECTION REPORT
FEDERAL ENERGY REGULATORY COMMISSION
OFFICE OF ENERGY PROJECTS
DIVISION OF DAM SAFETY AND INSPECTIONS
NEW YORK REGIONAL OFFICE**

Licensee Indian River Hydro LLC Project No. 2631-MA

Project Name Woronoco (NATDAM No. MA00737)

Inspected by C Y Hsu & Noel Aglubat Date July 29, 2010

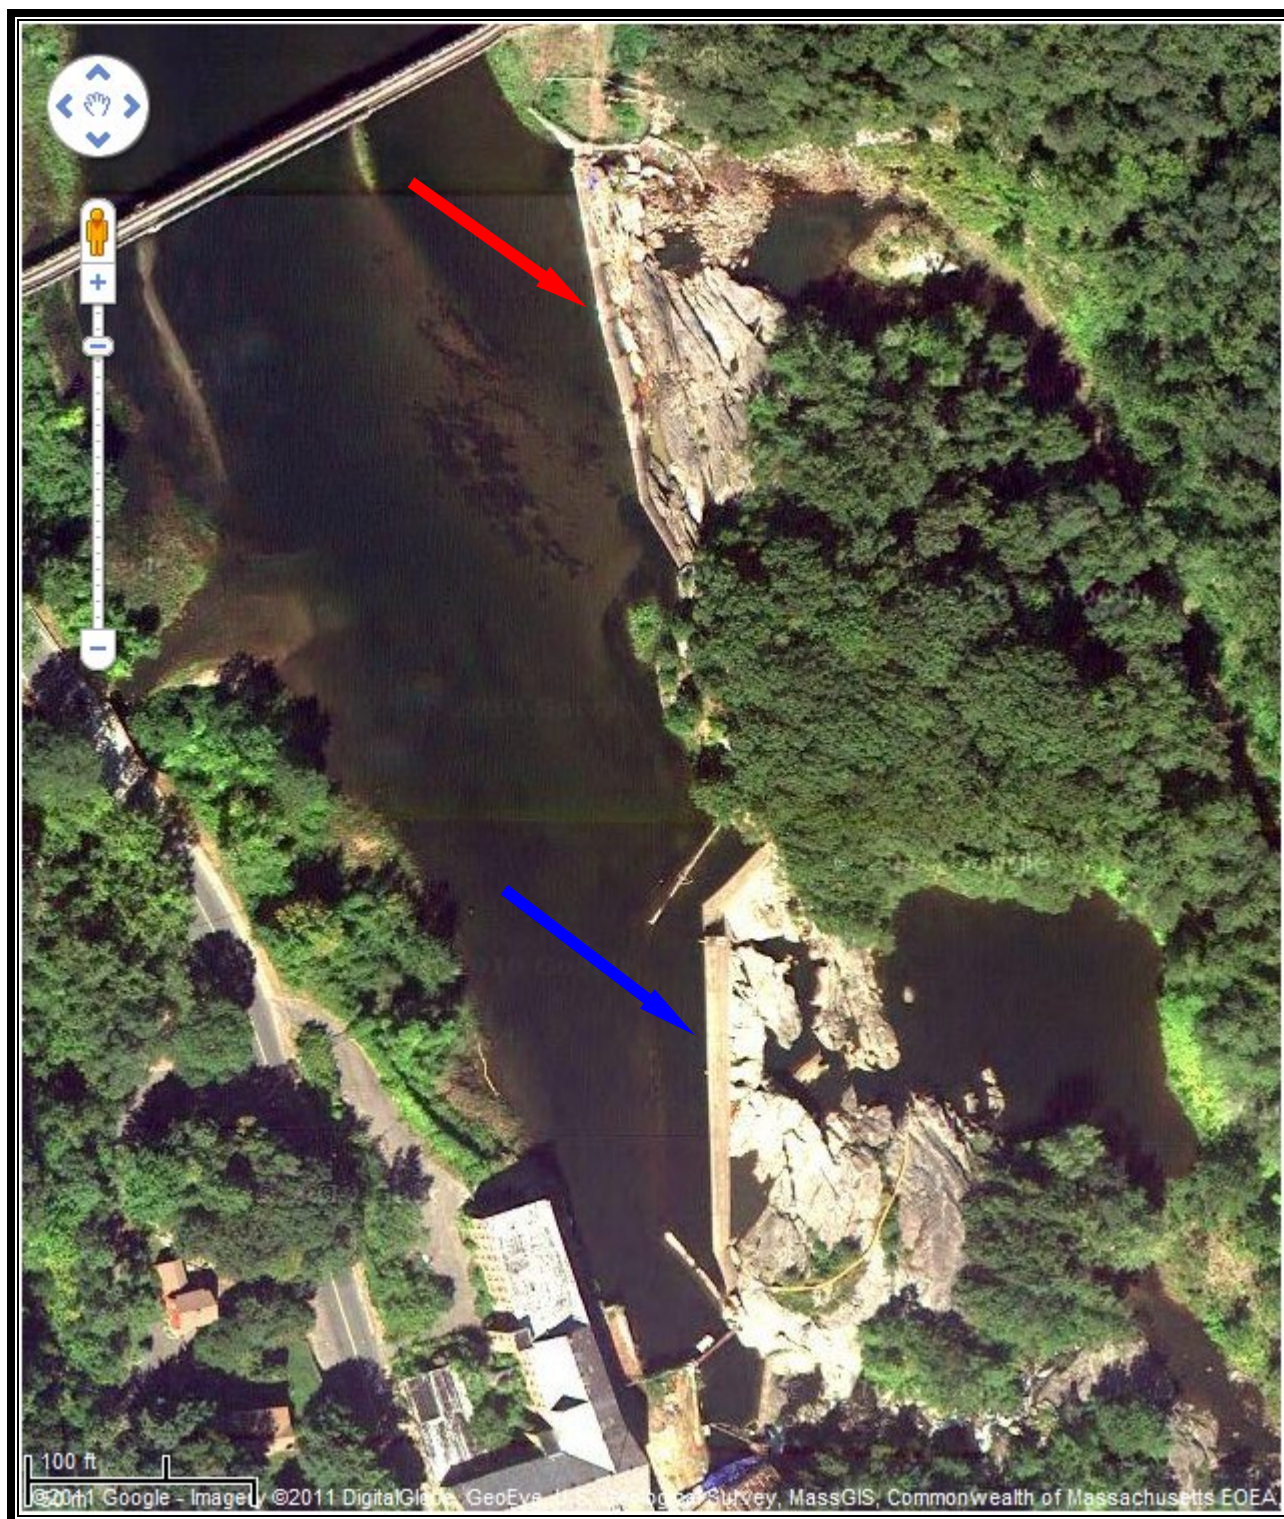
Aerial Photo – View of the Woronoco project. The red arrow indicates the location of the north dam. The blue arrow indicates the location of the south dam.
