WORONOCO HYDROELECTRIC PROJECT
(FERC NO. 2631)

Appendix N: June 2009 FERC Inspection Report of Woronoco Recreation Areas

**ENVIRONMENTAL INSPECTION REPORT
(ELECTRONICALLY SUBMITTED)
FEDERAL ENERGY REGULATORY COMMISSION**

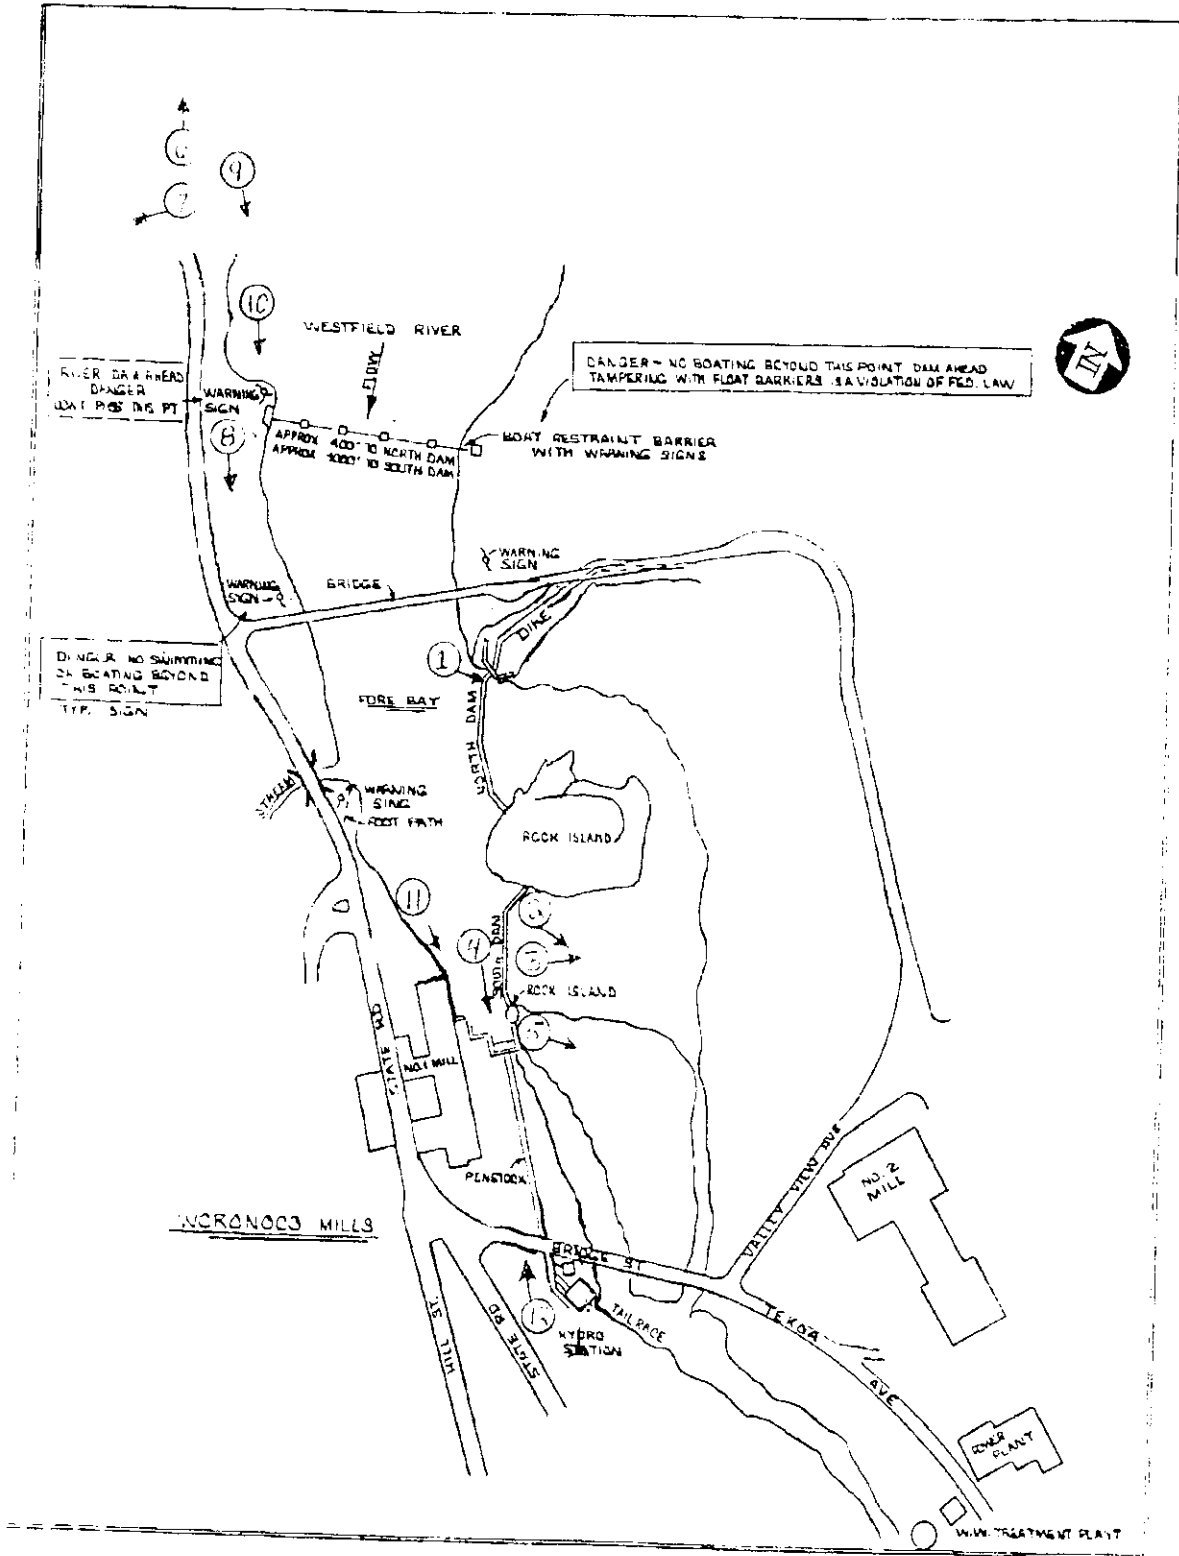
It was noted that the gate designed to release 22 cubic per second (cfs) minimum flow in the north channel was either not fully opened or was obstructed by debris (**Photo No.**). This was noted in the follow-up letter to the licensee.

Photograph No. 1- View of release of minimum flow from deep gate in the north channel. Flow should be at least 22 cfs.
