Ice House Partners, Inc. Bypass Flow Requirements A Retrospective Study

Ice House Partners P-12769 March 26, 2014

Bypass Flow Requirements: A Retrospective Study

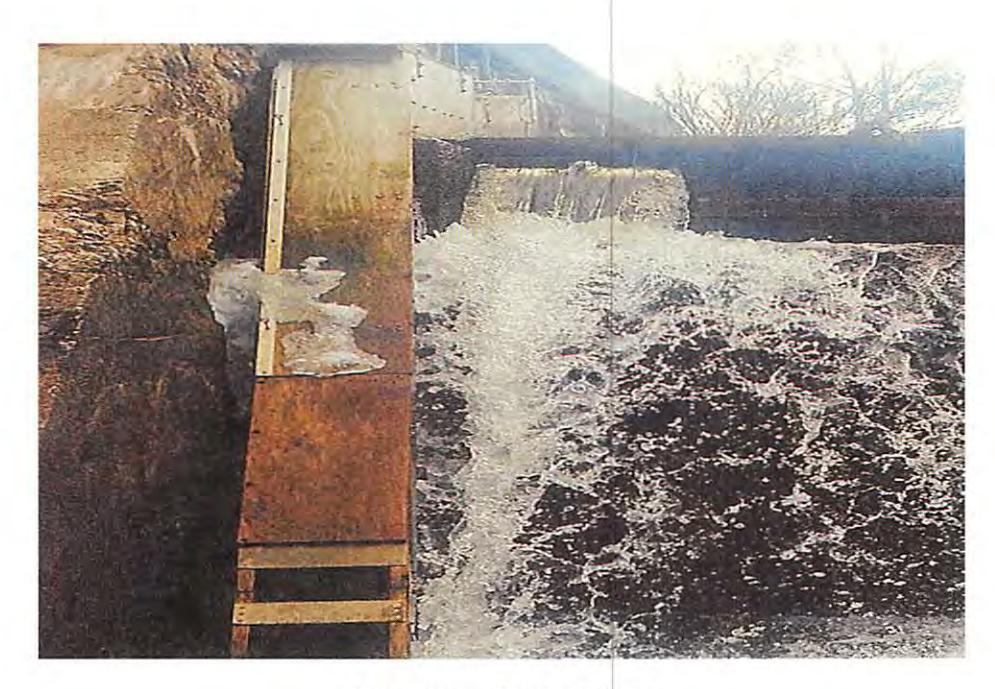
Photo taken March 20, 2014

This is assured by having the special aperture (5" x 24") designed for this bypass flow set below the normal weir height by approximately 4". This operation is inherently automatic and delivers 0ver 1 mgd at a water level equal to the weir height. For water heights above this, bypass flow is obviously higher, both due to flow over the weir and increased flow at the aperture due to a higher head. This notched weir is used to provide at least the minimum flow of 1 mgd to the bypass reach in accordance with article 18. See calculations attached; about 1,158,000 gallons per day passes through this rectangular opening.

The photo (next page) was taken on the downstream side, looking back up towards the dam; the rectangular aperture; 4" below the dam crest is passing the >1 mgd. (*The wooden structure to the left is the upstream eel passage.*)

The second photo (next page, also taken on March 20, 2014) shows the bypass reach. The photo of the notched weir (above) shows water passing through the opening, yet not spilling over the top of the dam. These photos of the bypass reach/downstream of the dam the same day document a typical bypass reach (backwater) condition, given the very flat and shallow river bathymetry.

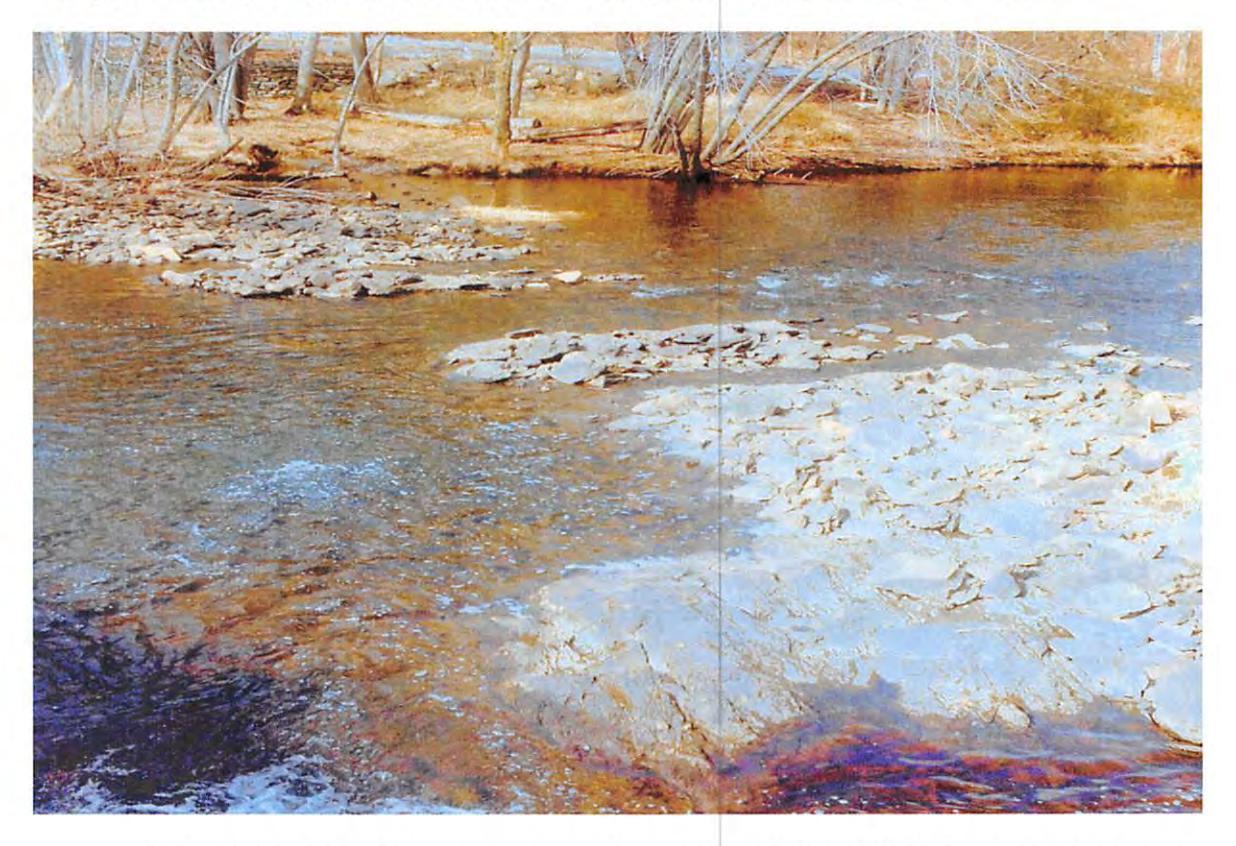
As noted in Dr. Slater's e-mail, our specific site conditions are such that "the river backwaters to within <100 feet of the dam". Actually, even under minimum river flow, there is always a pool of water at the dam toe, due to backflow. The topography does not slope away from the dam enough to drain this pool.

The photo below, taken on March 20, 2014 shows the area just below the dam.

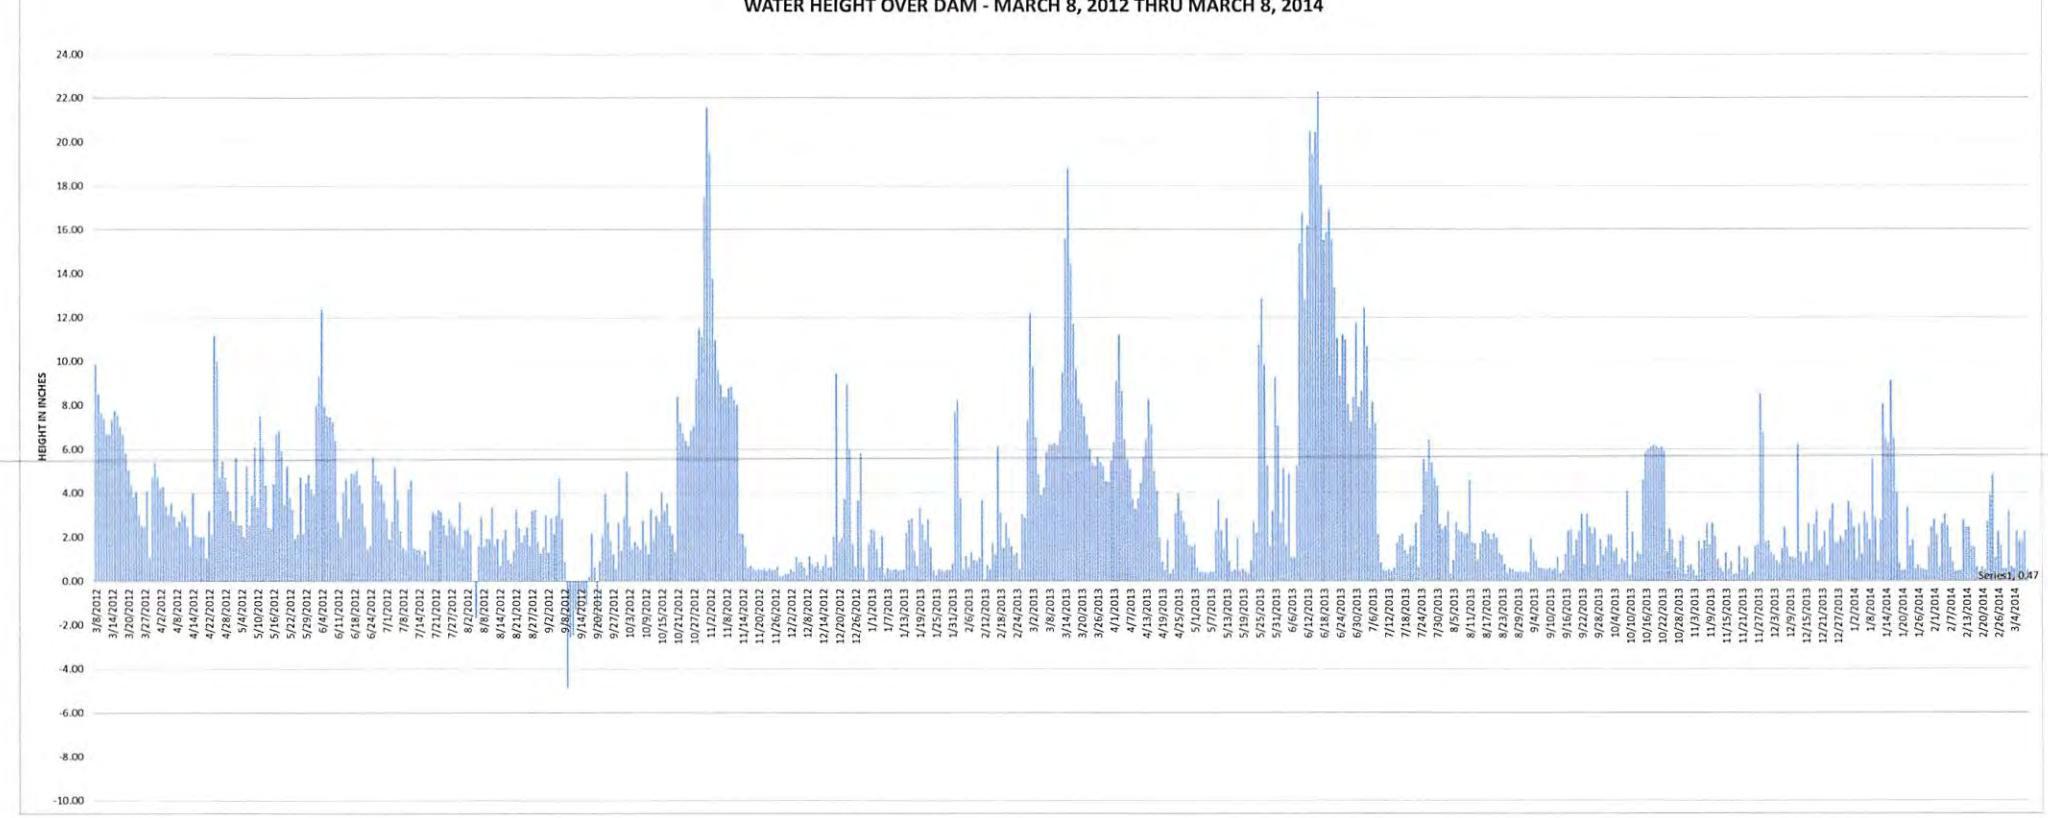
WATER HEIGHT OVER DAM - MARCH 8, 2012 THRU MARCH 8, 2014

The graph included on the next page displays the recorded water height over the dam data for the period starting on March 8, 2012 and ending March 8, 2014. This period includes the first and second field year of operation and is included in this study.

As long as the water height is no less than (-) 4", the downstream bypass spillway flow is maintained at the required amount. All recorded levels equal to or greater than zero illustrate when the bypass flow is exceeded by the additional spillage over the entire length of the weir. The (-) 4" below the dam crest is the setting of the top of the rectangular opening.

Based on the recorded daily data from a two year period, we can demonstrate that the bypass flow requirement has been met. The historical data also shows that the weir typically spills water across its entire length, which is additive flow to the minimum/conservation requirement. There is also normal leakage through the dam of the same order of magnitude as the notch flow, which exits via (3) core drains. The dam has a permeable, loose rock-fill core. The flow demonstration and onsite visual assessment conducted on November 22, 2014 confirmed that the recommended conservation flow is adequate to protect water quality and habitat. The historical data included in this report shows that the typical flow on site regularly exceeds the minimum bypass requirement. It has been noted, that our unique site conditions are such that the river "backwaters" to the base of the dam, thereby maintaining a fully watered bypass reach, even under the lowest of flow conditions.
