AUTOMATIC HYDROELECTRIC PLANT

> Re: Kennebec Water District's Upstream and Downstream Eel Passage Proposal as required by the Low Impact Hydropower Institute certification of the Automatic Hydroelectric Project issued May 26, 2011.

M4 Automatic nighttime observations Report

2015 Rice Rips Upstream Eel passage Report

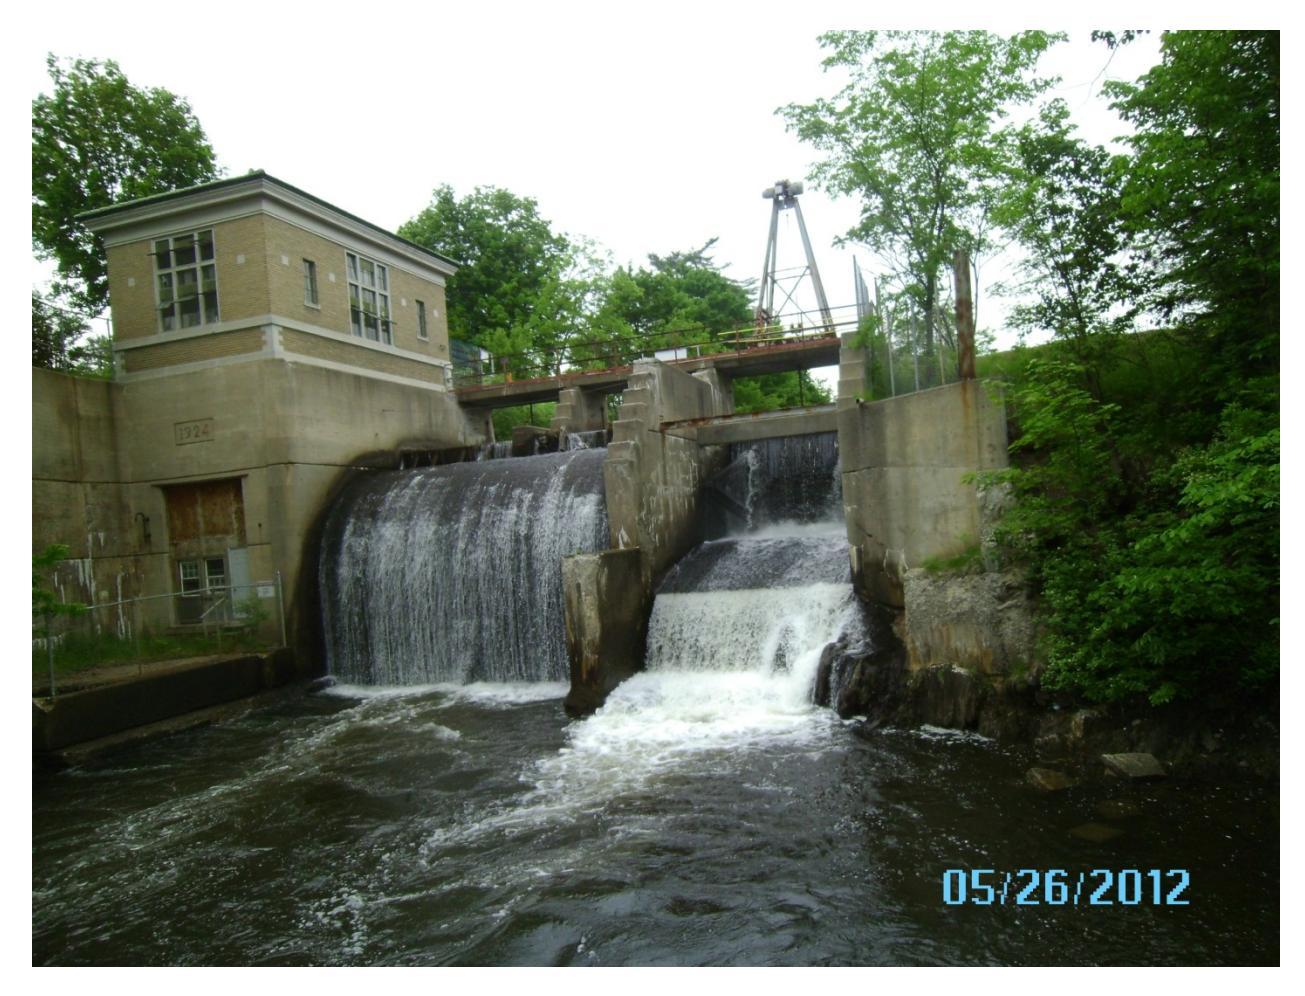
M4 Automatic From Downstream

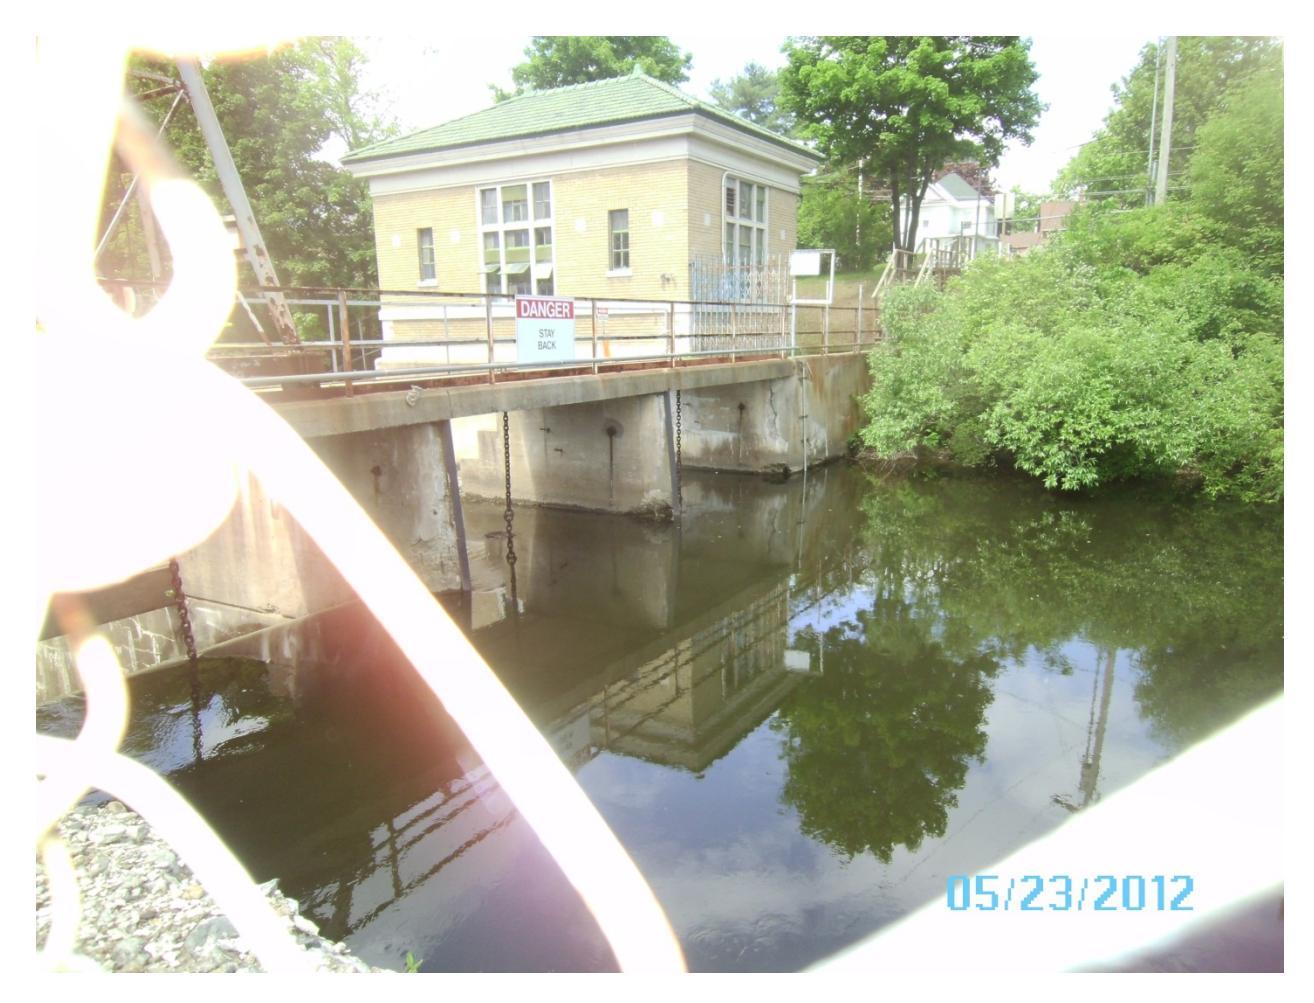
The stream, above the dam, has a canal shaped appearance with steep banks.

Upstream view M4 Automatic

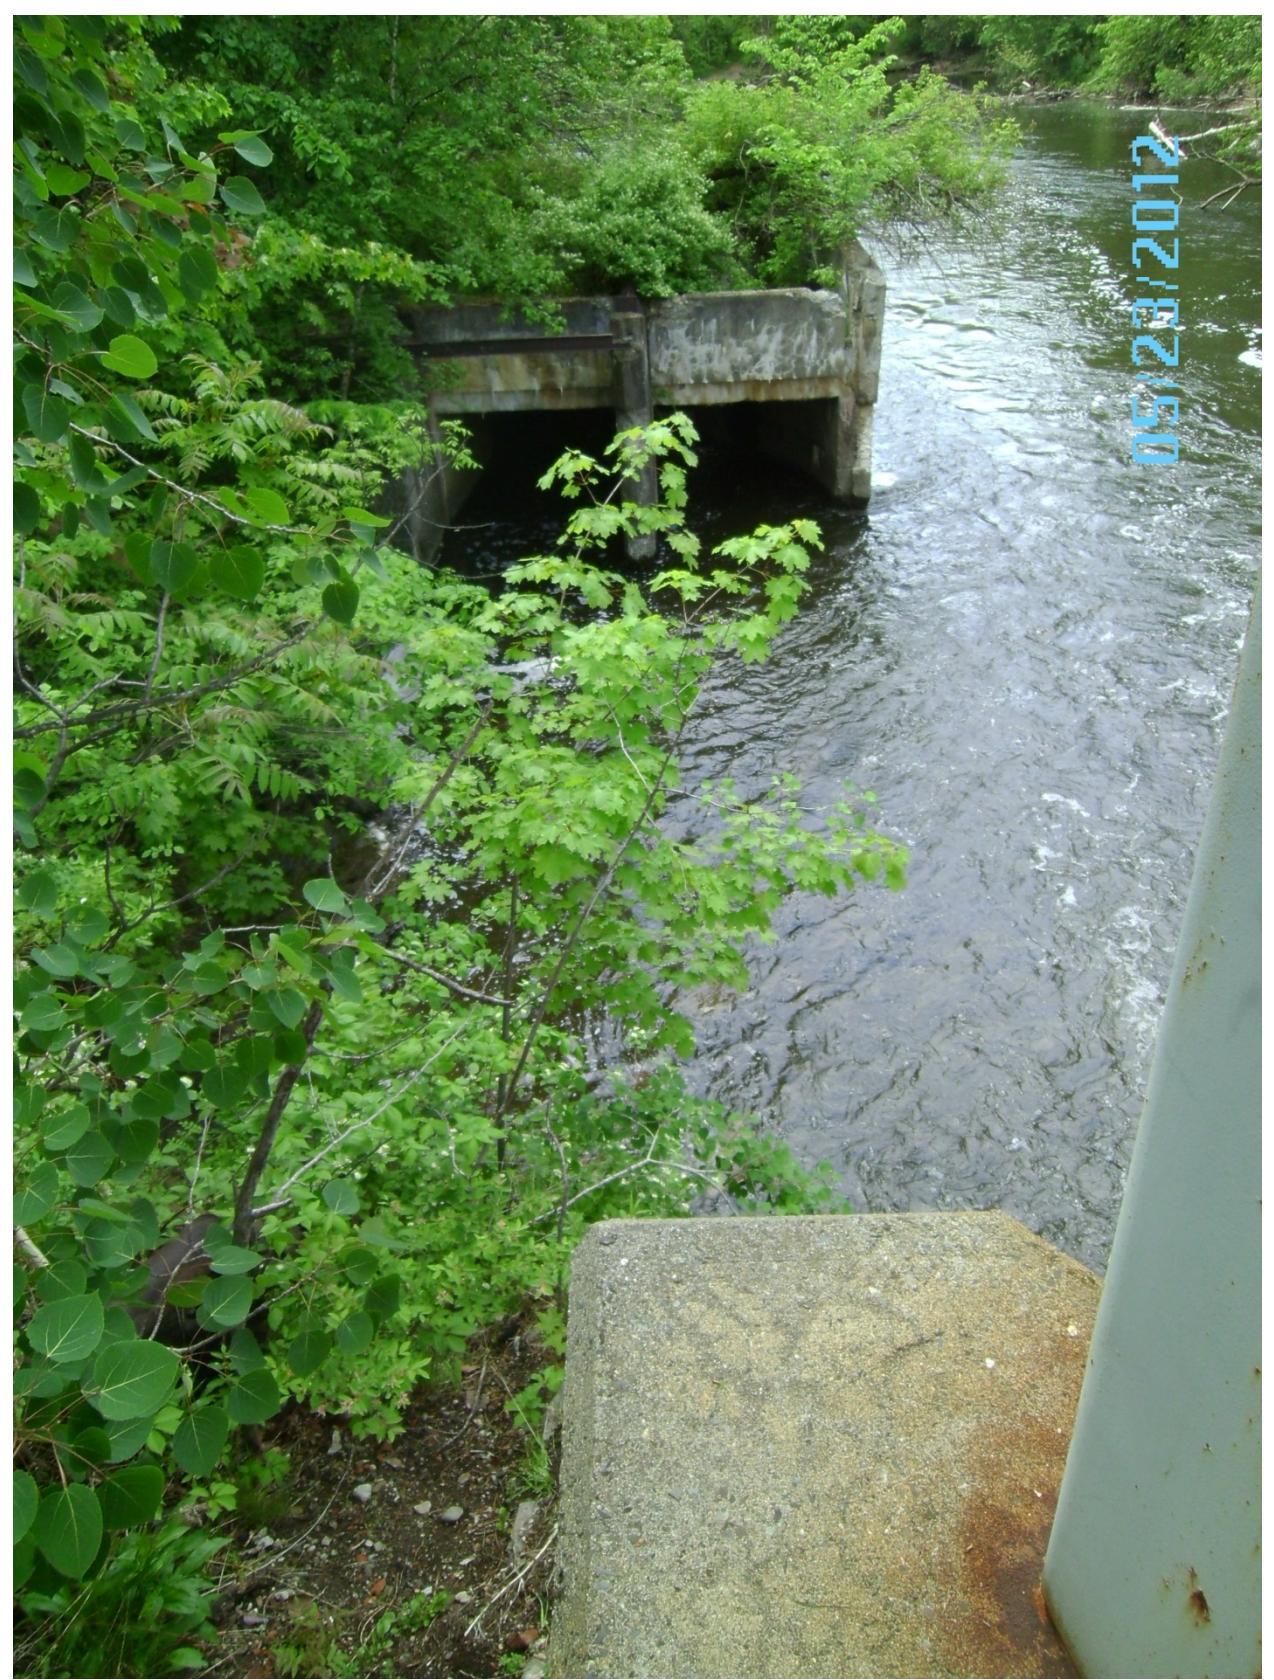
A similar contour below the dam occurs on the river right bank. On the river left bank, the stream widens out and although the banking is steep, the river is shallow with a slower flow. Approximately 75ft. downstream there is an old foundation that helps slow the flows and forms a pool between it and the hydro dam. The bottom is mostly ledge with some granite blocks scattered through out.

View downstream River left showing

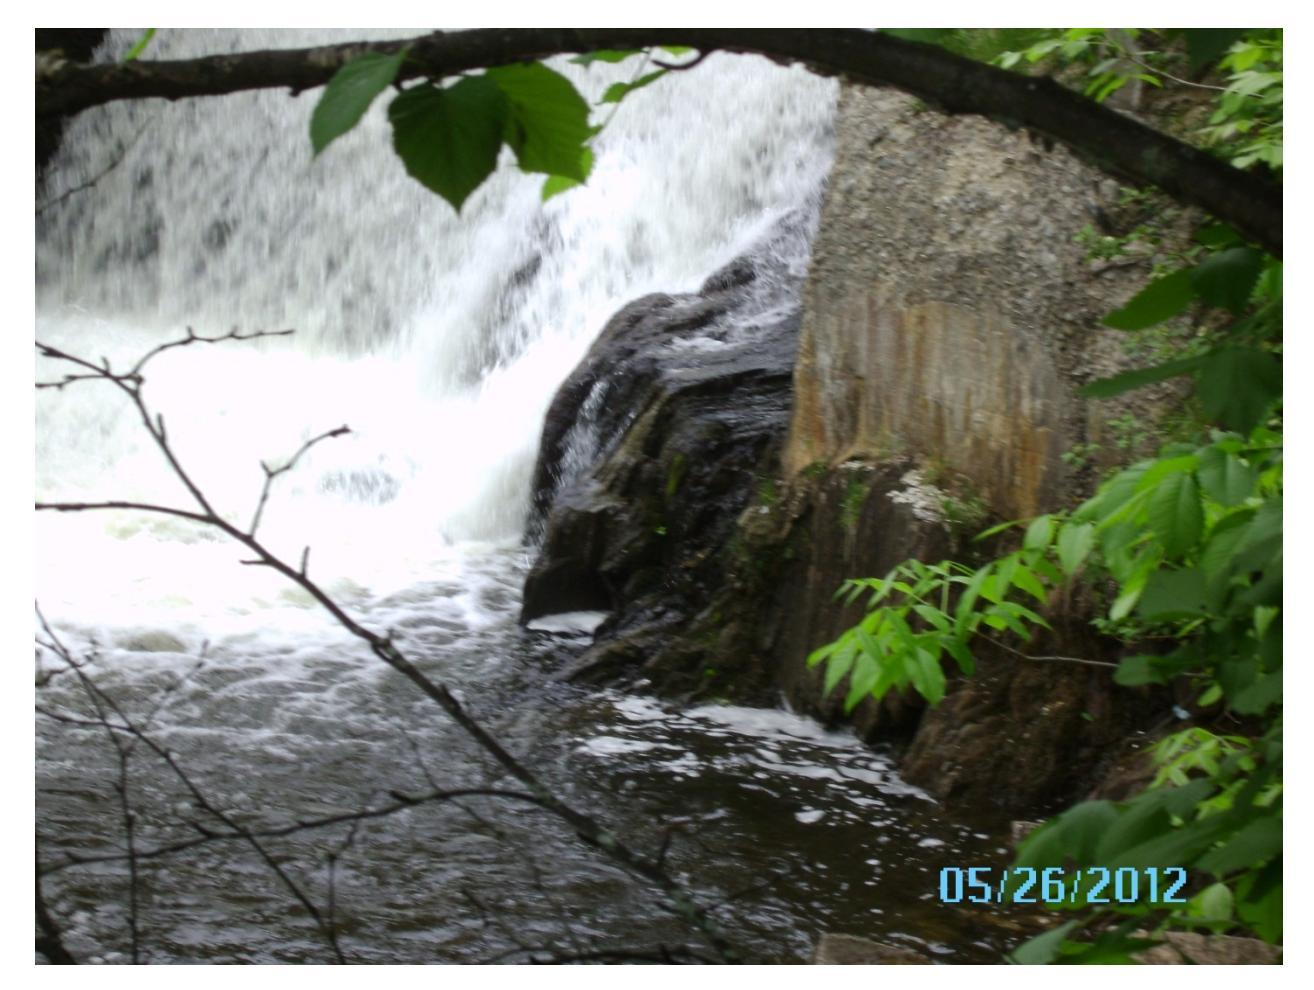
The river left side starts to widen into the pool described earlier where the left retaining wall concrete ends and an outcropping of ledge rises above the water level. This ledge is constantly wetted by the spray coming off the apron below the tainer gate and it is the divide between fast flow and the calmer pool. It also has a shallow slope with several pockets and pools that allows easy access to elvers and eels.

Ledge Outcropping Below Tainer Gate

As sunset passed eels started gathering on this ledge. Approximately 100 to 150 eels in the 10 to 25cm. size filled in the pools and crannies. Access to this area to net a sample was not possible. The water level over the gate was about 10 in. and no further passage upstream was observed. Air temp was 15.4°C and water temp was 17.8°C The weather was clear.

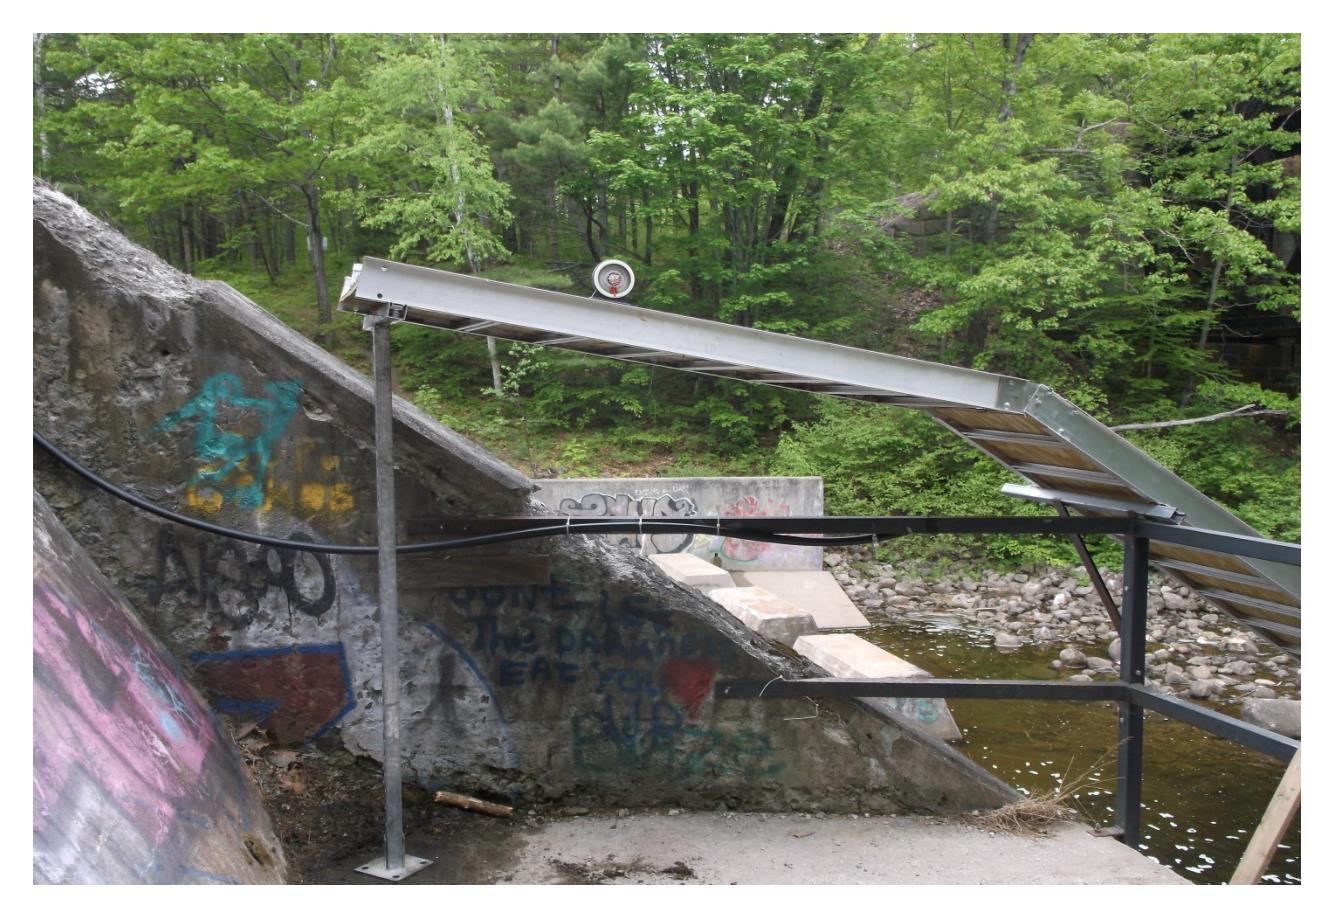
The first new section is six feet long and set at a ten degree angle. A support bracket is anchored to the deck and attached to the upstream end.

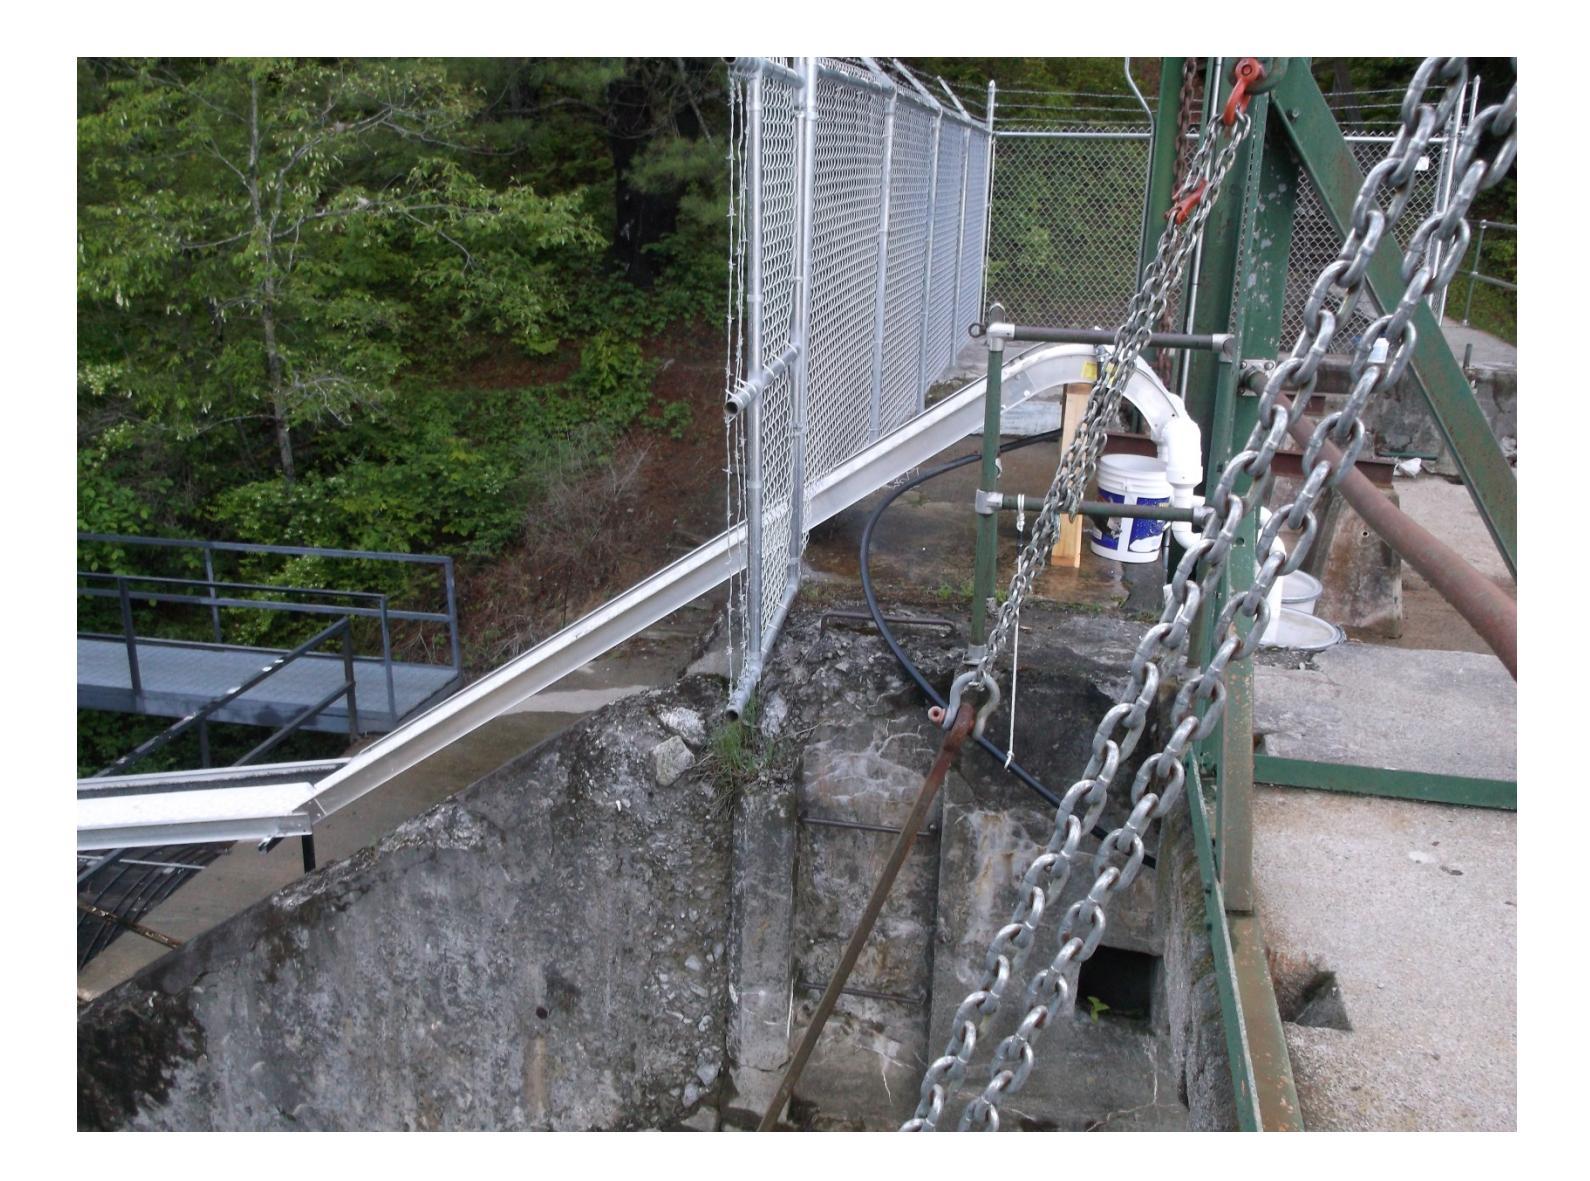
The next ramp is twelve feet long and is set at thirty-four degrees. It attaches to the supported end and rests on the concrete of the upper deck.

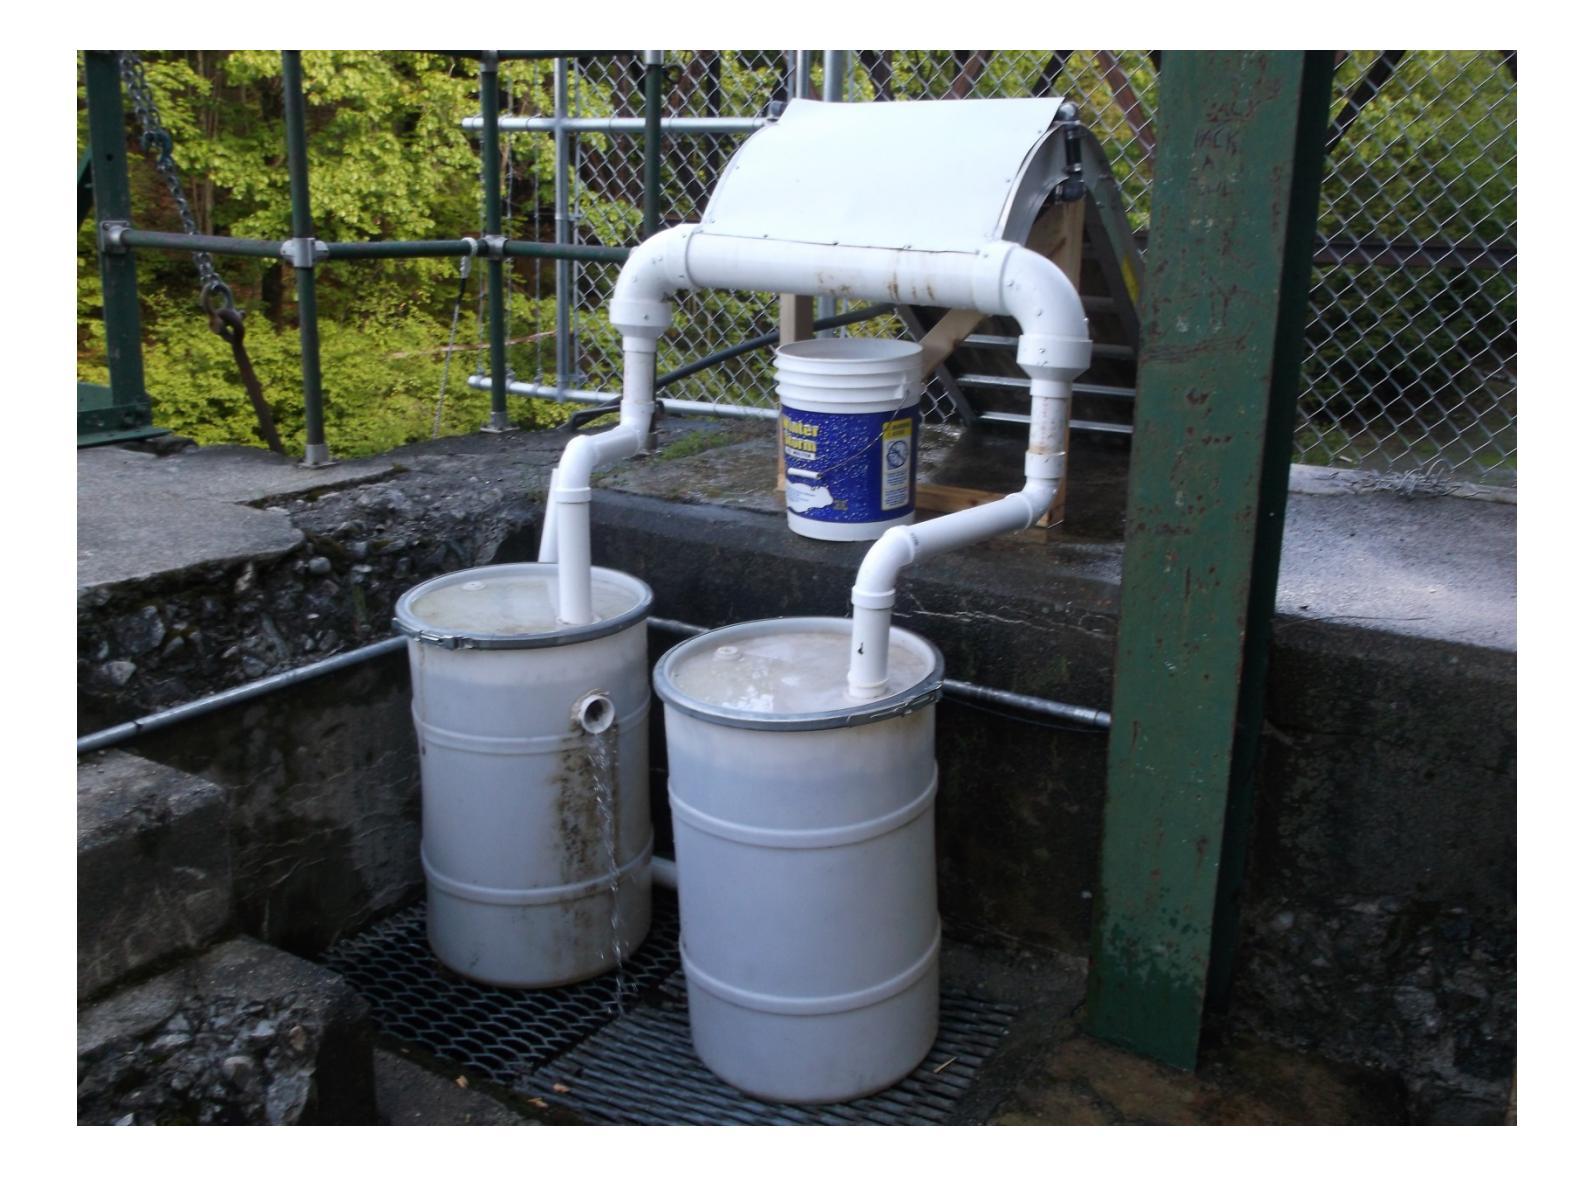
A ninety degree section is then attached and leveled with a support bracket. The attraction water and trap plumbing was then attached. Two catch barrels were temporarily connected for the collection of samples.

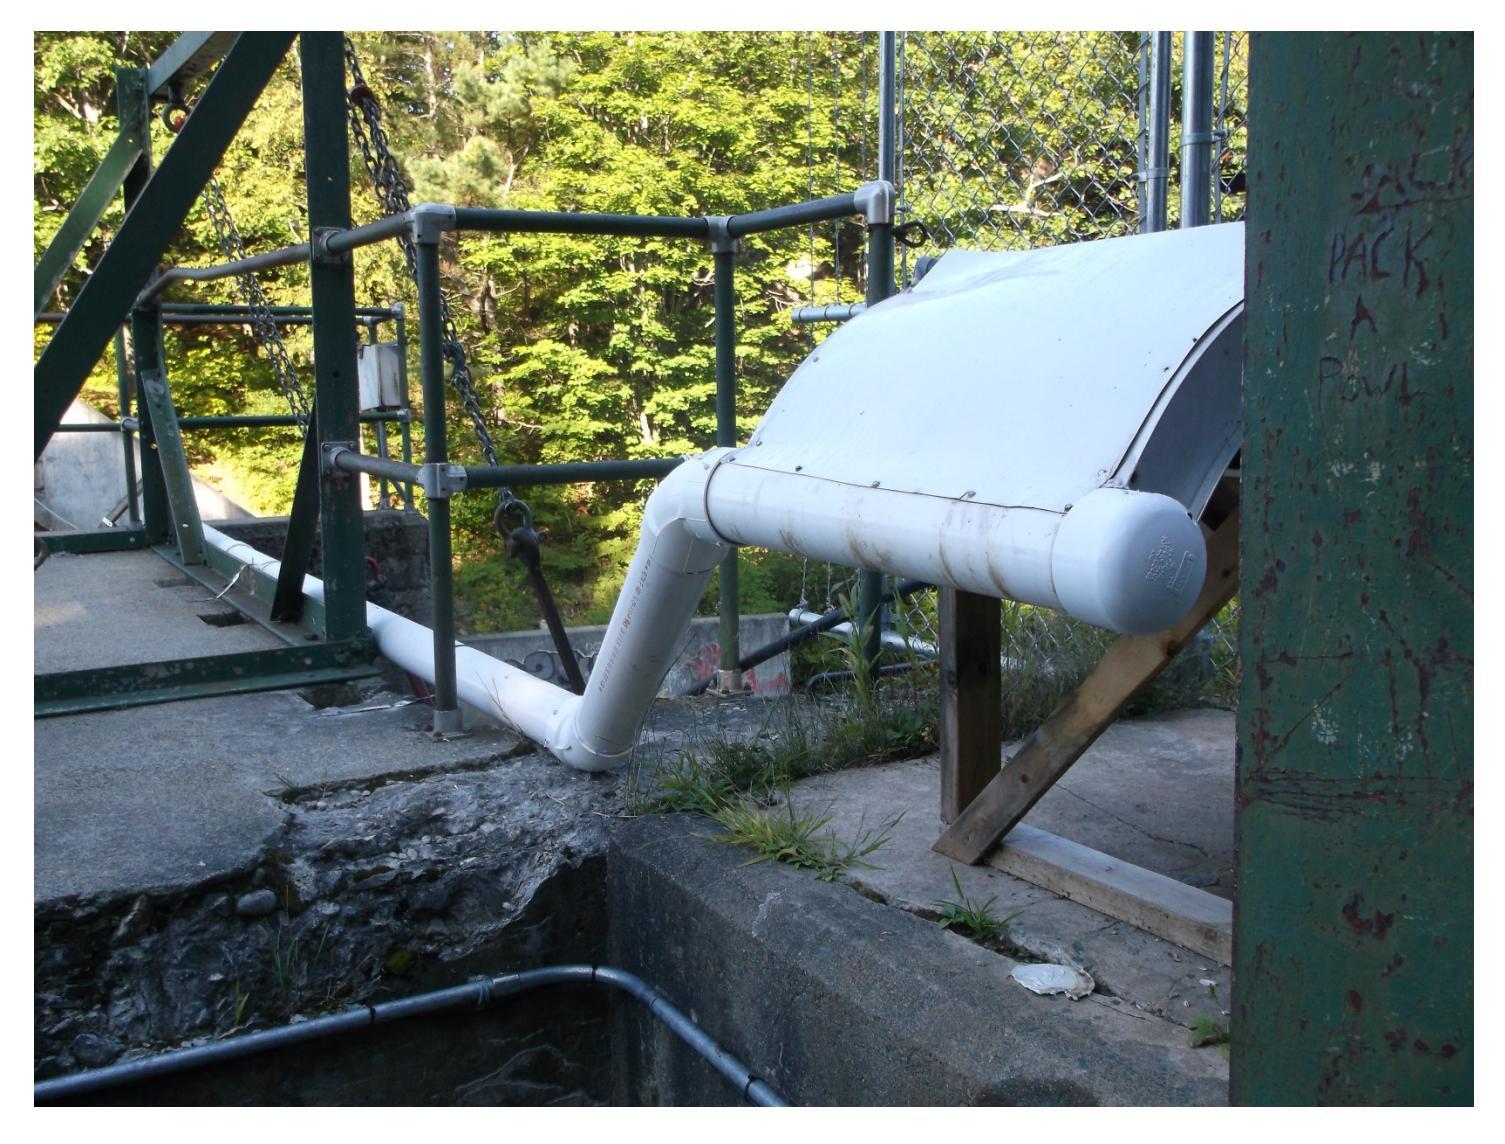
After samples and testing were completed, an exit system consisting of four inch, schedule 40, PVC piping was connected to the terminal end of the ramp to allow eels to gain access to the headpond. This piping carries eels across the minimum flow gates, down the concrete support wall, and into the water at the top of dam. The submerged pipe is angled at forty-five degrees and is fourteen feet long.

Piping across minimum flow gate

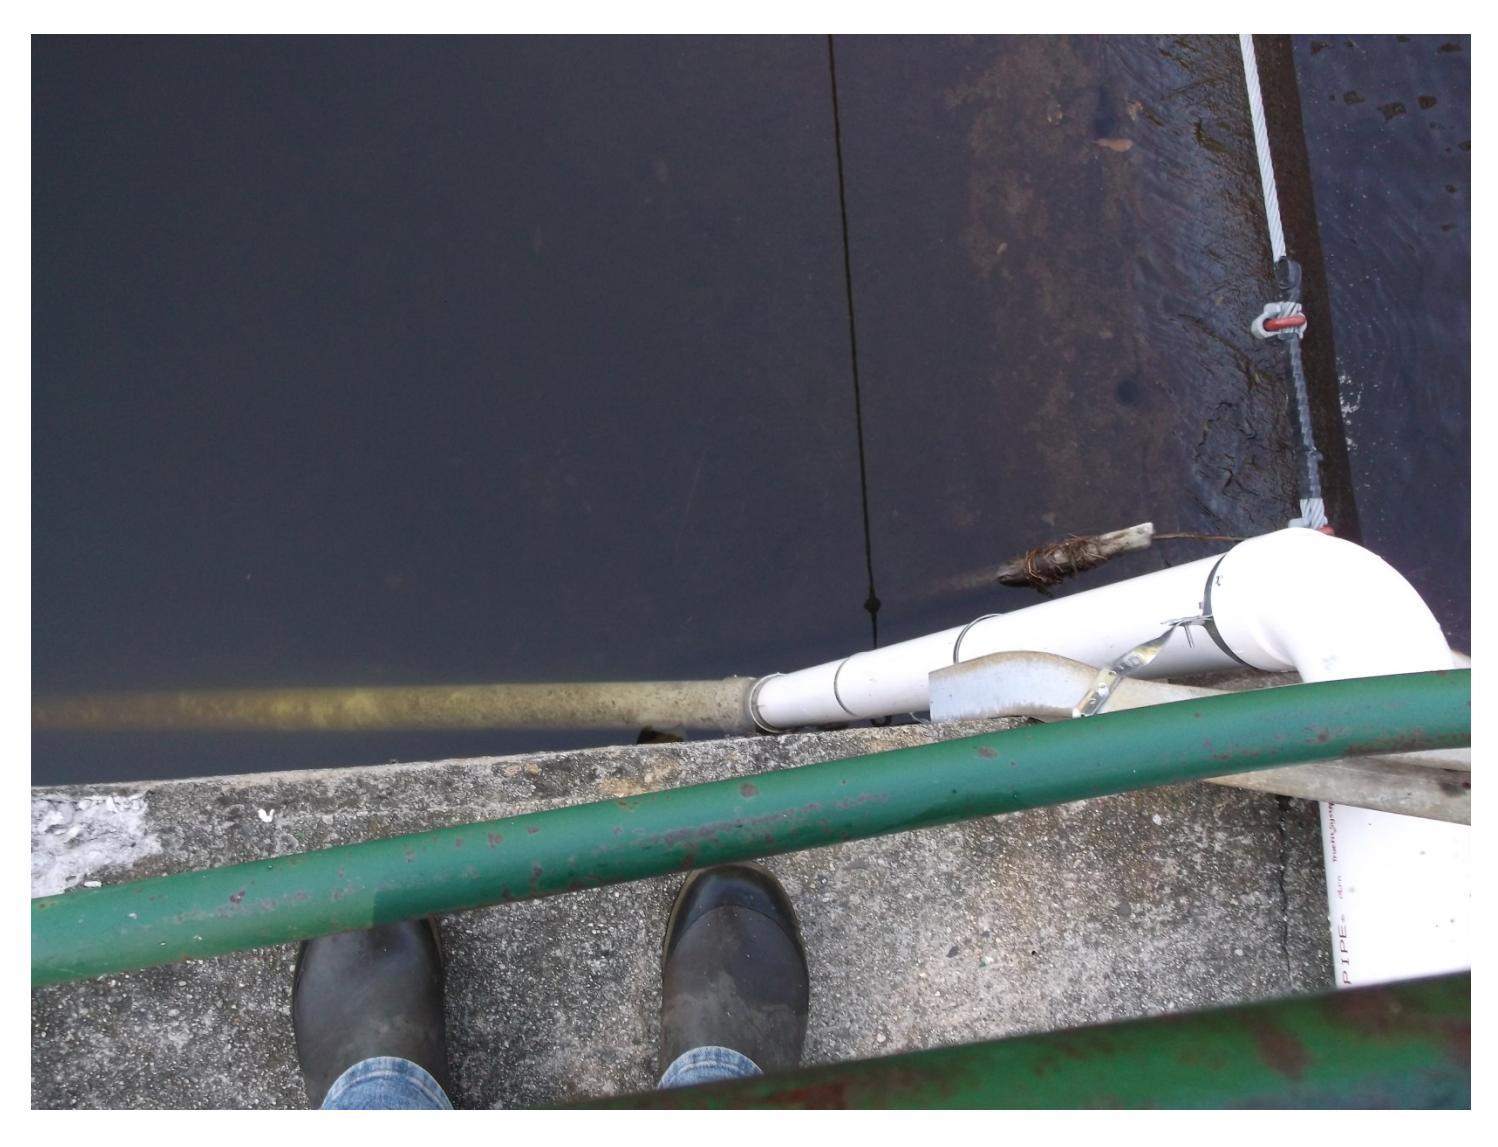
Fourteen ft. submerged exit pipe

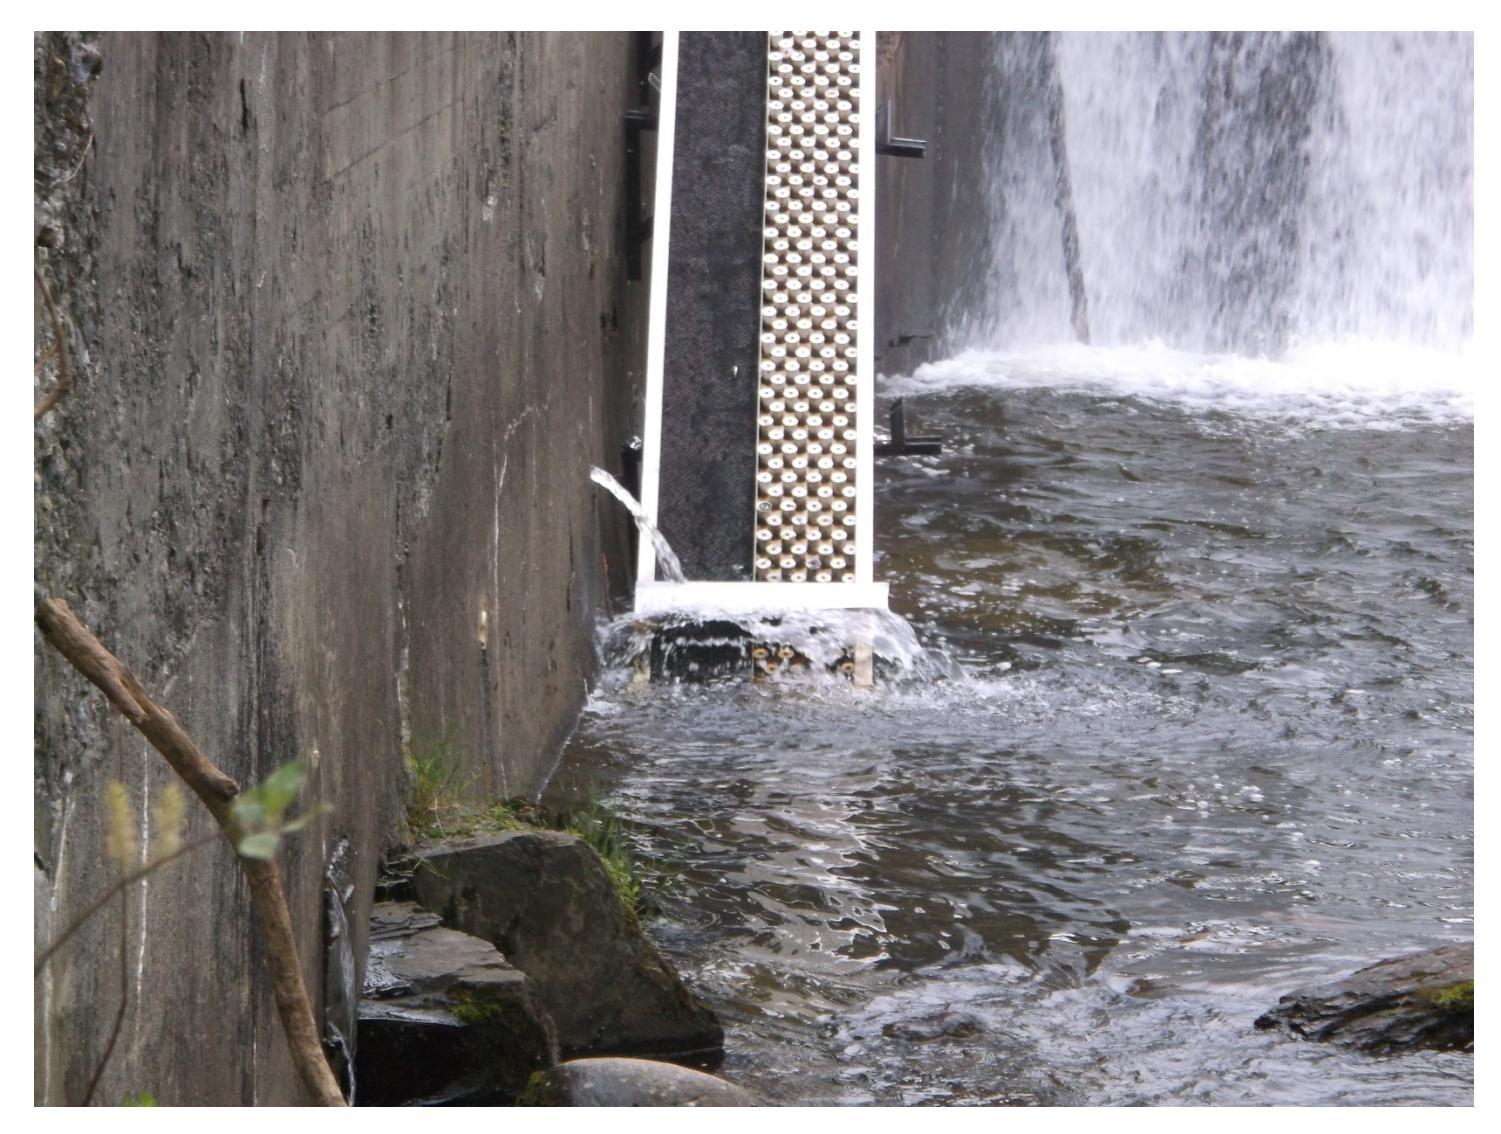
Penstock leakage was utilized as additional attraction flow at the bottom of the ramp. A curved double section of aluminum was secured across the ramp to disperse water at the entrance.

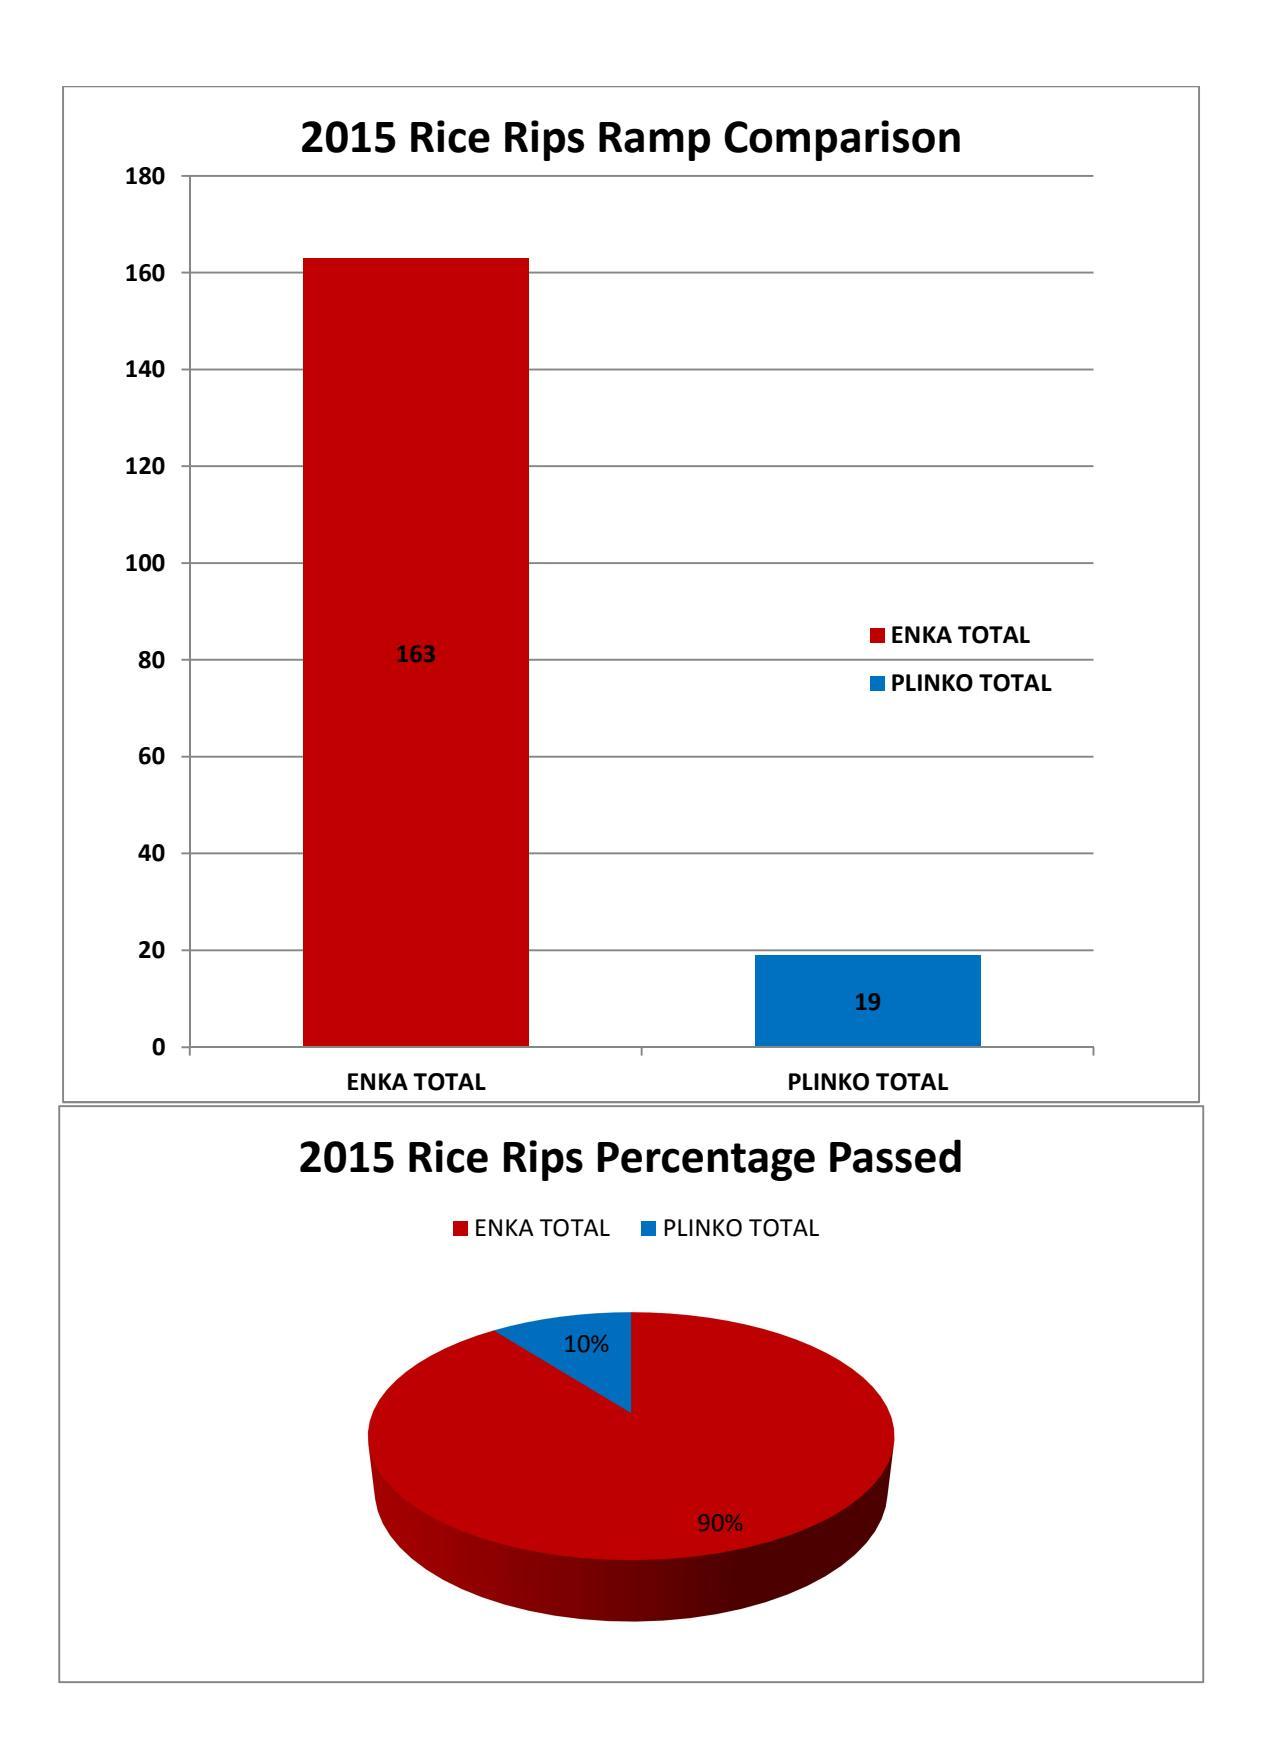
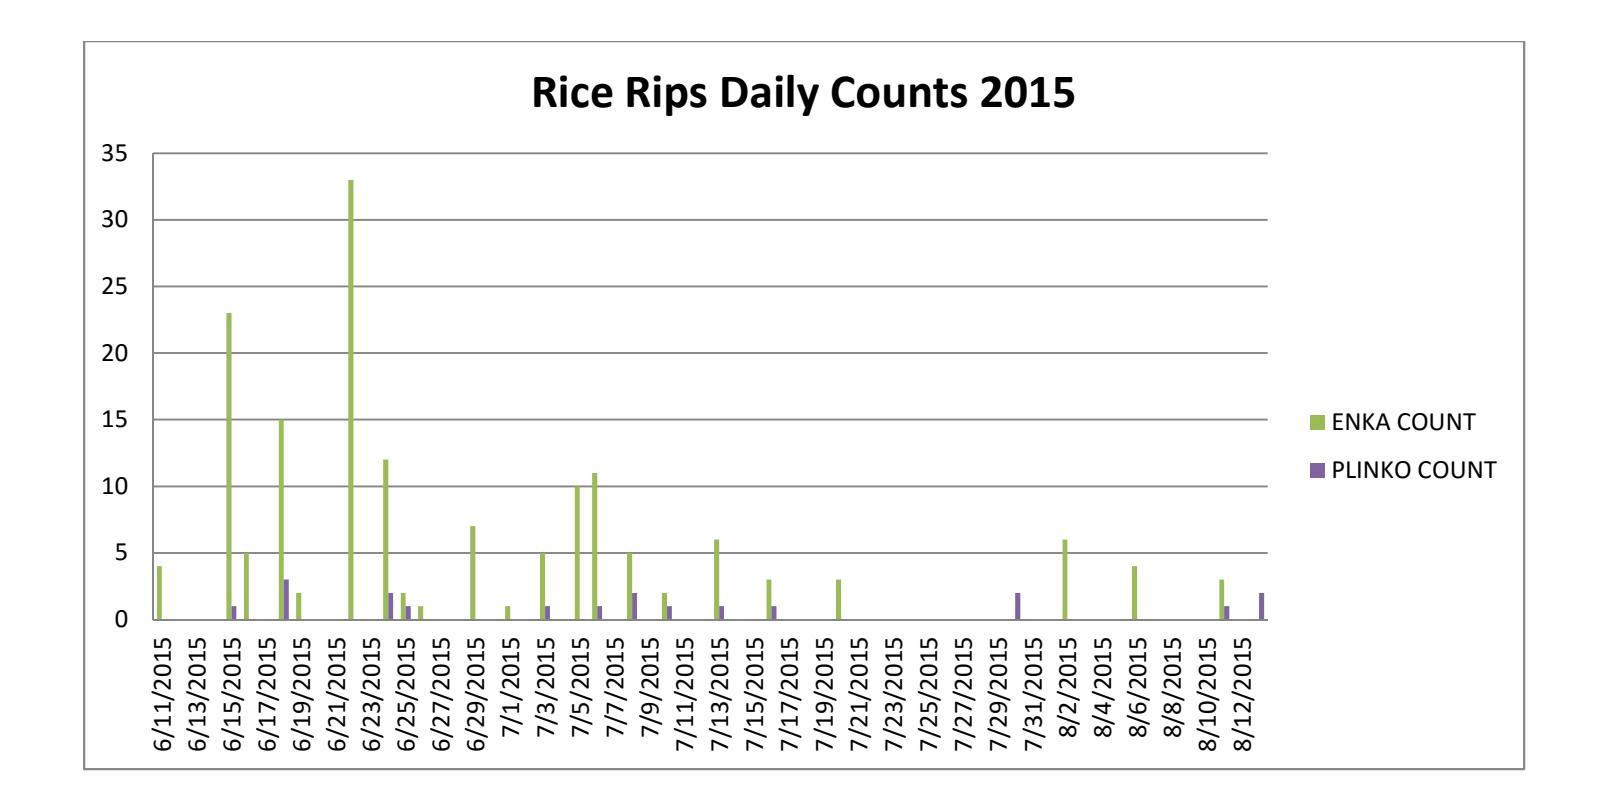
The Enkamat ramp passed a total of 163 eels weighing 337.3 grams, while the Plinko ramp passed a total of 19 eels weighing 245.1 grams. The smallest eel was 9.8 centimeters in length with the largest eel being 34.8 centimeters long.

2015 Sample and Catch Data					
DATE	ENKA CATCH (g)	PLINKO CATCH (g)	ENKA COUNT	PLINKO COUNT	SMALLEST (cm)	LARGEST (cm)
6/11/2015	12.2	0	4	0	10.7	15.1
6/15/2015	24.9	6.1	23	1	9.7	27.1
6/16/2015	10.3	0	5	0	9.8	12
6/18/2015	32.4	6.1	15	3		
6/19/2015	4.2	0	2	0	11.2	12.8
6/22/2015	19	0	33	0	11.6	14.7
6/24/2015	23.8	2.6	12	2	8.7	12.9
6/25/2015	3.9	1.7	2	1	10.1	13.6
6/26/2015	2.3	0	1	0	13.4	13.4
6/29/2015	16.9	0	7	0	10.1	16.2
7/1/2015	2.1	0	1	0	14.1	14.1
7/3/2015	13.6	1.8	5	1	10.1	15.5
7/5/2015	19.6	0	10	0	10	16
7/6/2015	29.2	4.7	11	1	11.8	16.4
7/8/2015	22.8	29.1	5	2	11.2	23.2
7/10/2015	4.8	17.6	2	1	14.6	24.1
7/13/2015	26.1	31.1	6	1	11.2	26.2
7/16/2015	8.7	20.8	3	1	11.9	25.1
7/20/2015	9.1	0	3	0	13.8	15.3
7/30/2015	0	35.7	0	2	15.3	26.6
8/2/2015	11	0	6	0	10.1	13.1
8/6/2015	8.9	0	4	0	10.5	12.8
8/11/2015	31.5	12.1	3	1	16.5	31.5
8/13/2015	0	75.7	0	2	23.1	34.8
Totals	337.3	245.1	163	19
